westrek
geotechnical services ltd.

TECHNICAL MEMORANDUM

Date: February 18, 2019
To: James Kay
City of Kelowna
Re: Slope Instability - 2045 Loseth Road
Questions for Discussion with Westrek

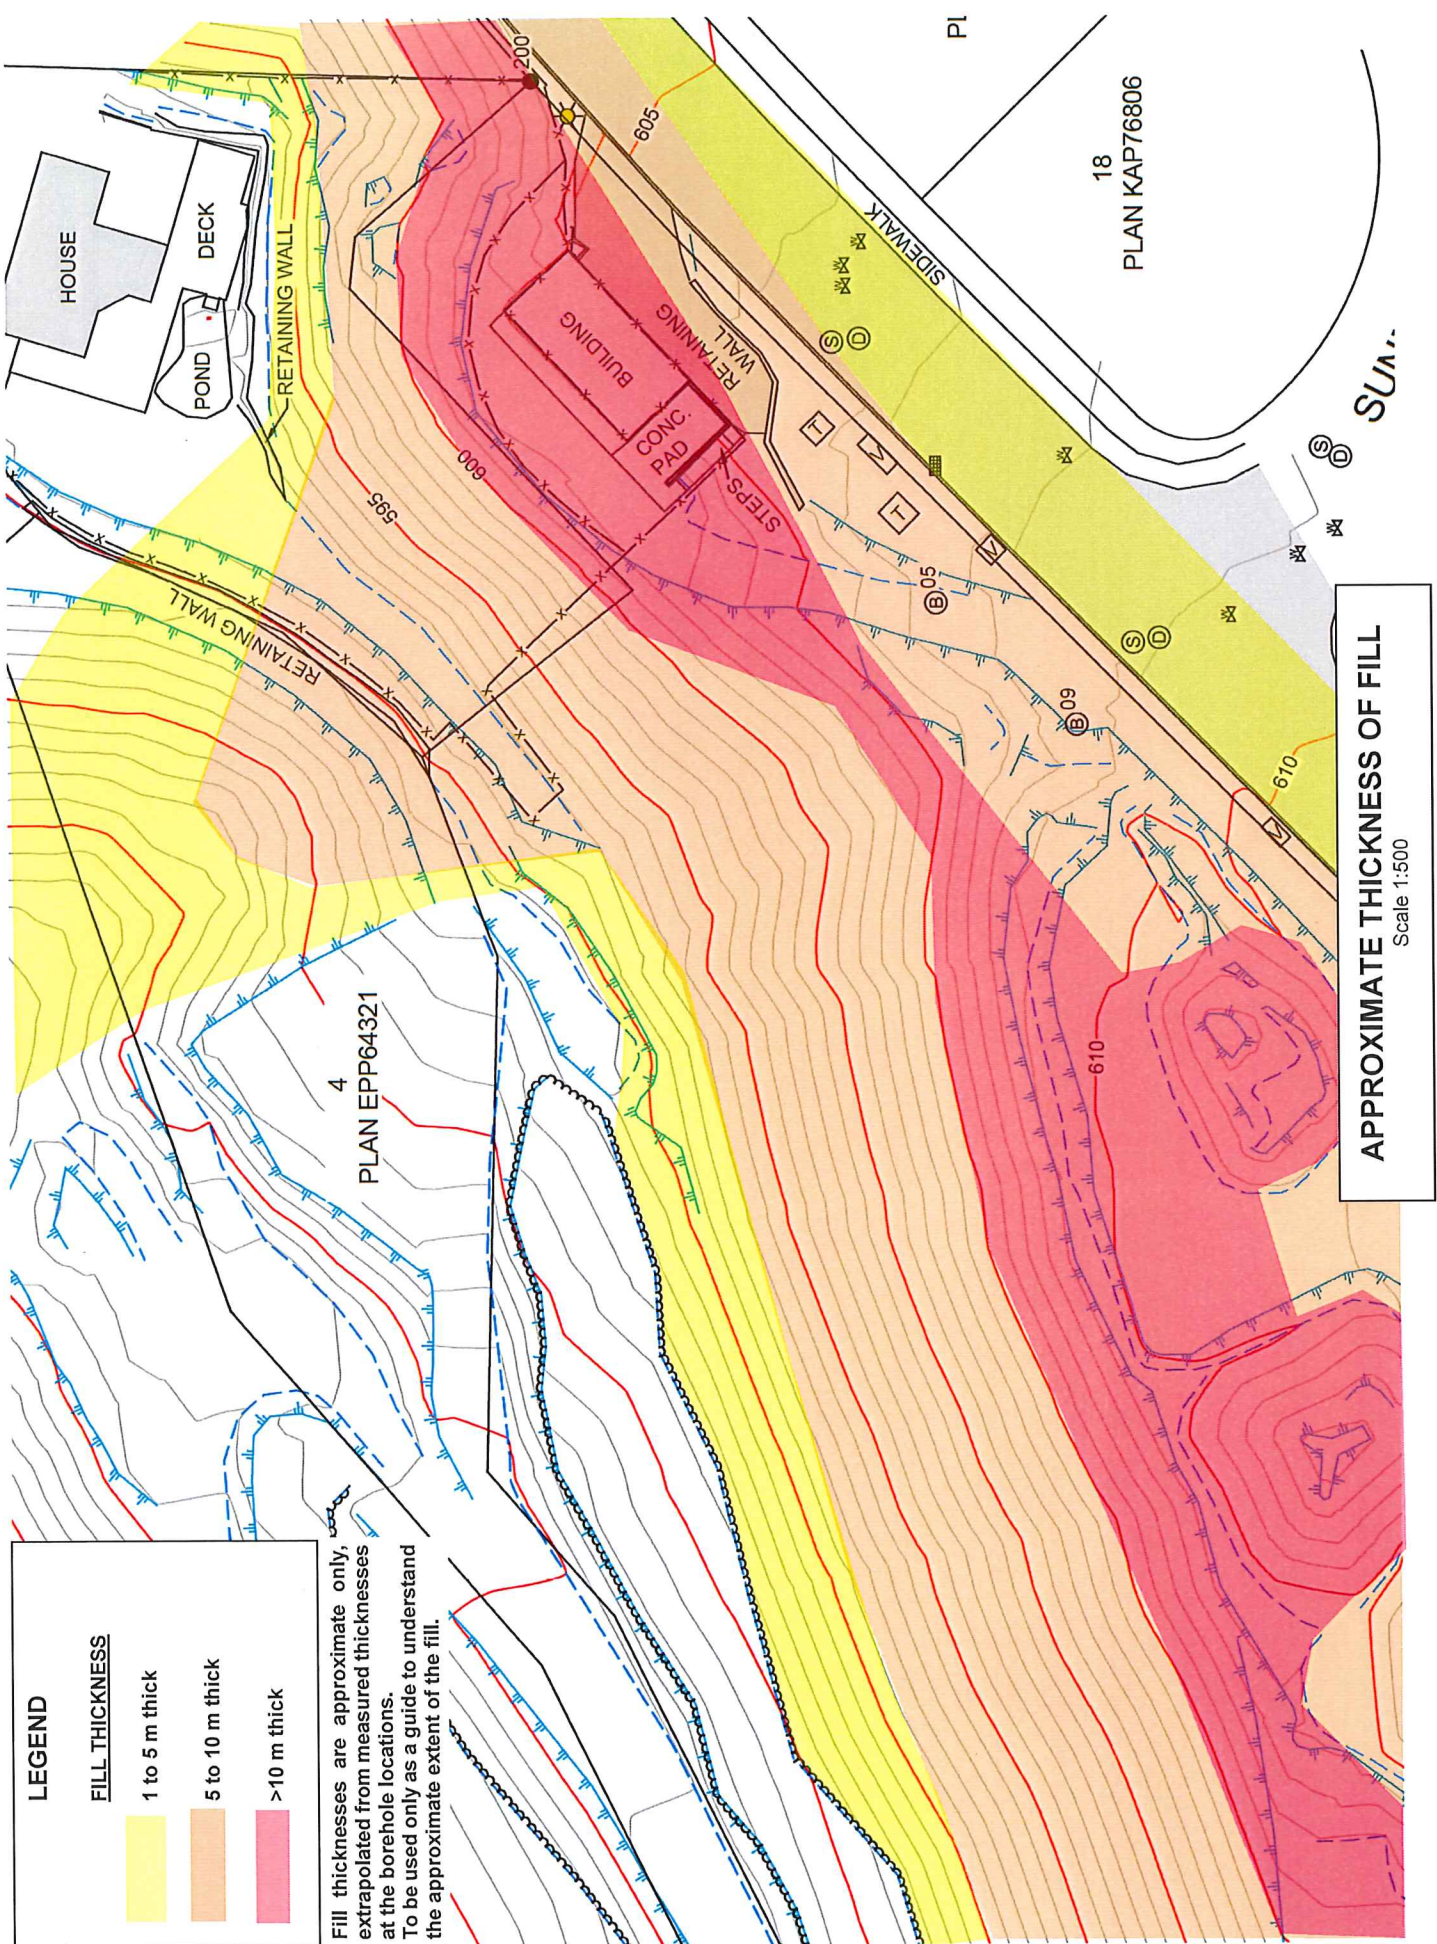
APPROXIMATE THICKNESS OF FILL

Answer 1: The approximate area of fill delineated by drilling and site observations is shown on the attached map.

Fill thicknesses are approximate only, extrapolated from measured thicknesses at the borehole locations. To be used only as a guide to understand the approximate extent of the fill.
