Pre-Renovation Hazardous Material Survey Report

John Bachelder Construction
409 Park Avenue, Kelowna, BC

December 14, 2018

Apex File Number: JBC18-009

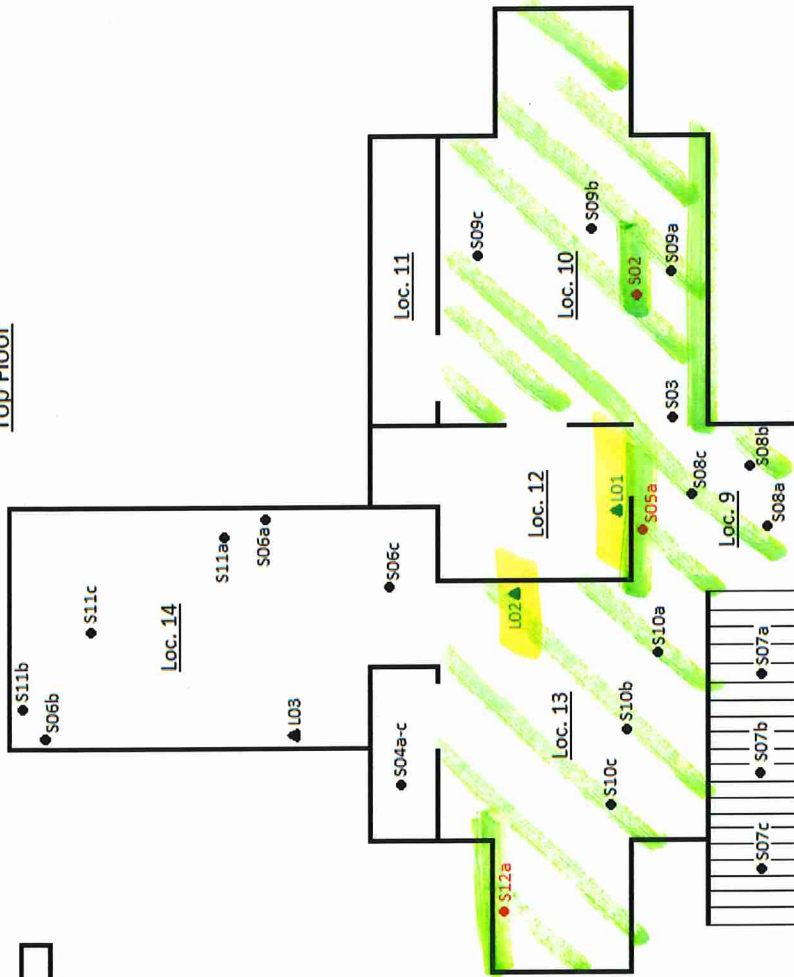
Top Floor

- Locations:
- 10. Bedroom 3
 - 11. Storage
 - 12. Bathroom
 - 13. Bedroom 4
 - 14. Bedroom 5

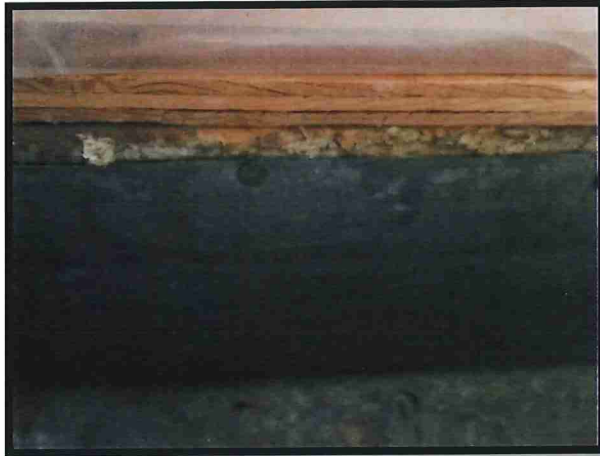
Duct wrap applied to floor registers throughout the top floor was found to contain **asbestos**.

- All asbestos-containing material must be removed using safe work procedures and practices prior to renovation activities.
- An asbestos risk assessment must be performed by a qualified professional prior to renovation work occurring to determine the exposure risk to workers and other persons.

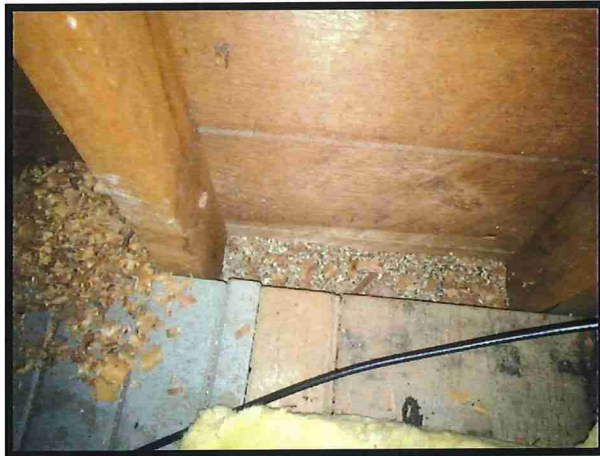
Vermiculite insulation present within the wall cavity of the east wall of the living room (Loc. 8) contains **asbestos**.

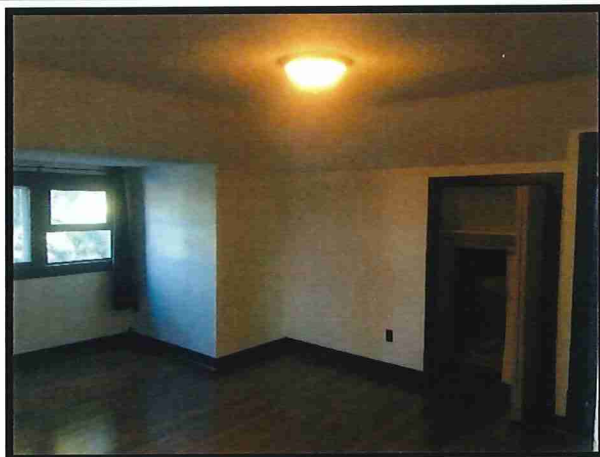
Drywall joint compound applied to drywall walls and ceiling within the landing, bedroom #3, storage, bathroom, bedroom #4 (loc. 9-13) contains **asbestos**.

White paint applied to drywall within the foyer, kitchen, storage, landing, storage, bathroom, and bedroom #4 (loc. 1, loc. 3, loc. 6, loc. 9, loc. 11-13) has a lead content >0.009%.

White paint applied to plaster foyer, landing, and bedroom #4 (loc. 1, loc. 9, and loc. 13) has a lead content >0.009%.

- Proper procedures and documentation such as safe work practices, an exposure control plan, risk assessments and/or other controls must be developed if paints containing greater than 0.009% lead are to be removed or disturbed.

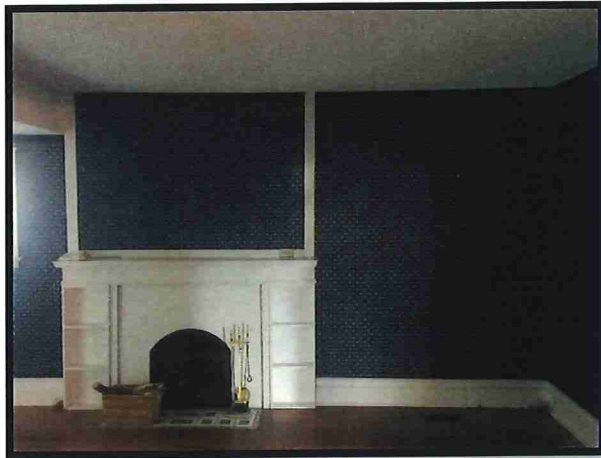
Plaster applied to walls and ceilings throughout the residence contains **asbestos**.
Blue paint applied to plaster within the living room (loc. 8) has a lead content >0.009%.
Plaster, ceramics, bricks, mortar, and stucco throughout the building are assumed to contain crystalline silica.

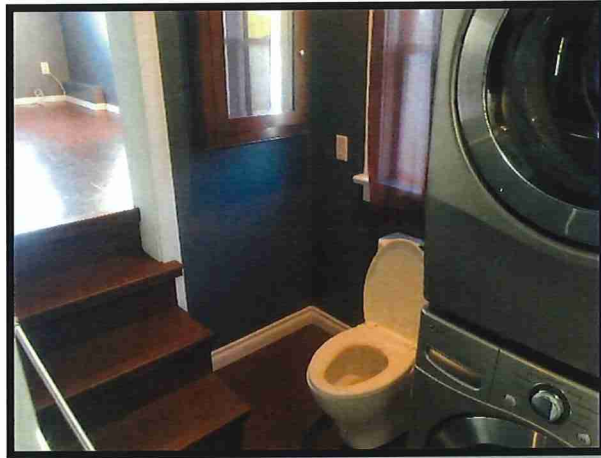
Drywall joint compound applied to drywall walls and ceilings within the laundry room (loc. 4) and bedroom #1 (loc. 5) contains **asbestos**.

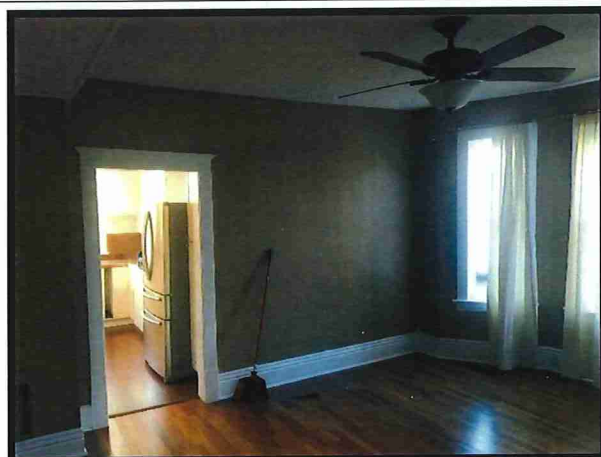
Brown paint applied to plaster within the dining room (loc. 2) has a lead content >0.009%.
White paint applied to wood trim throughout the residence has a lead content >0.009%.
