**409 Park Avenue,  
Kelowna, B.C.**

Structural Engineering Report  
on Existing Building

September 6, 2019

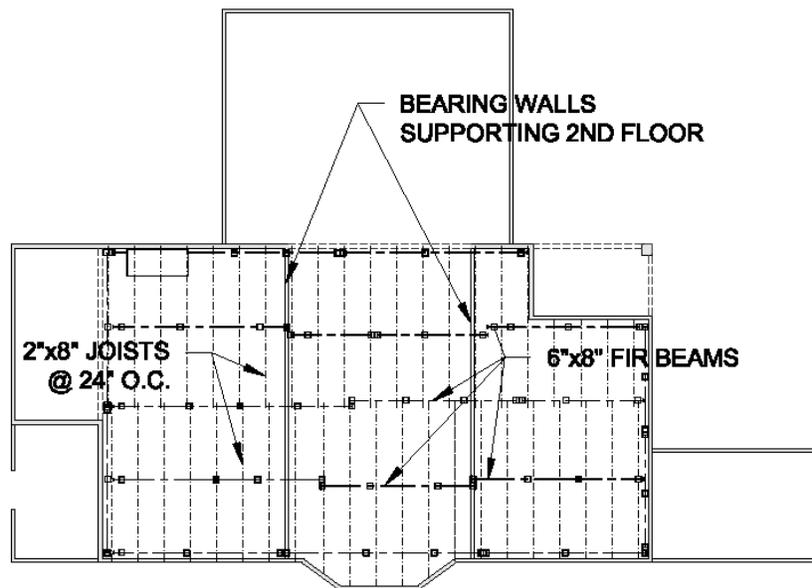
**Figure 2.1**

Both the exterior and interior walls are built off the main floor platform and do not have foundations in themselves. A sketch layout of the main floor framing system is shown in Figure 2.1 below. What is notable about this floor framing is that the primary beams (6"x8') are discontinuous and unconnected at the locations where one ends and another starts. There also do not appear to be any mechanical connections between the primary beams and their supporting columns or between the supporting columns and the concrete blocks beneath.

The floor exhibits sloping areas, localized depressions, and raised areas, all of which are indicative of differential settlement of the foundation system supporting the floor.

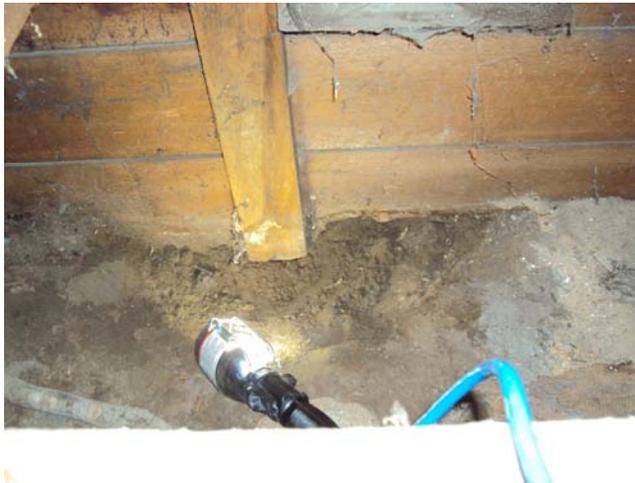
**Figure 2.2**

Fig. 2.2 is at the base of the west exterior wall showing the absence of a foundation.

The existing foundation system is structurally inadequate and in contravention of the Building Code. The foundation system could not be upgraded to satisfy the code and will therefore need to be completely replaced.

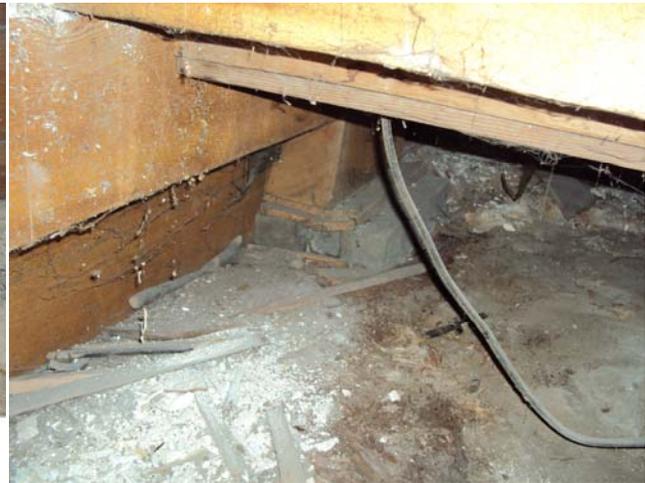
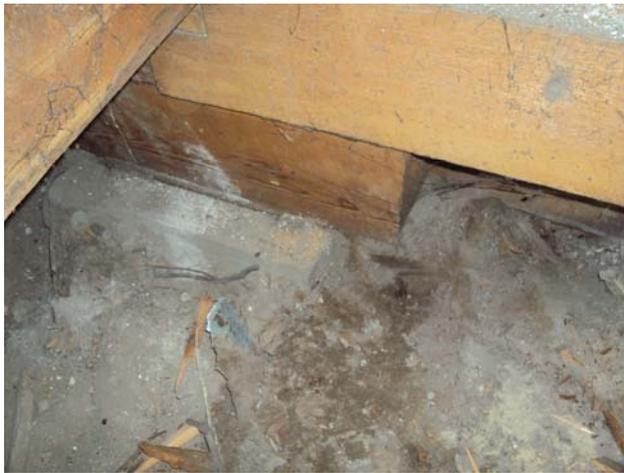
Figs. 2.3 & 2.4 showing typical supports of the primary beams around the building perimeter; these are stacked pieces of 6"x8" fir.

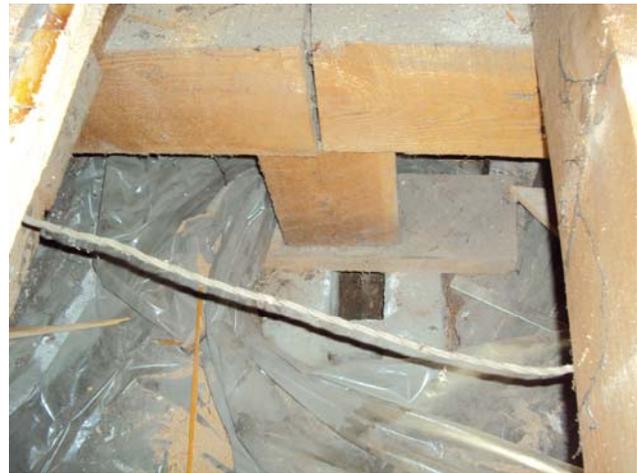
**Figure 2.5**

Fig. 2.5 shows a typical post support of a primary beam with a concrete block beneath.

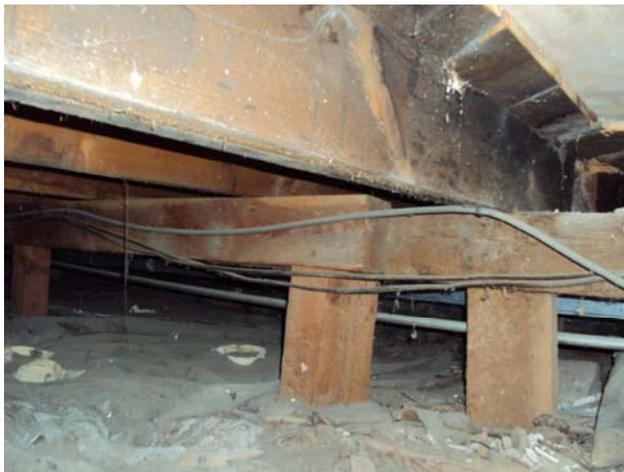
**Figure 2.6**

Figs. 2.6 & 2.7 show typical discontinuities of the primary beams and post supports. Note the significant out of vertical of the posts in Fig. 2.6

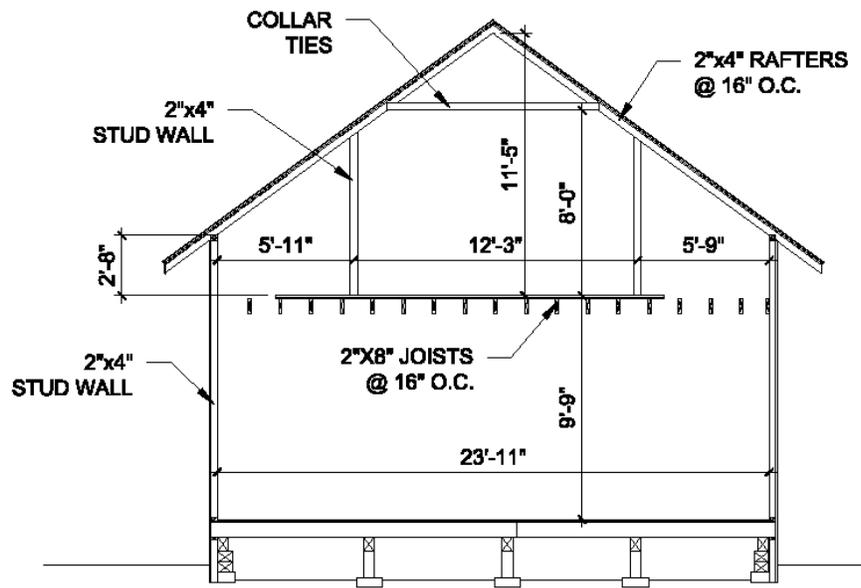
**Figure 2.8**

The house has a hipped roof framed from 2"x4" rough sawn lumber. The rafters are spaced at 16" on centre connected by collar ties at approximately the 1/3<sup>rd</sup> span point, there is no ridge beam. The rafters are supported by stud walls located just outside the midspan point and then bear on the outside walls. The interior stud walls also support the hip rafters. These stud walls are not aligned directly above beams or built up floor joists but bear solely on the floor sheathing. The original roof sheathing (still in place) is 1/2" thick x 6" wide rough sawn lumber spaced at about 10" on centre. This original sheathing has been overlaid with OSB in recent years. Figure 2.8 shows a cross section of the building clarifying the above descriptions.

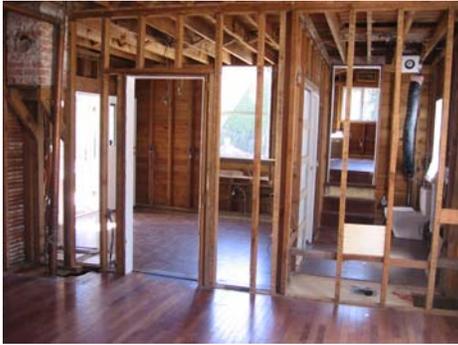
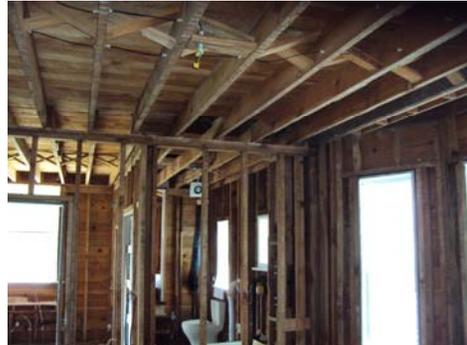
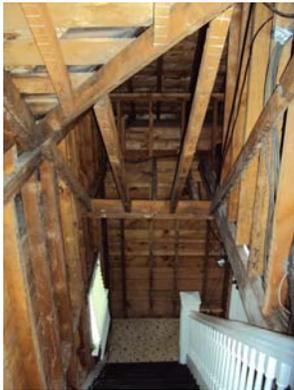
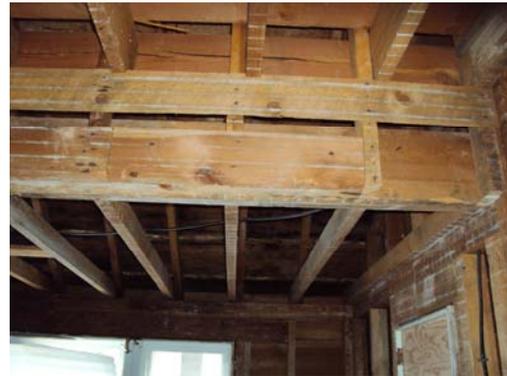
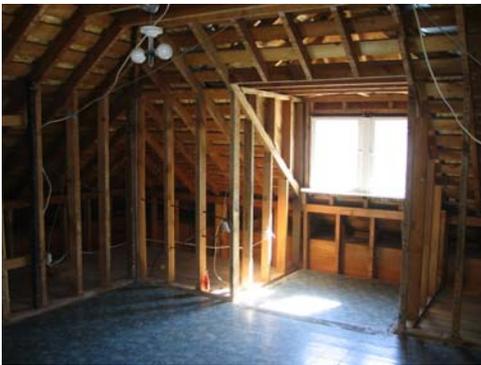
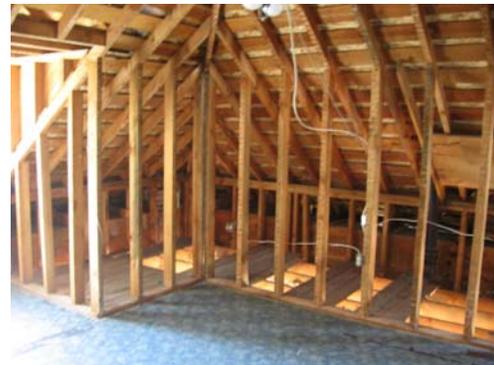
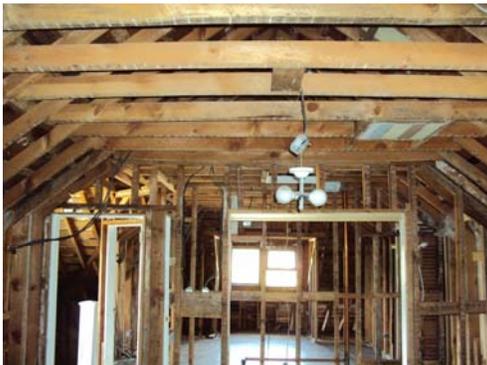
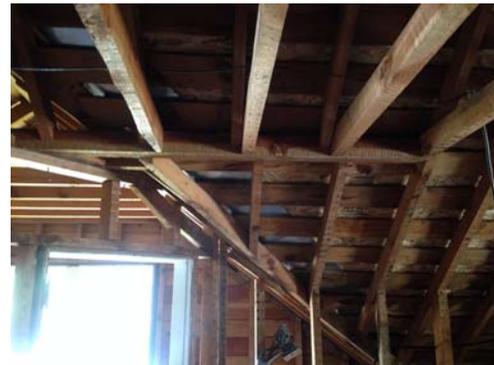
Figures 2.9 to 2.16 show various views of the second floor and roof framing.
