**409 Park Avenue,
Kelowna, B.C.**

Structural Engineering Report
on Existing Building

September 6, 2019

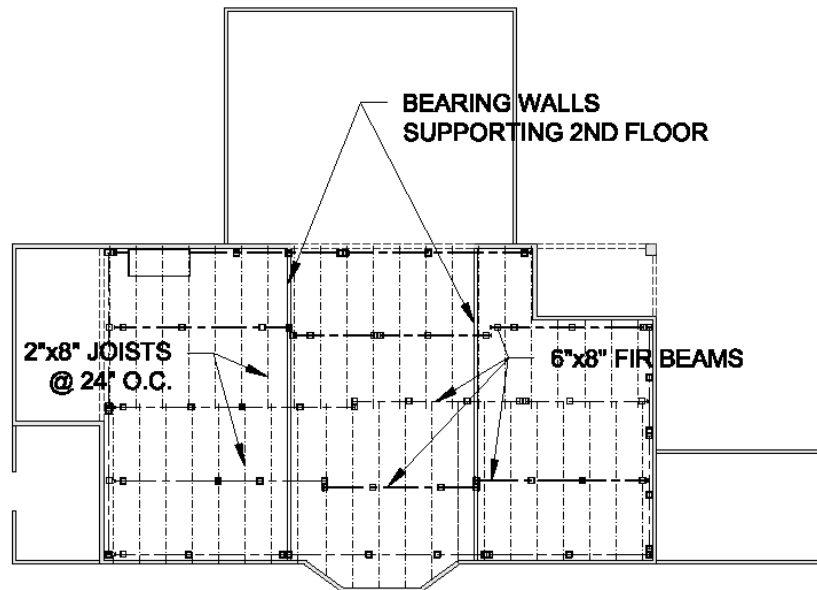
Both the exterior and interior walls are built off the main floor platform and do not have foundations in themselves. A sketch layout of the main floor framing system is shown in Figure 2.1 below. What is notable about this floor framing is that the primary beams (6"x8') are discontinuous and unconnected at the locations where one ends and another starts. There also do not appear to be any mechanical connections between the primary beams and their supporting columns or between the supporting columns and the concrete blocks beneath.

The floor exhibits sloping areas, localized depressions, and raised areas, all of which are indicative of differential settlement of the foundation system supporting the floor.

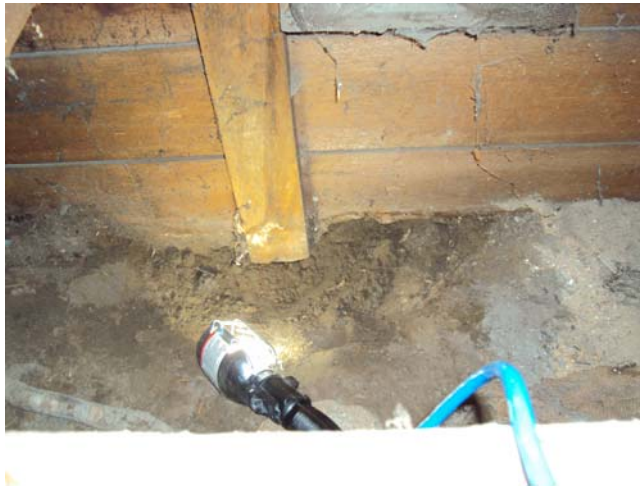
Figure 2.2

Fig. 2.2 is at the base of the west exterior wall showing the absence of a foundation.

The existing foundation system is structurally inadequate and in contravention of the Building Code. The foundation system could not be upgraded to satisfy the code and will therefore need to be completely replaced.

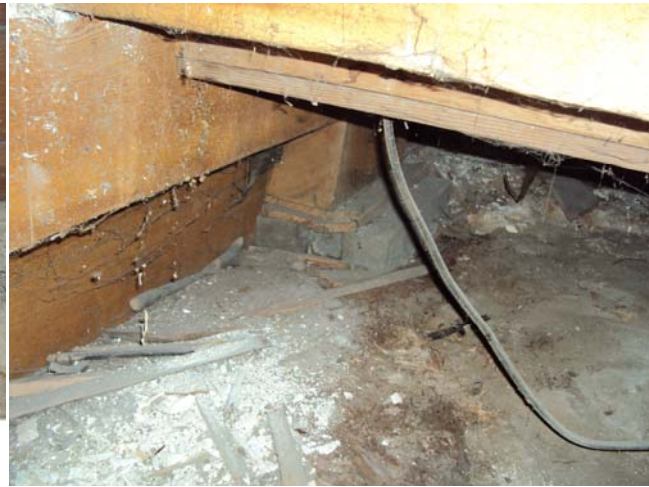
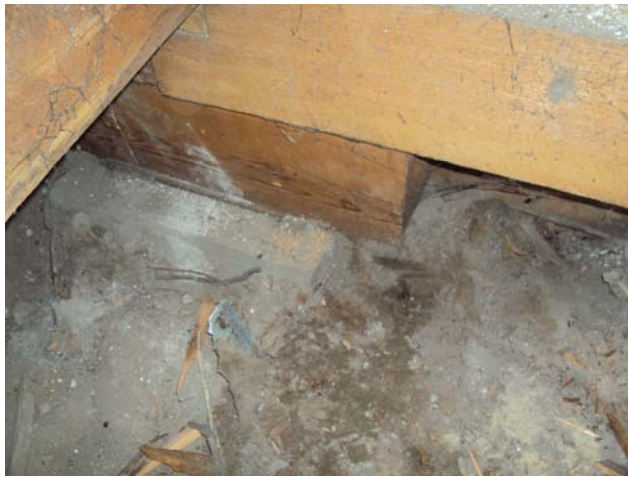
Figs. 2.3 & 2.4 showing typical supports of the primary beams around the building perimeter; these are stacked pieces of 6"x8" fir.

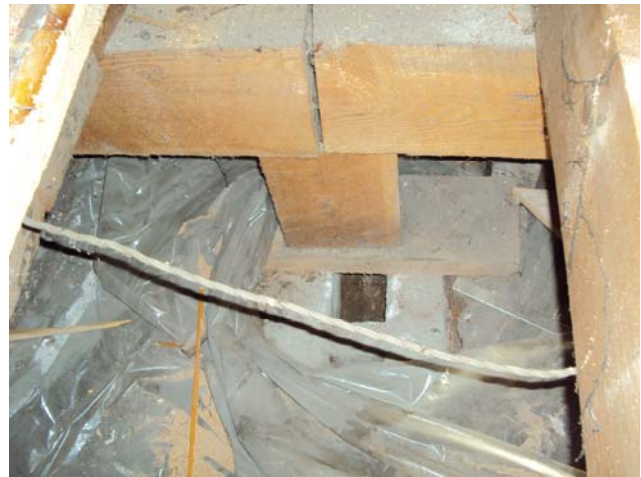
Figure 2.5

Fig. 2.5 shows a typical post support of a primary beam with a concrete block beneath.

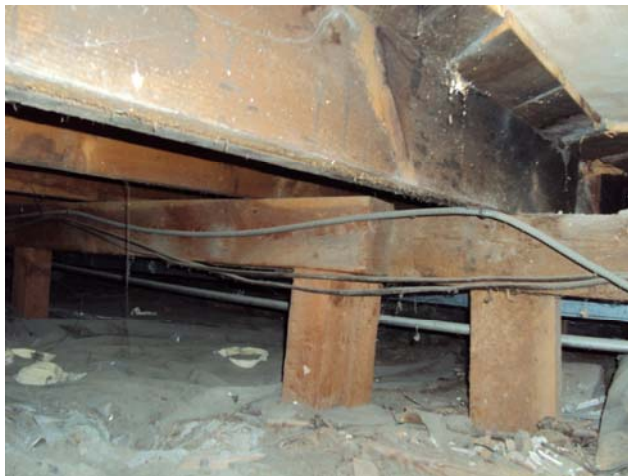
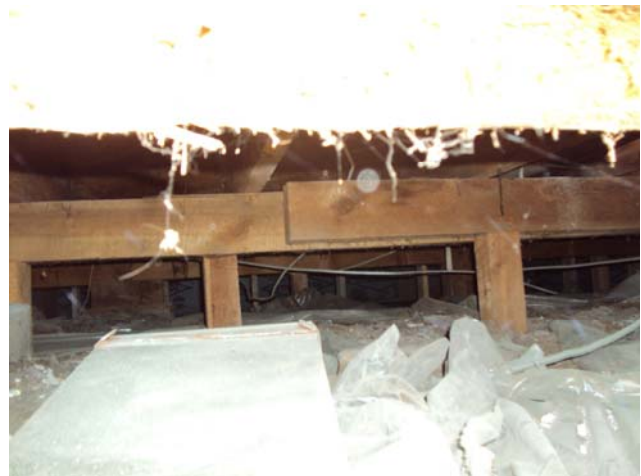
Figs. 2.6 & 2.7 show typical discontinuities of the primary beams and post supports. Note the significant out of vertical of the posts in Fig. 2.6

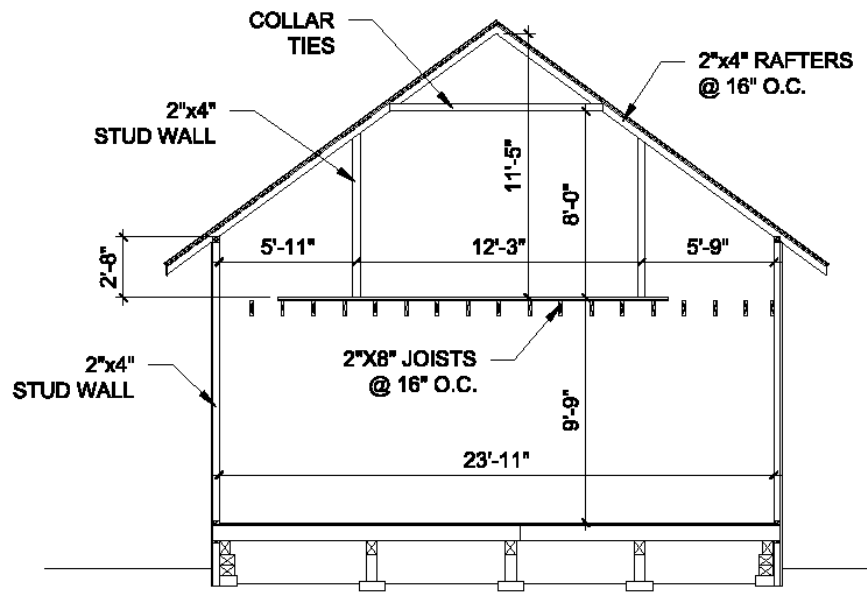
The house has a hipped roof framed from 2"x4" rough sawn lumber. The rafters are spaced at 16" on centre connected by collar ties at approximately the 1/3rd span point, there is no ridge beam. The rafters are supported by stud walls located just outside the midspan point and then bear on the outside walls. The interior stud walls also support the hip rafters. These stud walls are not aligned directly above beams or built up floor joists but bear solely on the floor sheathing. The original roof sheathing (still in place) is 1/2" thick x 6" wide rough sawn lumber spaced at about 10" on centre. This original sheathing has been overlaid with OSB in recent years. Figure 2.8 shows a cross section of the building clarifying the above descriptions.

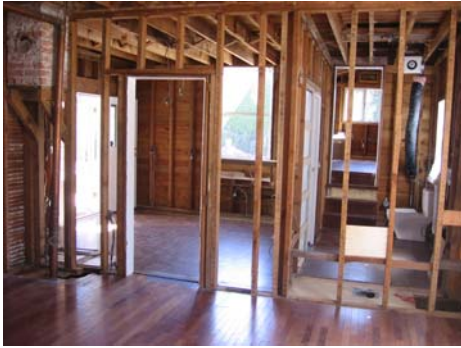
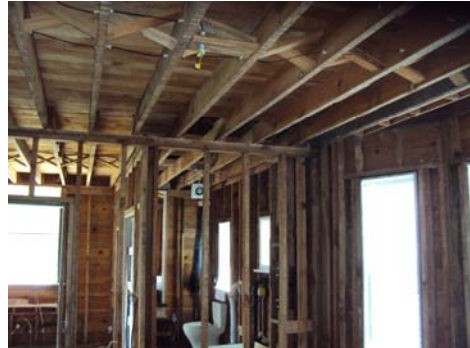
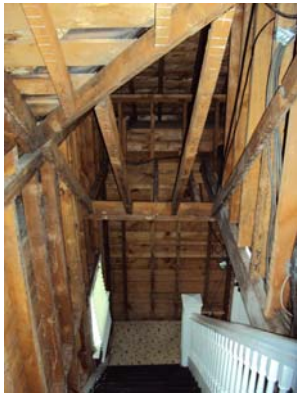
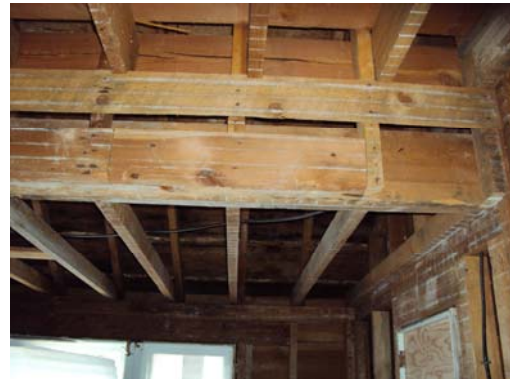
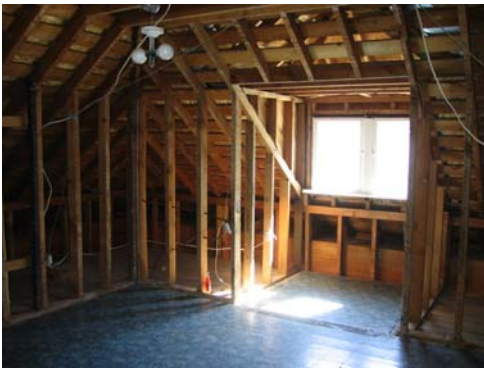
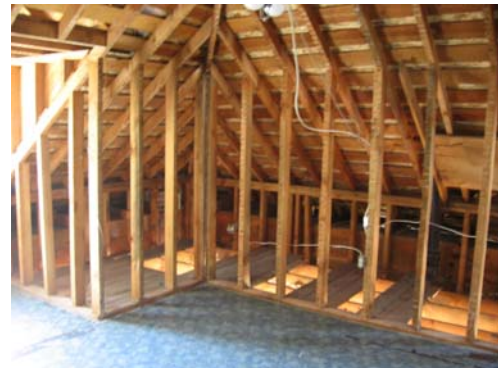
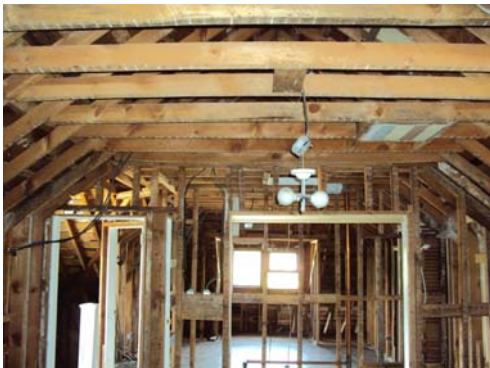
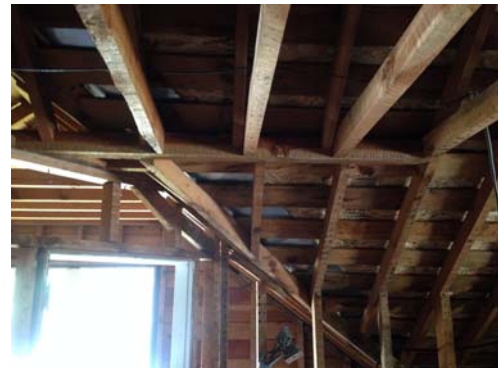
The gable on the west side is unquestionably a modification of the original roof construction. The roof framing of this gable is quite crudely done, its structural integrity being entirely reliant on an added interior stud wall on the 2nd floor. However, even if it were to be accepted that this additional stud wall is in itself competent, the modified and added to roof structure supported is unacceptably configured containing serious flaws. On one side the valley rafter is discontinuous and on the other side the valley rafter does not exist at all. The end of the gable ridge beam appears unsupported altogether.

In my opinion this roof structure is unsafe and would be vulnerable to serious deformation, or even collapse, under full snow load.

Figures 2.9 to 2.16 show various views of the second floor and roof framing.

The roof structure was so significantly compromised when the west side gable was cut into it that the entire roof in that area of the building would need to be removed and replaced with new framing. The northern end of the roof was also modified when the front of the house was extended. To be added into this equation is the need to develop usable 2nd floor space, which precludes the presence of the interior stud walls which currently provide the primary support to the rafters. Consequently, any approach other than complete removal and replacement of the entire roof framing would be impractical.

The roof structure has been heavily compromised during previous modifications to the building to the extent that it would be impractical to consider anything other than complete replacement.
