# **HERITAGE CONSERVATION (MANAGEMENT) PLAN for the McIver House**

**2269 - 2279 Benvoulin Road, Kelowna, BC**

**Prepared for: The Central Okanagan Heritage Society,  
August 2018**

**Prepared by: Lorri Dauncey, MA, BA, Dip**

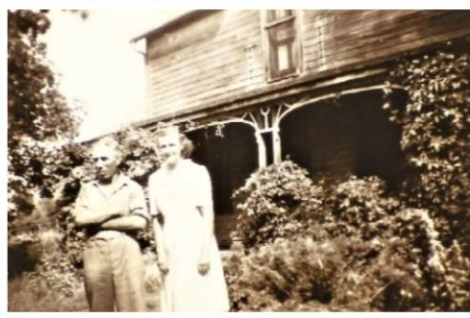
<p>Bernard ('Barney') and Harriet McIver standing in front of their house without the second-floor balcony. McIver Family Photos &amp; COHS Fonds, c.1945</p>	<p><b>Original element removed:</b></p> <p>The 40-year-old house appears to be in fair condition, with the first major change to the front façade visible. The second-floor balcony has been removed, likely due to rot. In this c. 1945 photo, the area where the balcony was attached to the house is visible.</p> <p>The house appears to be in desperate need of new paint, as there is a significant amount of bare wood showing on the upper siding. Some of the wood detailing on the verandah posts is missing.</p>
1940s/ 1950s	<p>A 'mudroom' was built at the rear of the house on the right-hand side, replacing the back verandah.</p> <div style="display: flex; justify-content: space-around;">

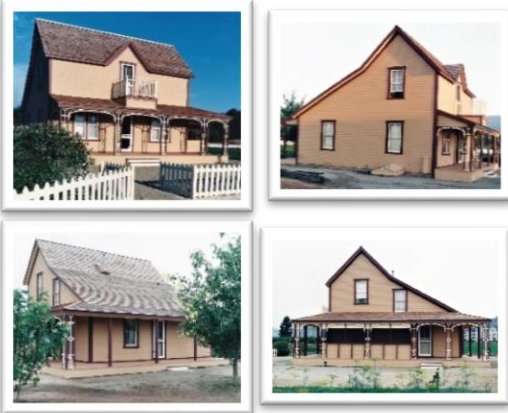
<p>View of SW, NW, NE &amp; SE facades. COHS Fonds, 1996</p>	<p><b>Original elements restored:</b></p> <p>See above for details</p>
Fall 1996

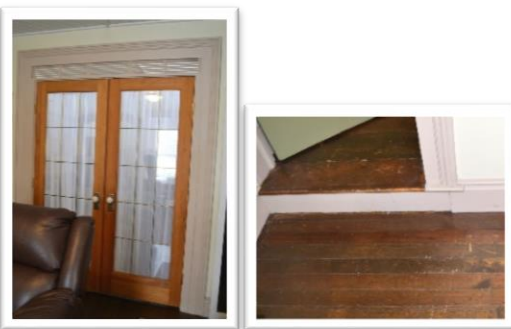
<p>New French doors &amp; Refinished floors (living room) with vintage paint removed. L. Dauncey, 2018</p>	<p><b>Renovation of interior to make more livable for caretaker(s)</b></p> <ul style="list-style-type: none"> <li>-floors were refinished (the perimeter black paint in living room was removed) and work done to keep mice from getting into the house through the crawlspace</li> <li>-interior was repainted</li> <li>-new French doors were installed between the living room and the dining room to create a new main floor bedroom. The space was modified in order to install the new doors.</li> <li>-two bathrooms had renovations and updates, such as new sinks, toilets, etc.</li> </ul>

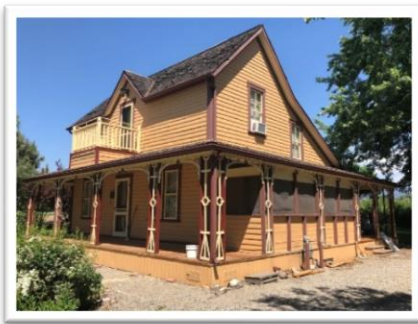
**\*Note:** The conservation work undertaken in 2017-18 included a coat of paint where repairs or replacement was necessary using the True Colours palette. The match is not exact, partially due to fading of the intense colours (repainted 11-12 years ago), especially the dark burgundy colour. This will be corrected once the house is repainted in the near future. It should also be noted that the siding is not a very close match to the True Colour palette. The True Colour, Strathcona Gold VC-9, chosen is the closest colour on the palette. It was decided to use a closer match for the verandah skirting and the balcony boards for this project and use the VC-9, when the house is repainted.
