Heritage Register Evaluation

2079 Pandosy Street

Prepared By: Mountain Heritage- Susan Medville, MA, CAHP, BCAHP
May 17, 2023, Revised May 18, 2023
For: Bjelica Holdings Ltd.

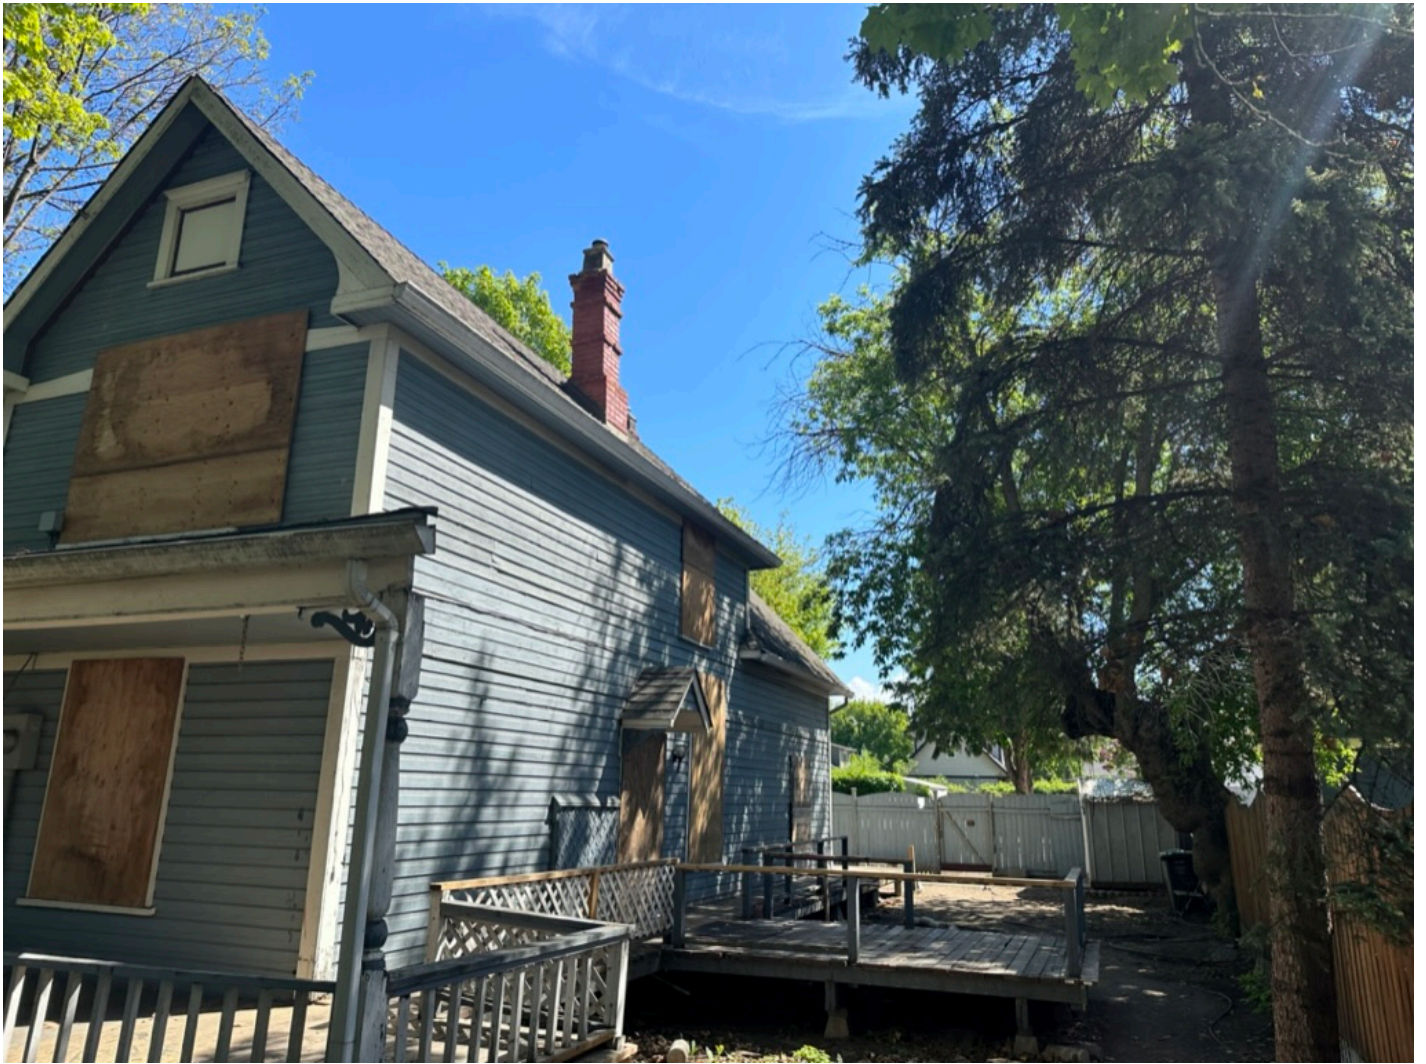
May 10, 2016, south elevation

around porch roof and the addition of non-compatible decking along that elevation. The removal of the porch roof on the south elevation has led to the deterioration of the lathed porch column and baluster railing as they are now exposed to moisture. Some of the windows have been damaged due to vandalism and as a result have been boarded over. The remaining intact windows appear to be historic and in their original locations; their working condition is unknown. The original front door has been replaced. Both front and rear doors to the building have also been secured with sheet boards to dissuade squatters.

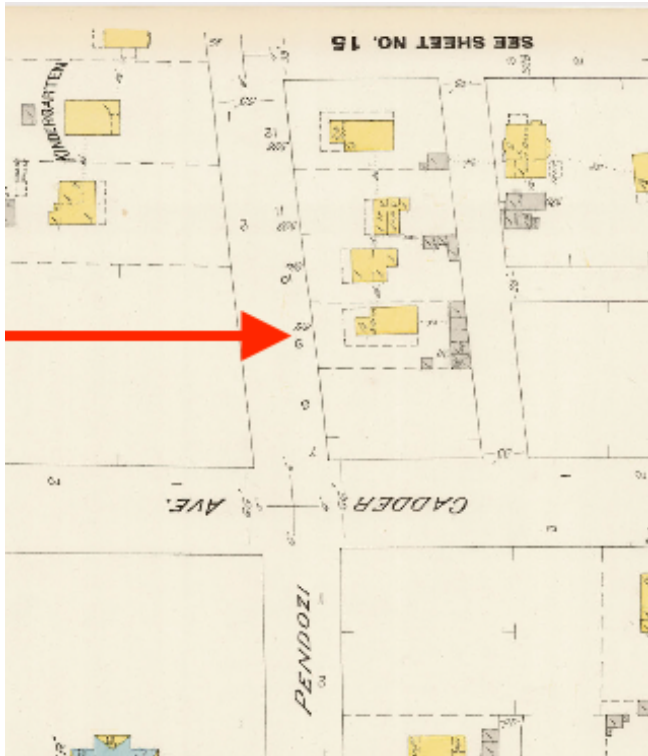
Goad's Fire Insurance Maps, Kelowna May 1914, note no rear addition and full wrap around the south side with covered porch.

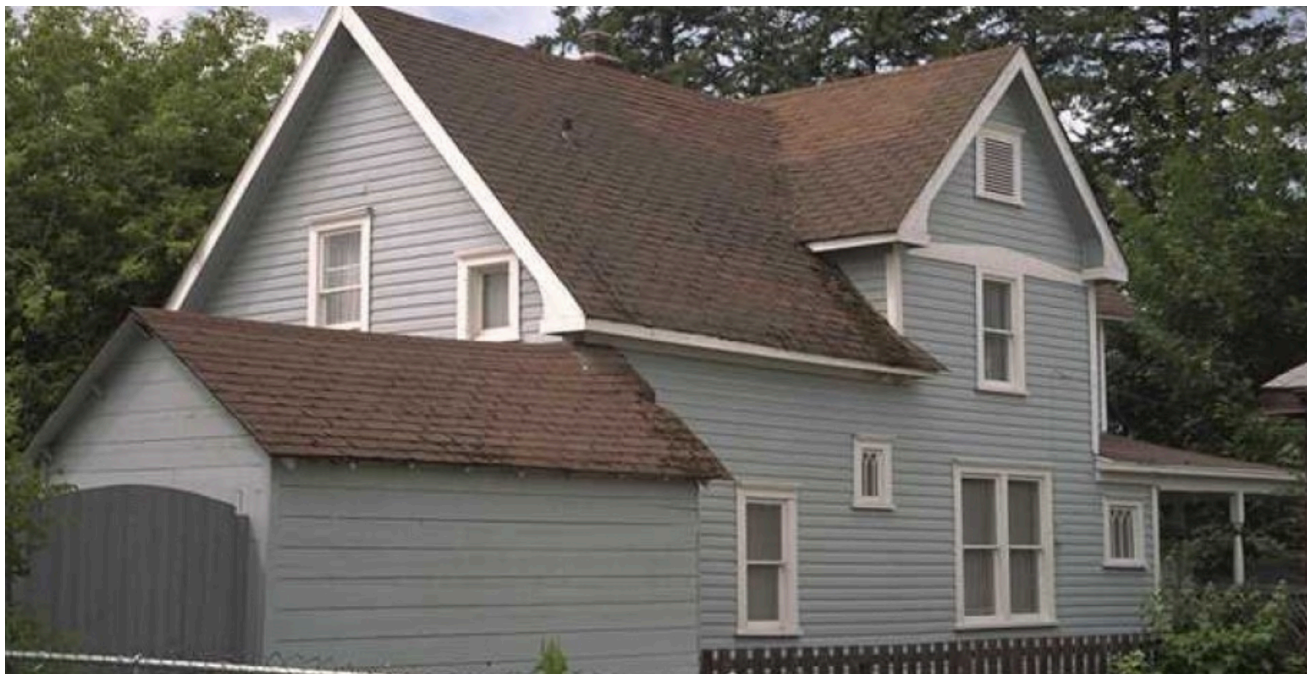
1994 Kelowna Heritage Register, note the current rear addition appears larger in scale than this one.

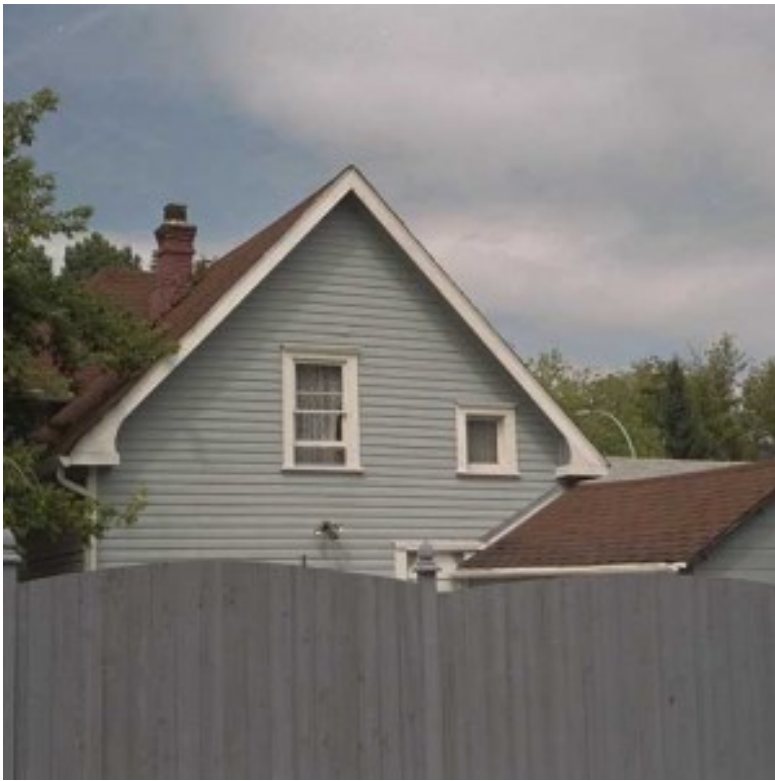
The wrap around verandah/ porch is now only partially intact with the south side removed. The SoS speaks to decorative shingles in the gabled end, however the lap-sided building does not have visible evidence of ever featuring decorative shingles nor does the house appear to have replaced siding. The largest negative impact to the house is the results of general neglect and non-maintenance. It appears from the directory listing that the house may have had only periodic occupants between 1978-1990. For at least the last five years it was a rental house and then occupied by squatters from October 2022- April of 2023.

1994 Kelowna Heritage Register, note no shingles in gabled end of building as noted being present in SoS.
