**RE: Heritage Element and Structural Visual Assessment
Kelowna Train Station Pub
1177 Ellis Street, Kelowna, BC**

RJC No. KEL.104377.0006

Introduction

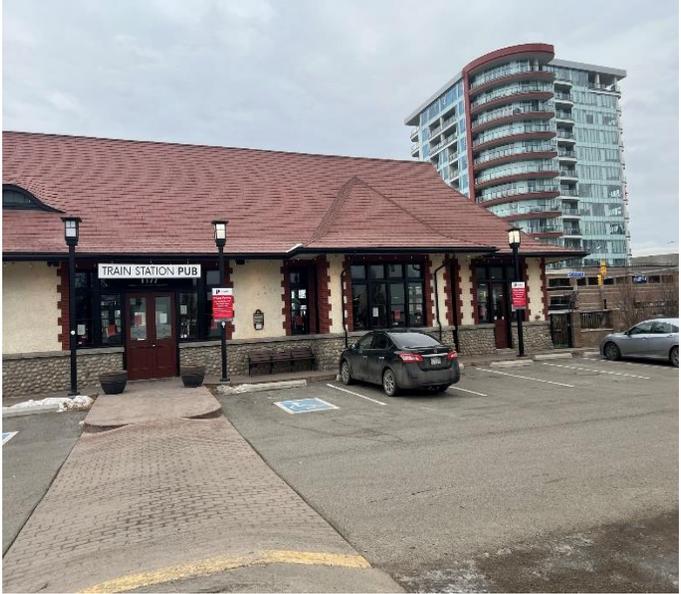
<p style="text-align: center;">Photo 1</p>
<p>December 13, 2022</p> <p>General overview of eastern end of the north elevation.</p>

PHOTOS	
Description	Photo
<p>December 13, 2022</p> <p>General overview of western end of the north elevation.</p>

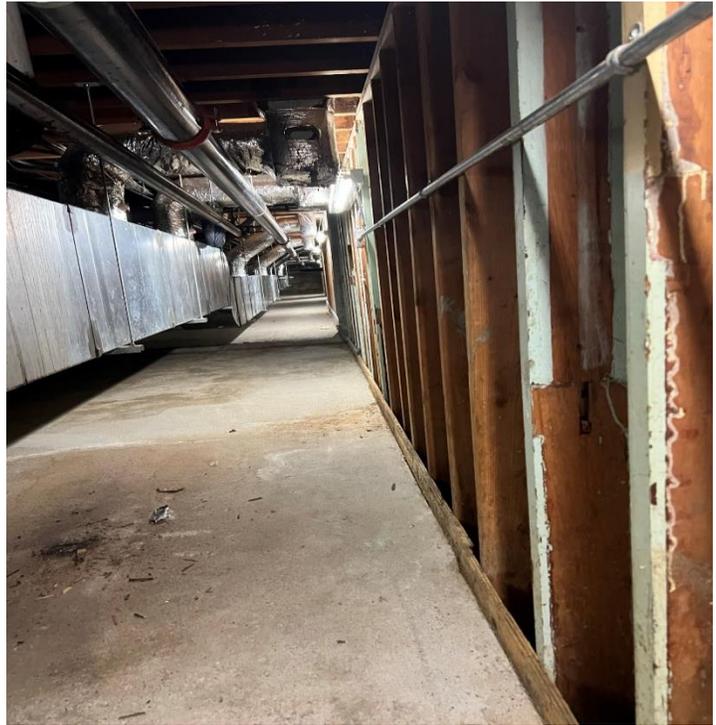
Photo 3

- Foundation
 - The building foundation wall consists of concrete of unknown thickness with a 2x6 wood build out on the interior side of the wall. The build out is located at the east end of the crawlspace and is not continuous around the entire foundation wall (Photo 3).
 - There is a mud slab of unknown thickness in the crawlspace. The crawlspace mud slab contained minor cracks (Photo 4). RJC is of the opinion that these cracks are not structurally significant.

2x6 stud wall build out on the interior of the concrete foundation wall.

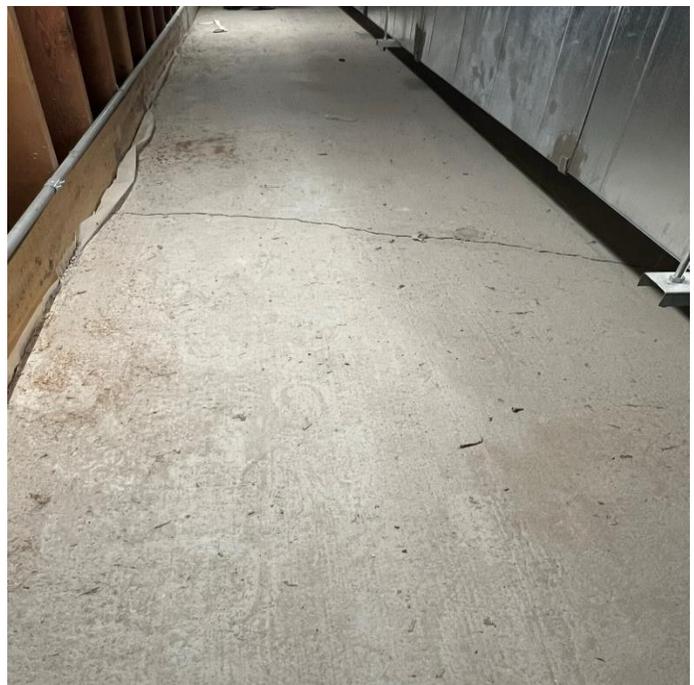
Photo 4

Crack in the mud slab.

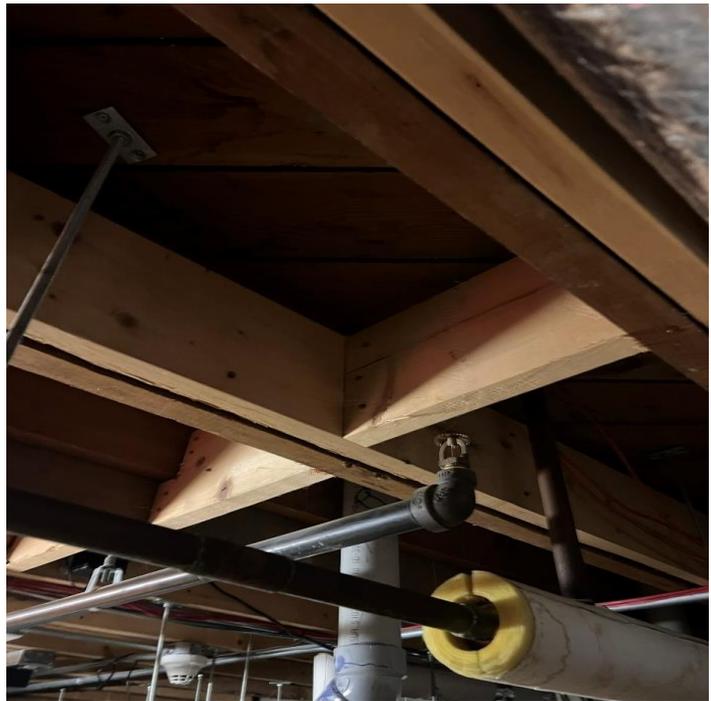
Photo 5

- Main Floor
 - The floor system consists of 2x10 floor joists spaced at 16" o/c. Some floor joists were sistered with additional 2x10 joists (Photo 5), presumably during prior renovation work. The floor joists are embedded into the concrete foundation wall at one end and are bearing on 8" wide x 11" deep rough-sawn timber beams at the other end. The beams are bearing on concrete columns (Photo 6).

Overview of the original 2x10 joists sistered with additional 2x10 joists.

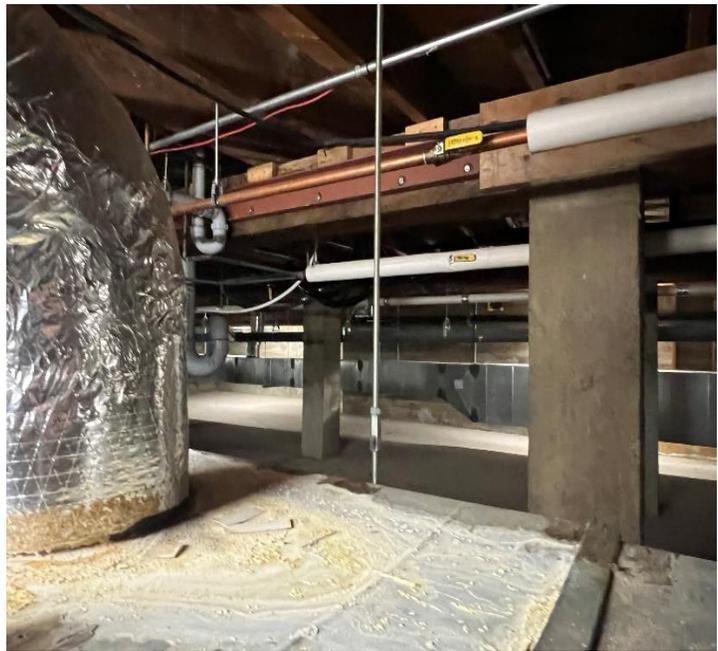
Photo 6

Overview of the beams bearing on concrete columns.

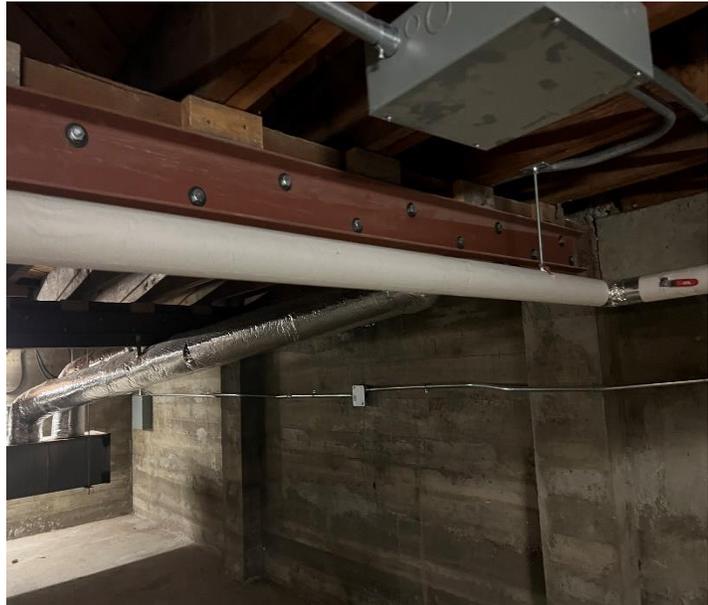
Photo 7

- Structural steel C-channels have been fastened to most of the timber beams supporting the floor. It appears that these have been installed after original construction to increase the load capacity of these members (Photo 7).

Metal C-channel installed after original construction.

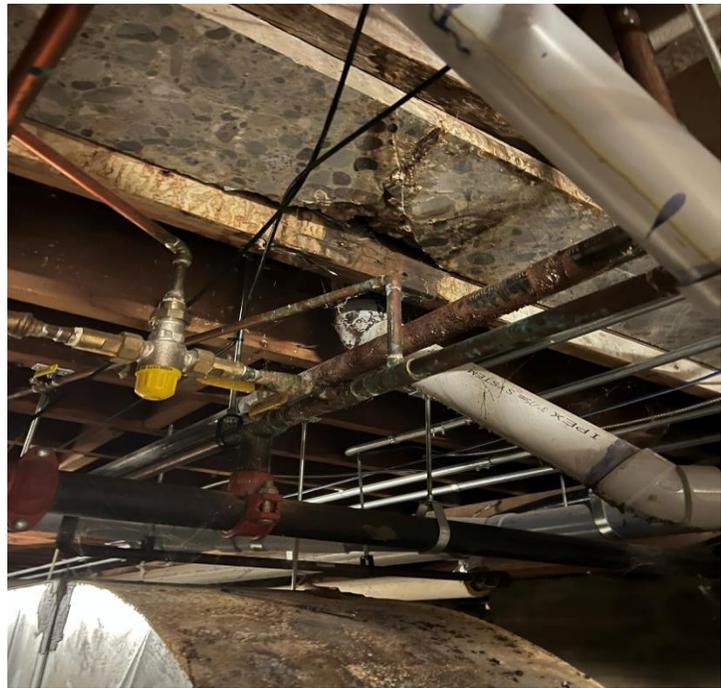
Photo 8

- There are localized signs of moisture staining and deterioration on the joists and beams below the bathroom at the north end of the building (Photo 8) and the bar (Photo 9). There is a vent and a drain located at the bar and bathroom, respectively. Floor framing at both locations does not appear to be deteriorated to a point of structural concern. Plans should be developed to monitor and maintain these locations.

Moisture staining in floor joists below washroom. Concrete cut-out in original foundation wall.

- Periodic monitoring of the progression of the water damage in the crawlspace below the bar vent and the north bathroom drain.
- Paint touch-ups and/or trim repairs at multiple doors and windows.
- Replacement of curling roof shingles.
- General cleaning of the stucco to remove the dirt and stains.

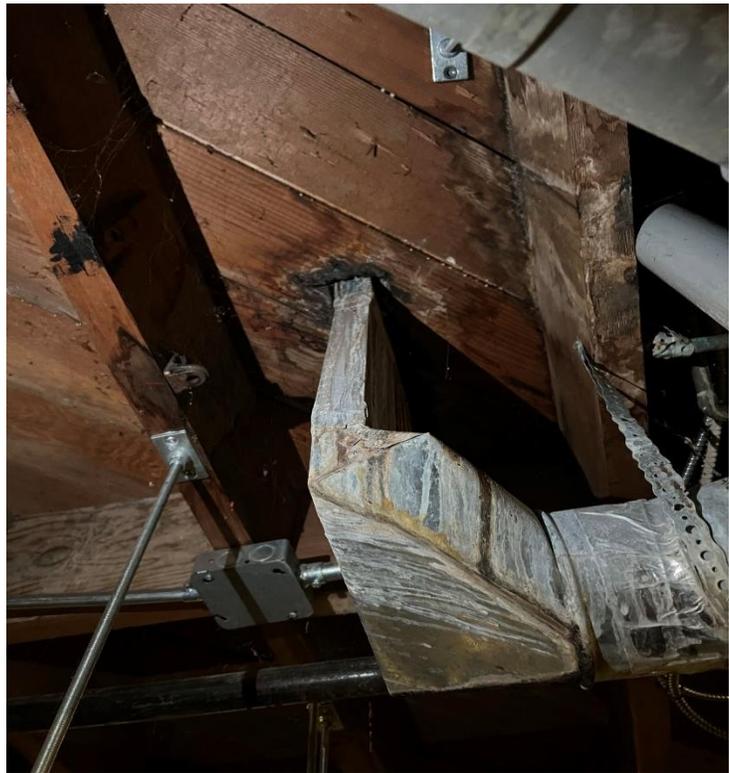
Photo 9

Moisture staining in joists and floorboard near vent location below the bar.

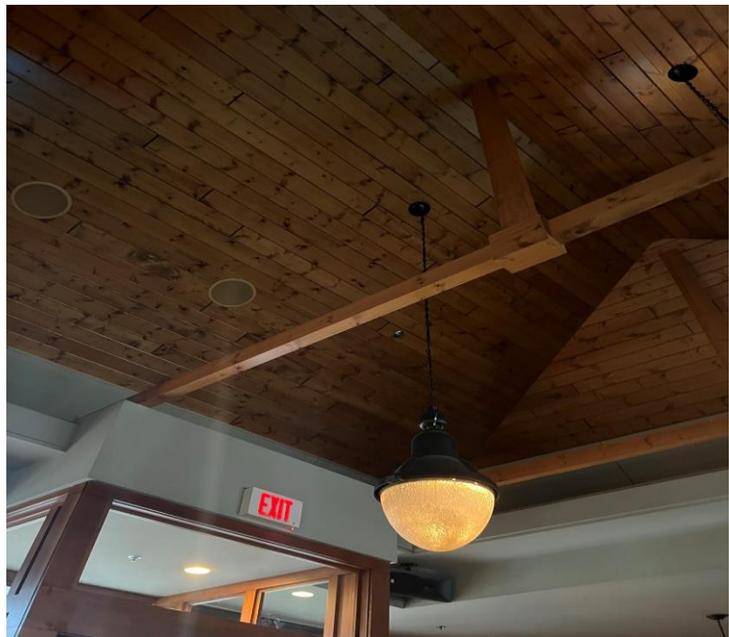
Photo 10

- Superstructure
 - Visible portions of the existing roof trusses appeared to be in good condition (Photo 10).
 - The wall systems appeared to consist of 2x studs at unknown spacing. No exploratory recesses were performed to confirm the size or spacing of the studs, however the wall appeared to be in good condition.

Overview of exposed roof trusses.

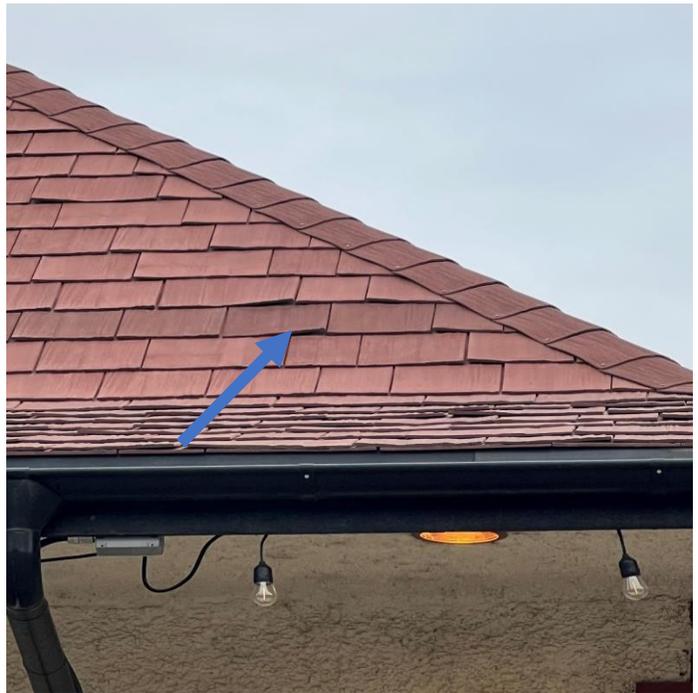
Photo 11

- The roof appeared to be in good condition other than minor curling of the shingles (Photo 11).
- The windows and doors appeared to be in good condition other than chips and peeling of the paint on the units and the trim (Photo 12). Trim had become detached at one window in the room that accesses the crawlspace (Photo 13). These are maintenance items and should be included in future maintenance plans.
- The exterior stucco is generally in good condition other than minor marks and staining (Photo 14).

Curling shingles on the east end of the south elevation.

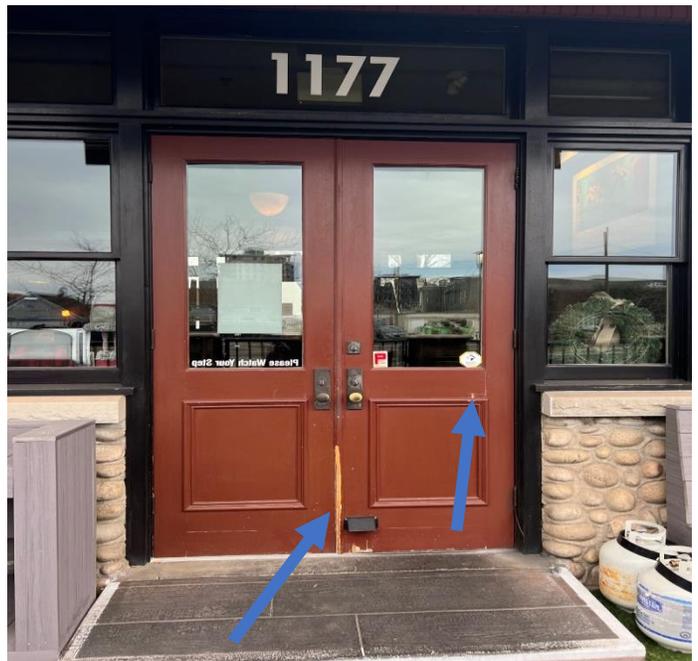
Photo 12

Peeling of paint and chips in the door on the south elevation.

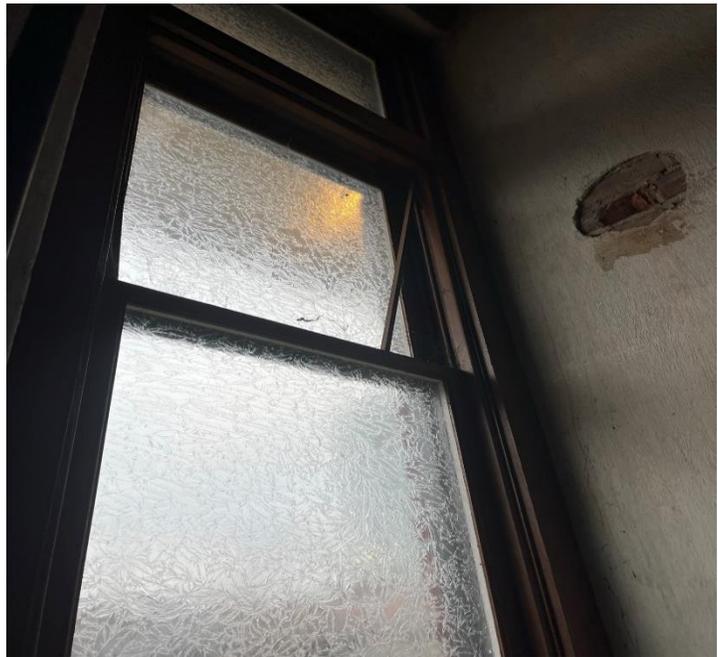
Photo 13

Detachment of the window trim on the interior of the window in the room that accesses the crawlspace.

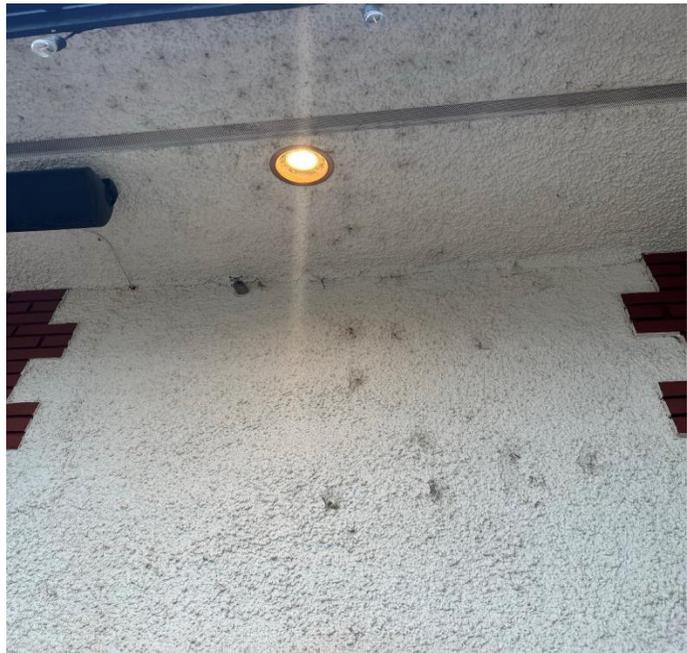
Photo 14

Dirt and staining on the stucco.
