Canadian National Railways Station Railway Garden and Plaza Heritage Assessment

1177 Ellis Street, Kelowna BC

February 2023

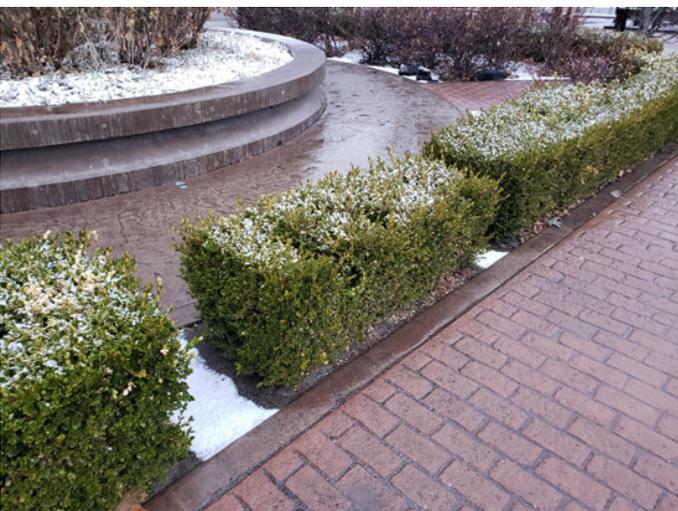
Generally, the garden appears to be in good condition. At the time of the site visit (mid-February, 2023), some foliage was visible on the perennial Lamb's Ear plantings (figure 5), and decorative rose hips were visible on both types of roses (figure 3). The boxwood looked green and healthy (figure 3). Plant density appeared good, with only a few small gaps in the boxwood hedge along the perimeter (figure 4 & 6).

Figure 6: Small gaps in Boxwood hedge at eastern edge of garden

Based on a review of the original plans for the garden, some plant material, most specifically the Sweet Alyssum plantings appear to be missing. While there are noticeable empty areas in the planting beds along the perimeter of hardscapes, the existing shrubbery may grow into this space in the summer months. Additional groundcover plantings could be incorporated, however, these may compete with the existing rose plantings. It is recommended that at a minimum, all planting beds be cleaned up through a top dressing of 25-50mm depth of wood mulch.

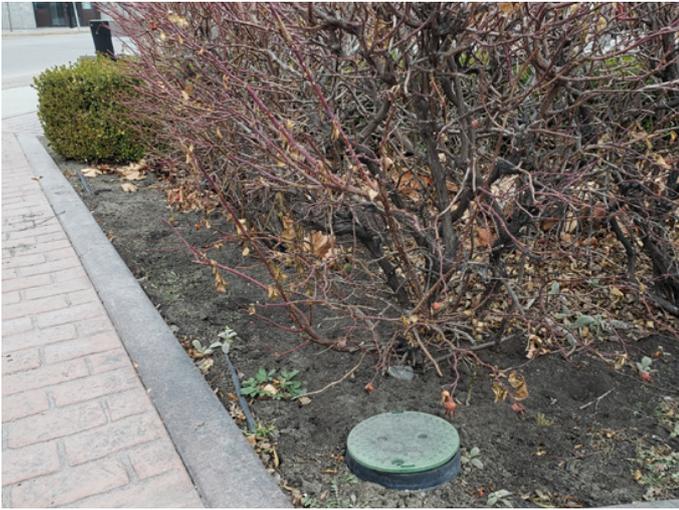
Some irrigation lines were visible, exposed above the soil, and there appeared to be no mulch remaining within the planting beds (figure 8 & 9). A few of the irrigation valve boxes were missing lids and a substantial amount of garbage was noted within the planting beds at the time of inspection (figure 10).

Figure 8: Exposed irrigation lines visible in planting bed at Northwest corner.

Exposed irrigation lines should be re-buried and additional stakes added to hold these in place. Mulch, as noted above, should then be added to the planting areas. Locking lids should be replaced for the two irrigation valve boxes which do not have these. Consider adding lockable lids for remaining valve boxes, as required.

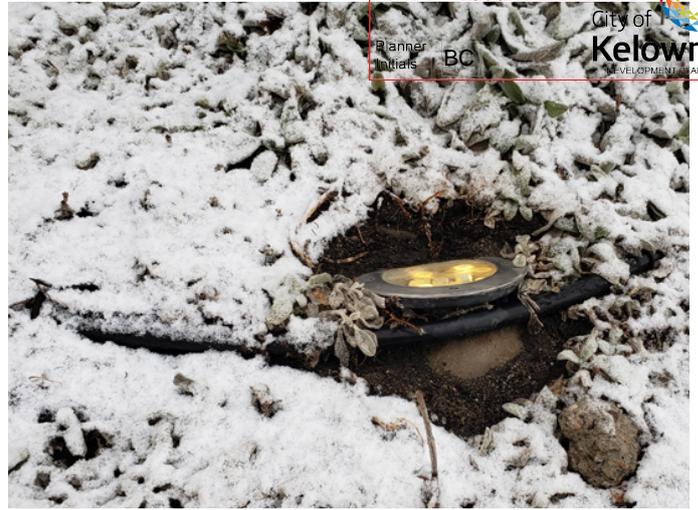
Figure 9: Exposed irrigation line visible in raised planter near uplight.

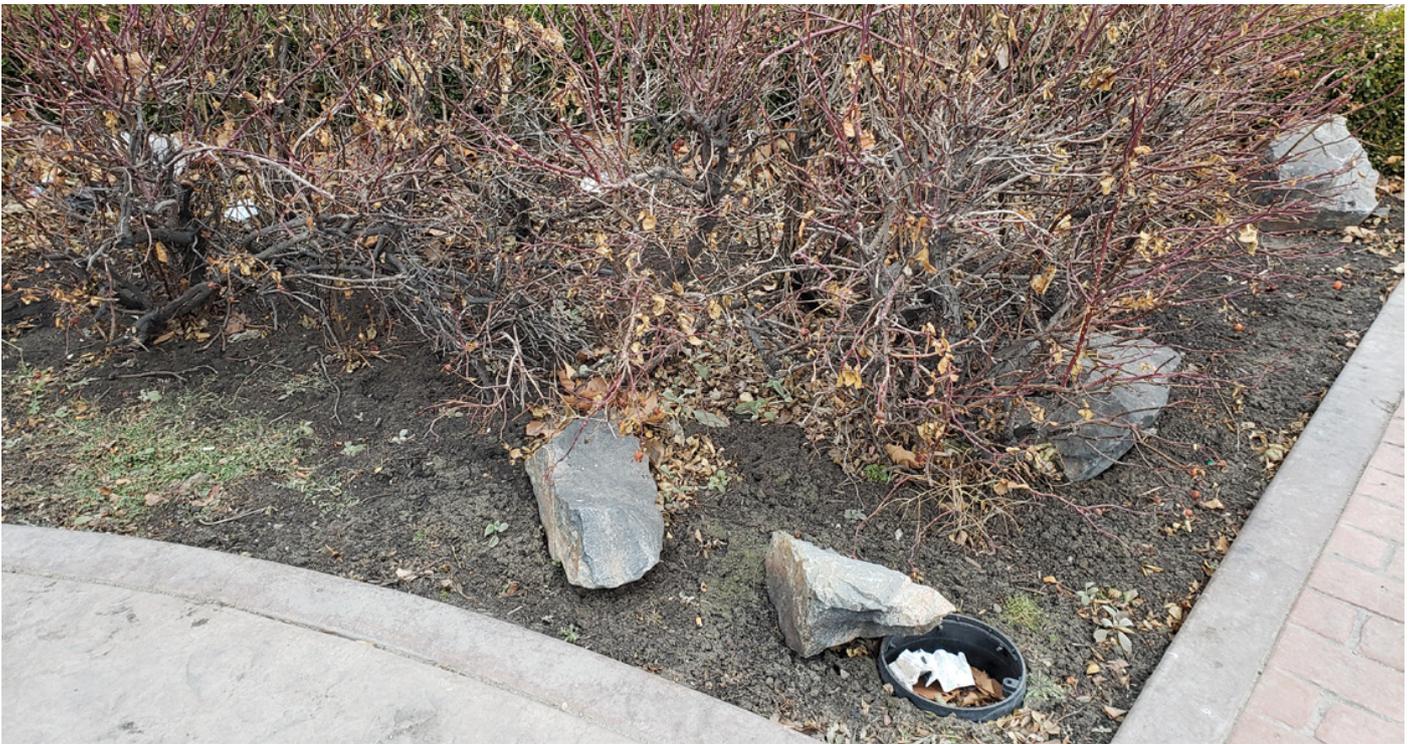
Figure 10: Irrigation valve box missing lid and garbage behind roses in North planting bed. Another valve box was missing a lid in the southwest planting bed.

General site cleanup, such as removal of garbage and leaf debris should occur prior to additional wood mulch being placed.

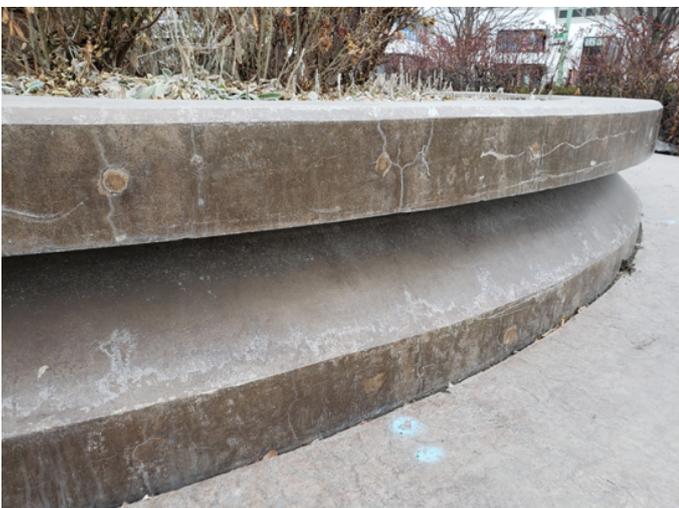
The circular raised planter was in fair condition, with some minor cracking, scratches, and cone tie holes from normal aging of the plaza (figures 11-13). Some graffiti was noticeable on the edges of the planter (figure 14).

Figure 11: Cracking and scratches along top edge of raised planter

The visible linear cracking within the walls of the raised planter may be a result of the rebar spacing and lack of control joints installed during construction. There is little that can likely be done to fix this.

Regarding the various cracking and/or holes where cone ties were used in construction of the planter, there are two possible recommendations for the treatment of these. The first would be to remove cracked concrete and patch with new concrete. It is likely that patches may result in similar cracking in the future. Another option would be to break out all concrete from the cone ties locations and re-finish the entire planter wall with a sand blast. This will create a consistent look across the planter, but may come with a higher cost. Either option would be an acceptable sand blast the entire planter wall.

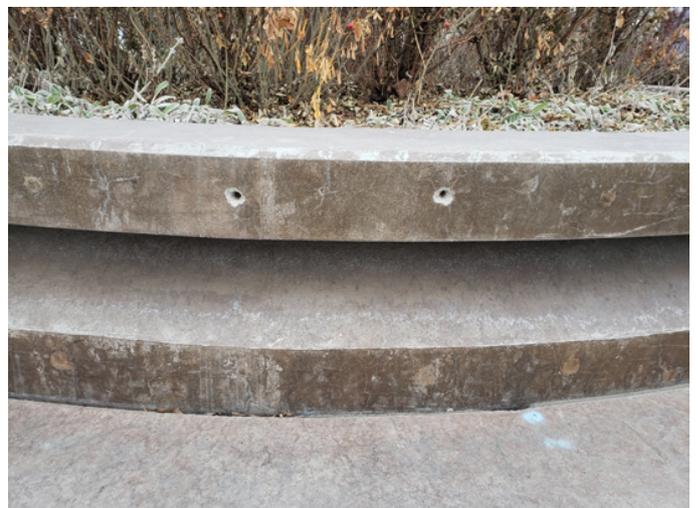
Figure 12: Holes in wall of raised planter

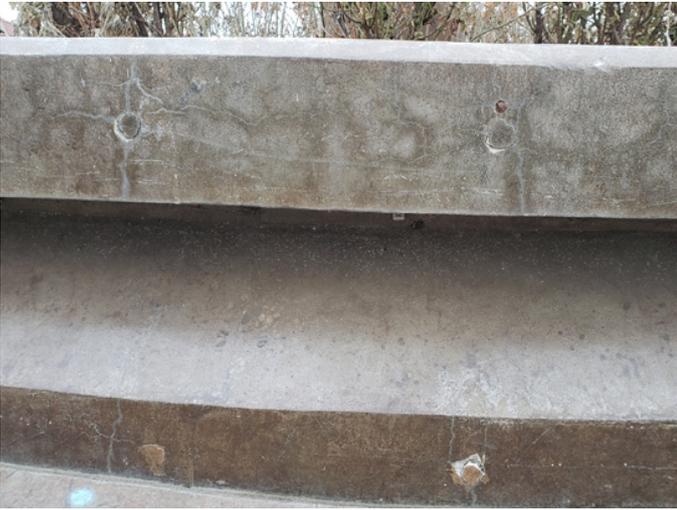
Figure 13: Additional cracking along wall of raised planter

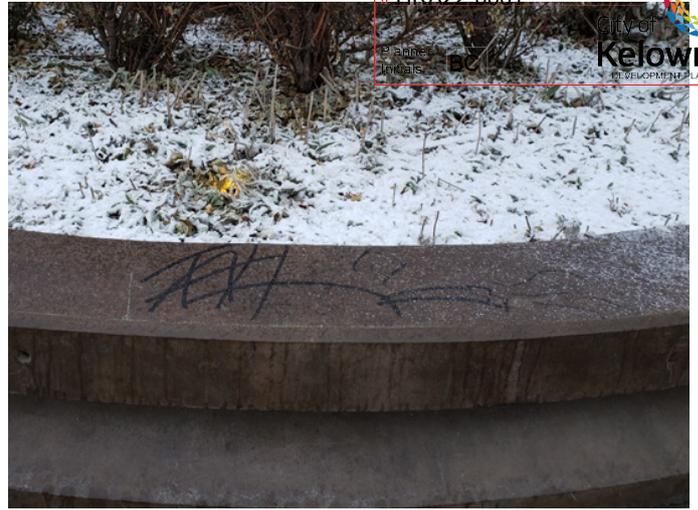
Figure 14: Graffiti on raised planter

Graffiti on the raised planter walls should be removed. Consider applying an anti-graffiti stain to the wall.

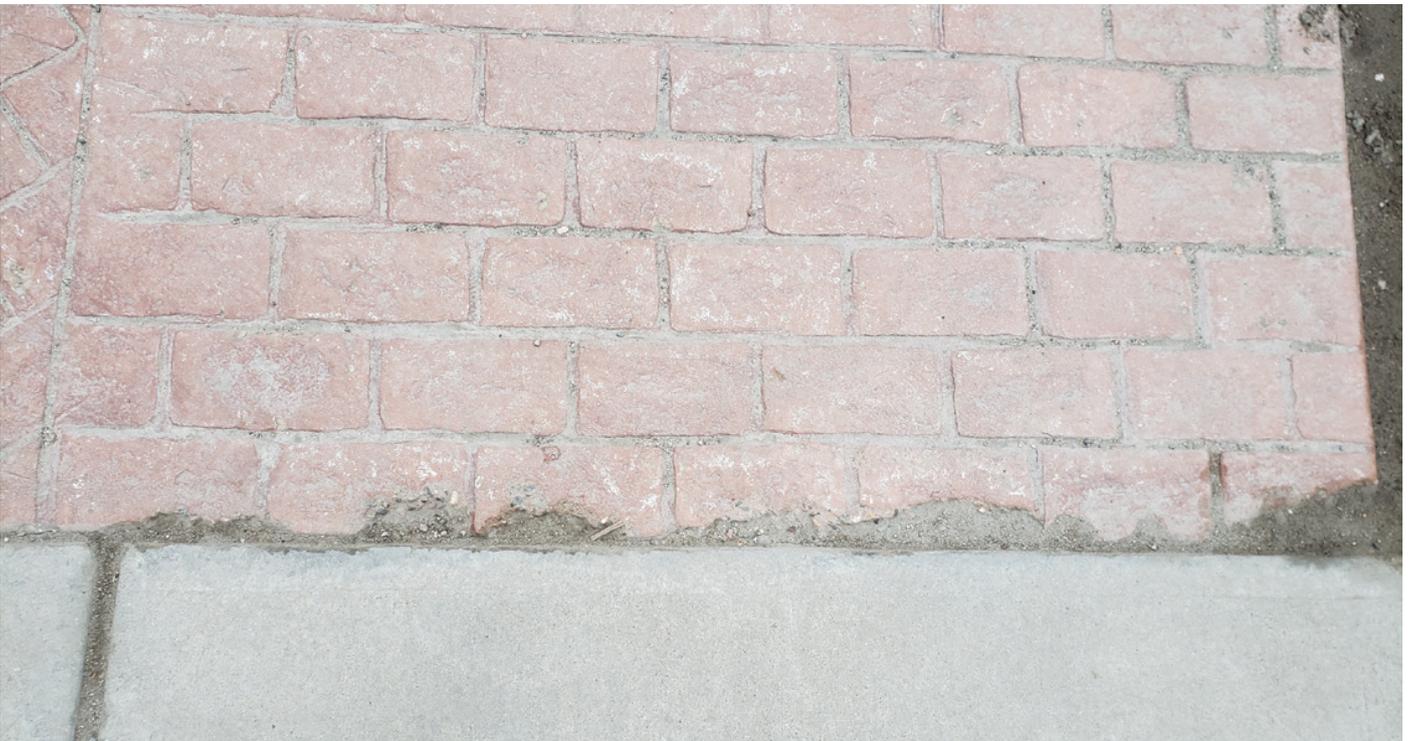
The stamped concrete paving has a red brick finish to complement that found on the station building. Only a couple tiny cracks were visible, likely from expansion and contraction of the material through the winter seasons, but do not pose structural or public safety hazards (figures 14 & 15). Some salt damage was visible at the East side of the garden, where a pathways connects North-South from Clement Avenue to the Train Station pub, next to an asphalt parking area (figure 16). Some fading of the red colour has occurred over the years due to sun exposure.

Figure 15: Cracking of stamped concrete paving along edge of municipal sidewalk at Southeast corner of garden, off Clement Avenue

The cracking of the stamped brick finish concrete paving is superficial and does not require attention.

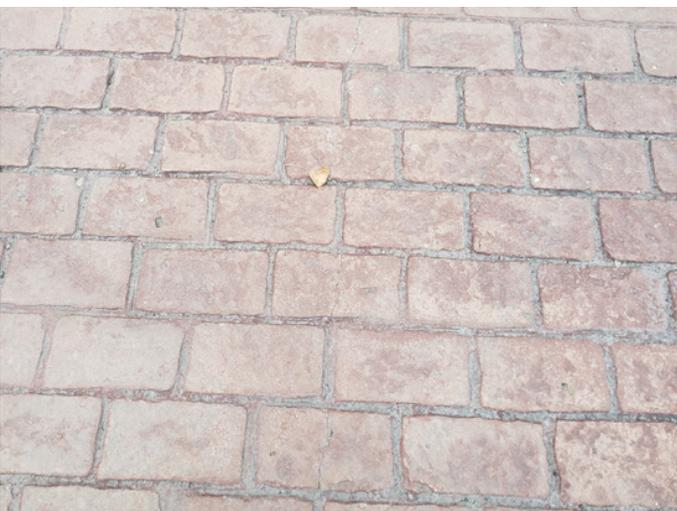
Figure 16: Small crack in surface of stamped concrete paving

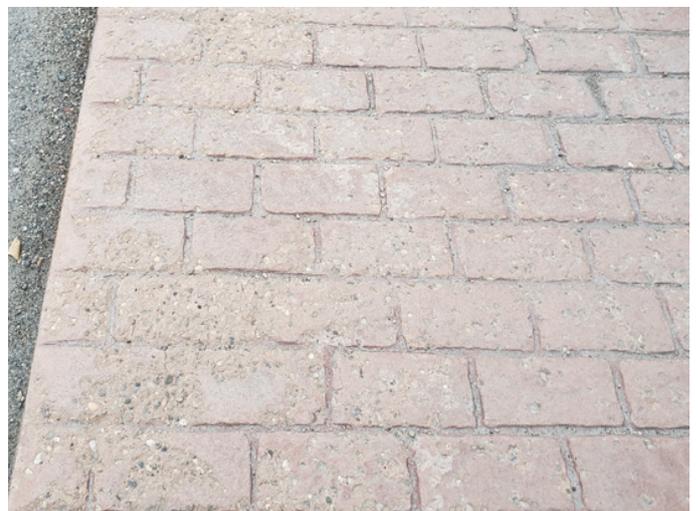
Figure 17: Salt damage along East pathway bordering asphalt parking area

Regarding the salt damage or spalling, a densifying sealer could be applied to preserve the stamped surface and increase longevity. A contractor would need to be hired to specify and apply an appropriate sealer for this particular application.

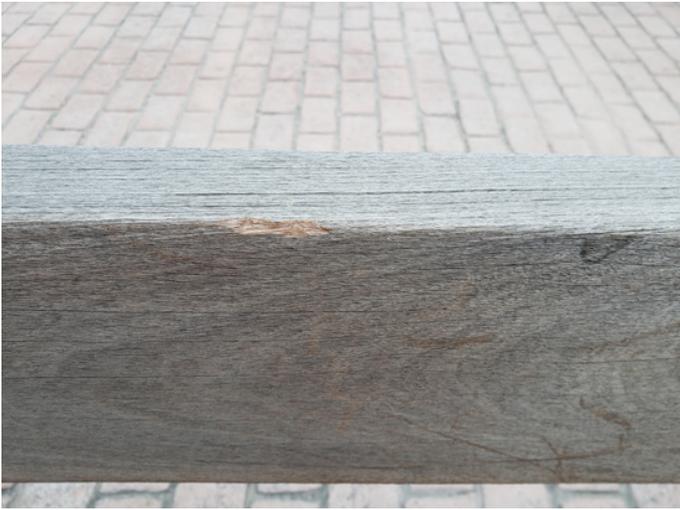
The site furnishings were in good condition and were firmly bolted to the concrete surfacing. There were some signs of wear and damage on the timber slats of the benches, such as small chips in the wood and minor checking (figure 20 - 22).

Figure 20: Chip damage on timber backrest top slat of bench

All items of note for the site furnishings are a result of normal wear and tear in this type of public application. These are aesthetic items only which do not affect the function or structure of the furnishings.

- An overcoat or paint could be applied to the waste receptacle where powdercoating has chipped. A paint contractor would need to be hired to specify and apply the appropriate product for re-coating.
- Bench boards could be replaced with an IPE wood, which may grey to a similar colour over time.
- Pressure washing or general cleaning of the bicycle racks could remove scuffs and other stains.

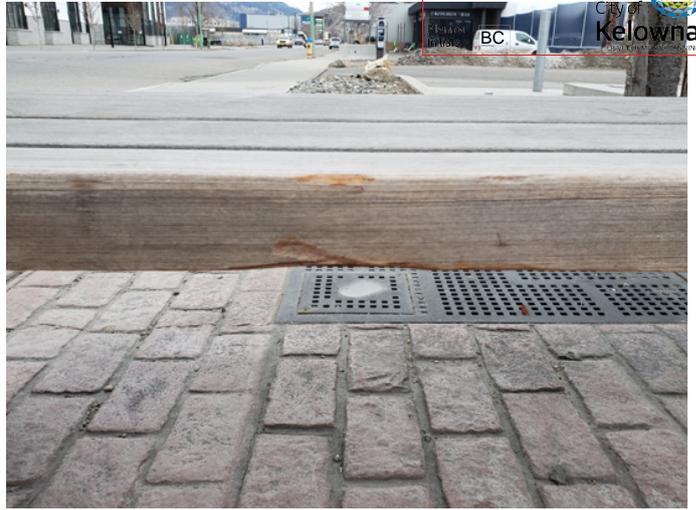
Figure 21: Chip damage on front of timber bench slat

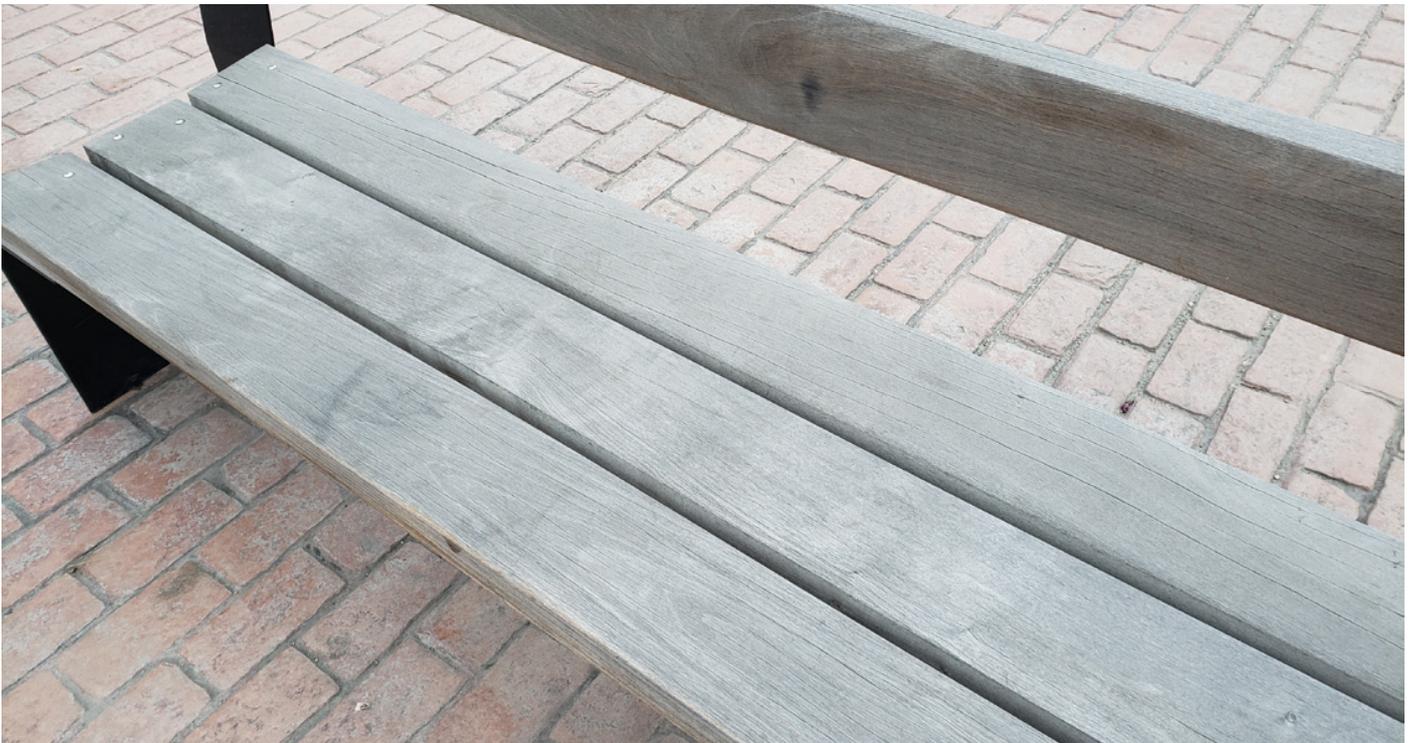
Figure 22: Timber checking on rear bench slat

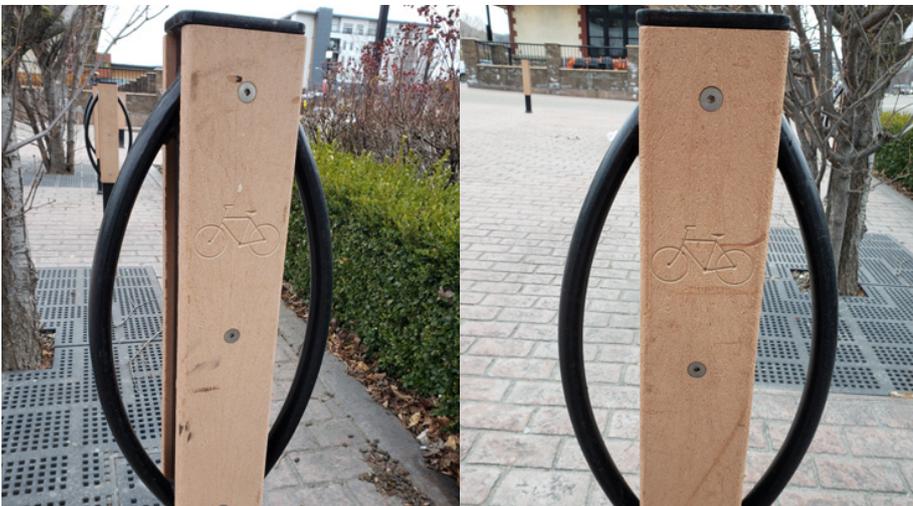
The bicycle racks and bollards had some signs of weathering of the recycled plastic components. There were some minor scuffs and other aesthetic impurities, but otherwise were in good condition (figure 23 & 24).

Figure 23: Scuffing and wear on bike rack posts

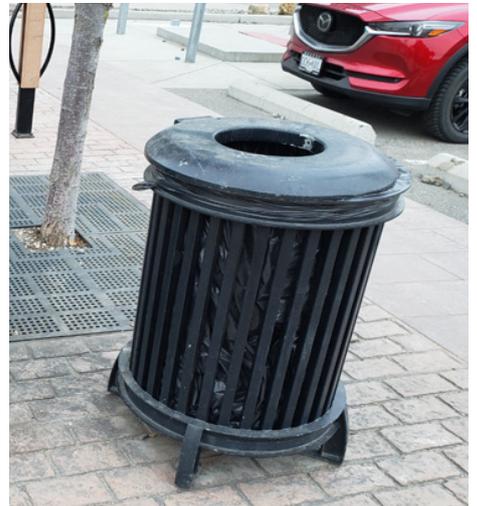
The waste receptacle has some chipping of the powdercoat surfacing along the inner rim and top surface, from normal use. It was otherwise in good condition (figure 25).

Figure 24: Chipping of powdercoat along rim of waste receptacle

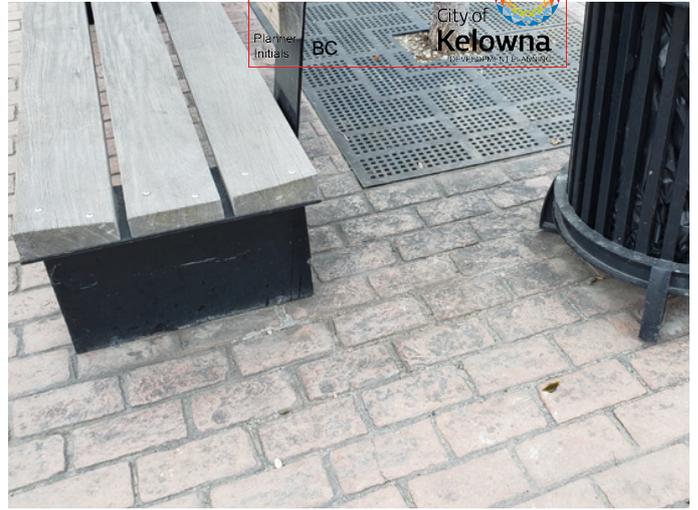
Figure 26: Darkening on stamped concrete paving

It is recommended that the entire stamped plaza and garden pathway system be pressure washed to remove dirt and darkened spots and restore consistency in the colour. This should occur in Spring once there is less sand and salt around.

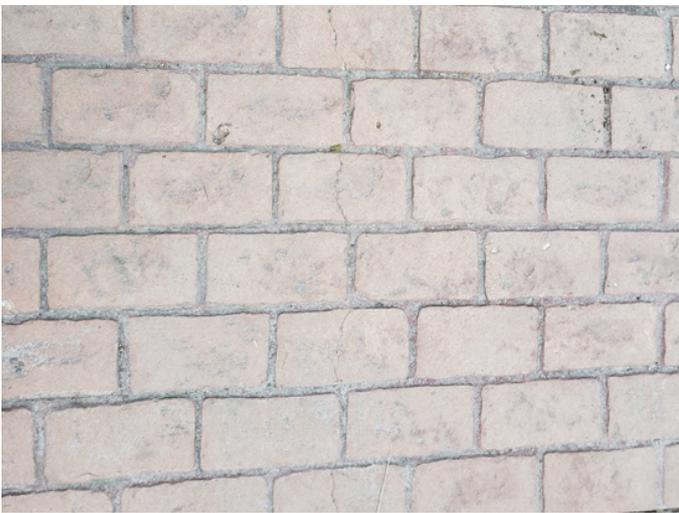
The stamped red brick concrete paving was in good condition, with some fade in colour over the years due to weather and sun exposure, similar to that of the garden area. There still appeared to be positive drainage across the plaza, with no visible low spots (figure 26). There was some additional wear of the surface near the Northeast most tree planting, where the surface was darkened (figure 27). Minor cracks were visible in a few places, but do not pose structural or public safety hazards (figure 28).

Figure 27: Small crack in surface of stamped concrete paving

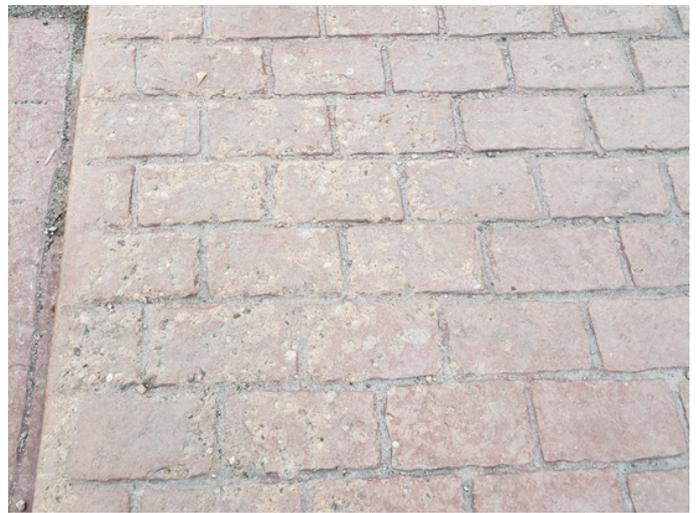
Figure 28: Salt damage along East side of plaza
