BYLAW NO. 11408

Heritage Revitalization Agreement Authorization Bylaw HRA17-0001 –

4629 Lakeshore Road

SURTEES HOUSE & BARN

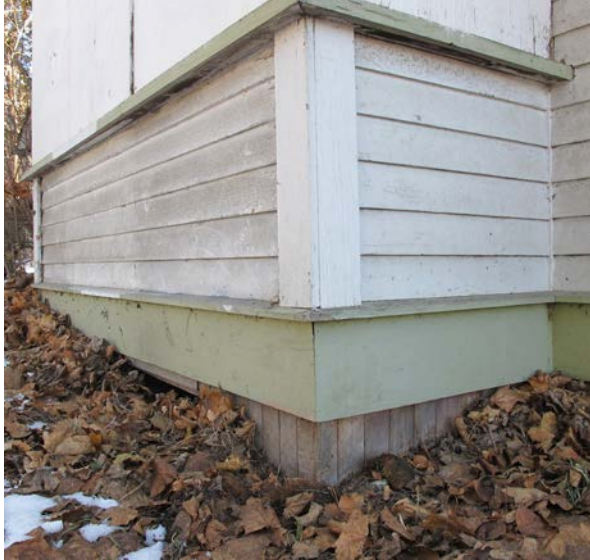
Lower portion of bay window at north elevation, showing wood lapped siding, window sill, and board trims. Note that foundation wall is clad in later vertical siding.

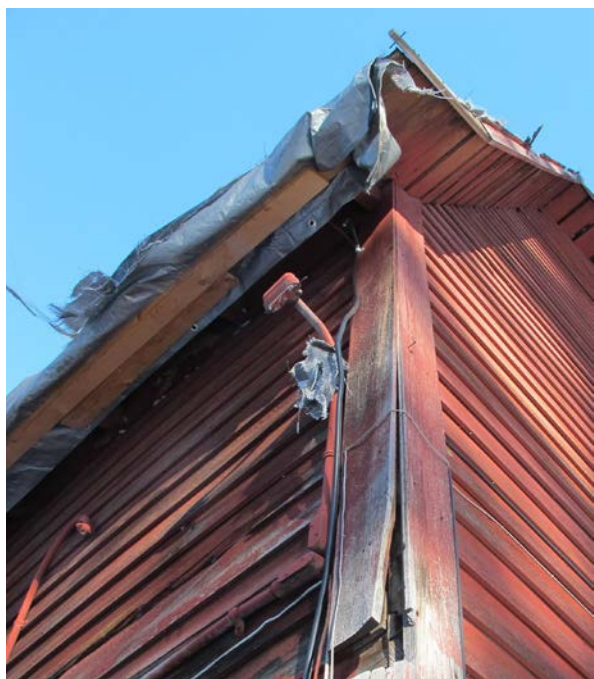
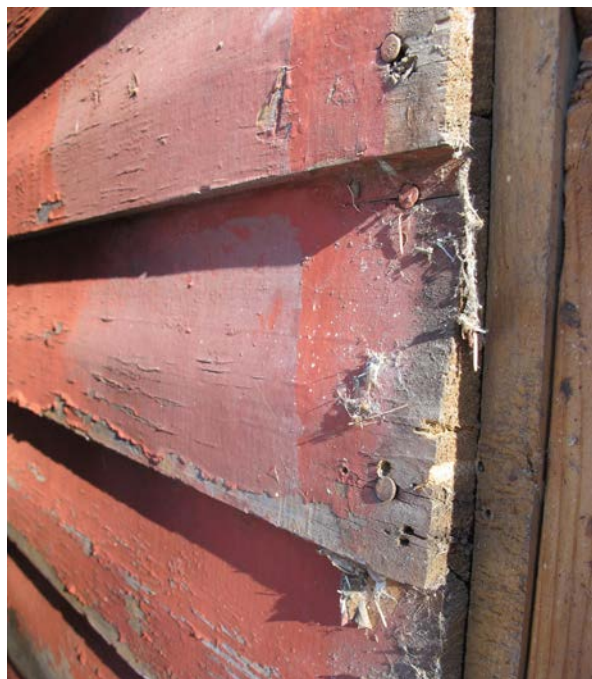
Photos showing typical deteriorated condition of exterior wall cladding, as well as roof soffit and corner board trims.

- Cleaning procedures should be undertaken with non-destructive methods. Areas with biological growth should be cleaned using a soft, natural bristle brush, without water, to remove dirt and other material. If a more intense cleaning is required, this can be accomplished with warm water, mild detergent (such as D/2 Biological Solution®) and a soft bristle brush. High-pressure power washing, abrasive cleaning or sandblasting should not be allowed under any circumstances.
