Subject: 4629 Lakeshore Rd Lot A Plan 71341 SURTESS HERITAGE PARK

SURTEES HOUSE & BARN

4629 LAKESHORE ROAD, KELOWNA, BC

SURTEES HOUSE
CONSERVATION PLAN

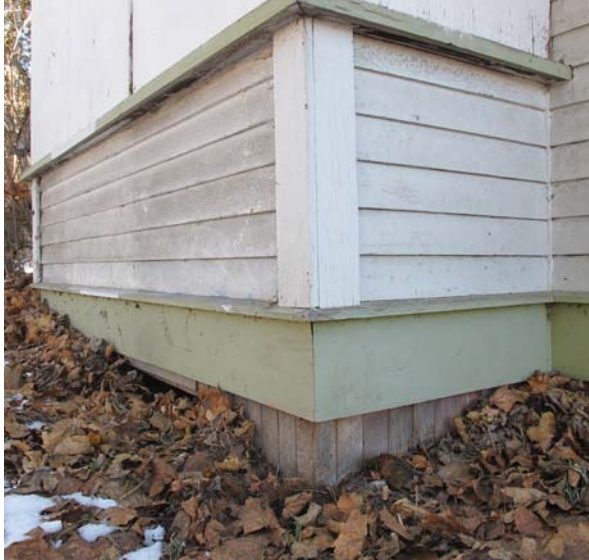
Lower portion of bay window at north elevation, showing wood lapped siding, window sill, and board trims. Note that foundation wall is clad in later vertical siding.

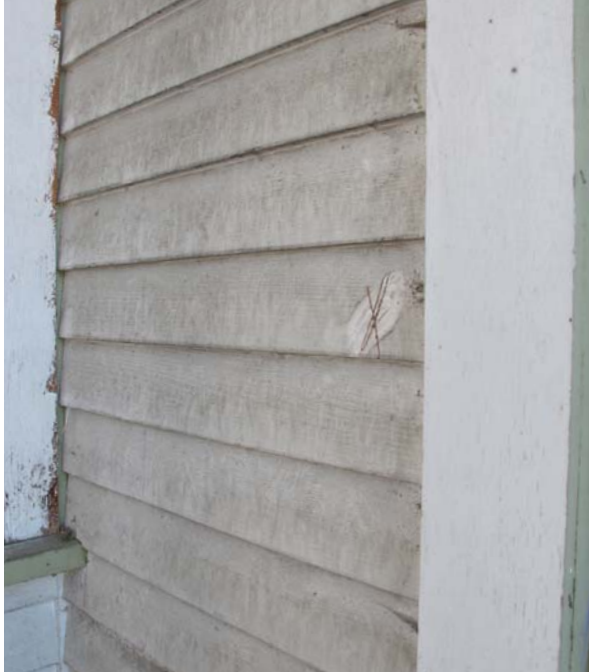
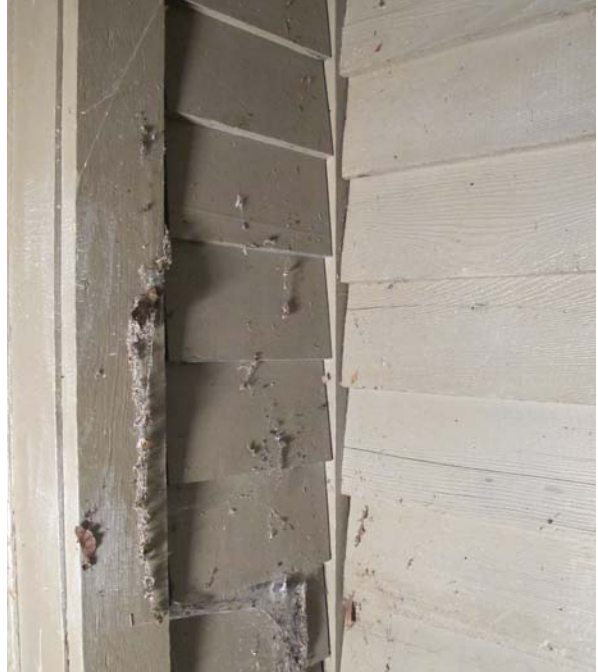
Photo showing existing condition of original exterior wall, with horizontal lapped wood siding and trims at north elevation (top left), and at the interior return walls of the enclosed early addition to the west (top right).

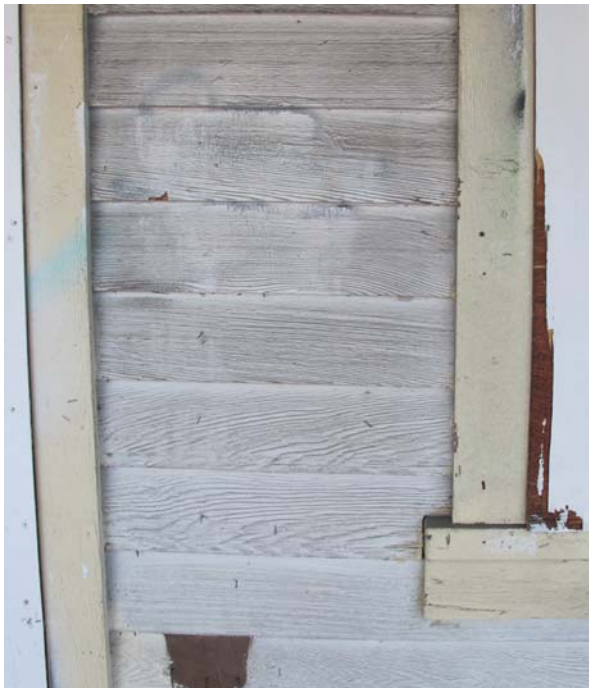
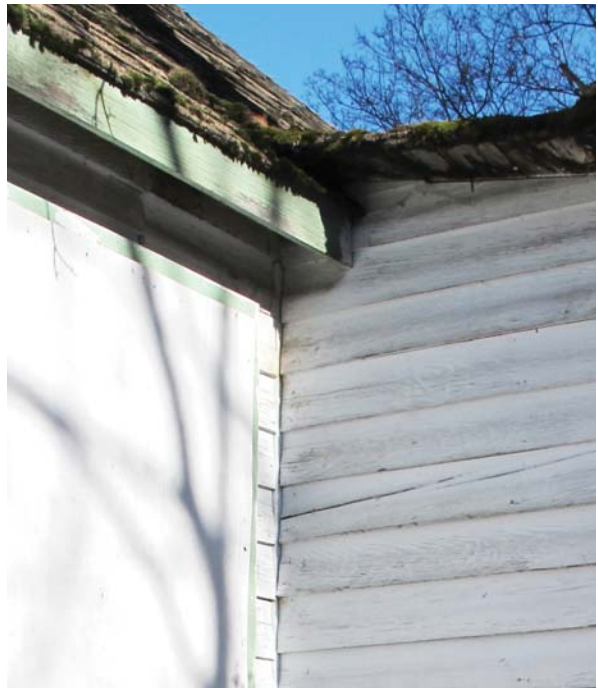
Photos showing original exterior walls with original materials interfaced with later rehabilitation with inappropriate detailing; at historic front facade between door and window opening (bottom left), and at south elevation and return wall of later addition (bottom right).

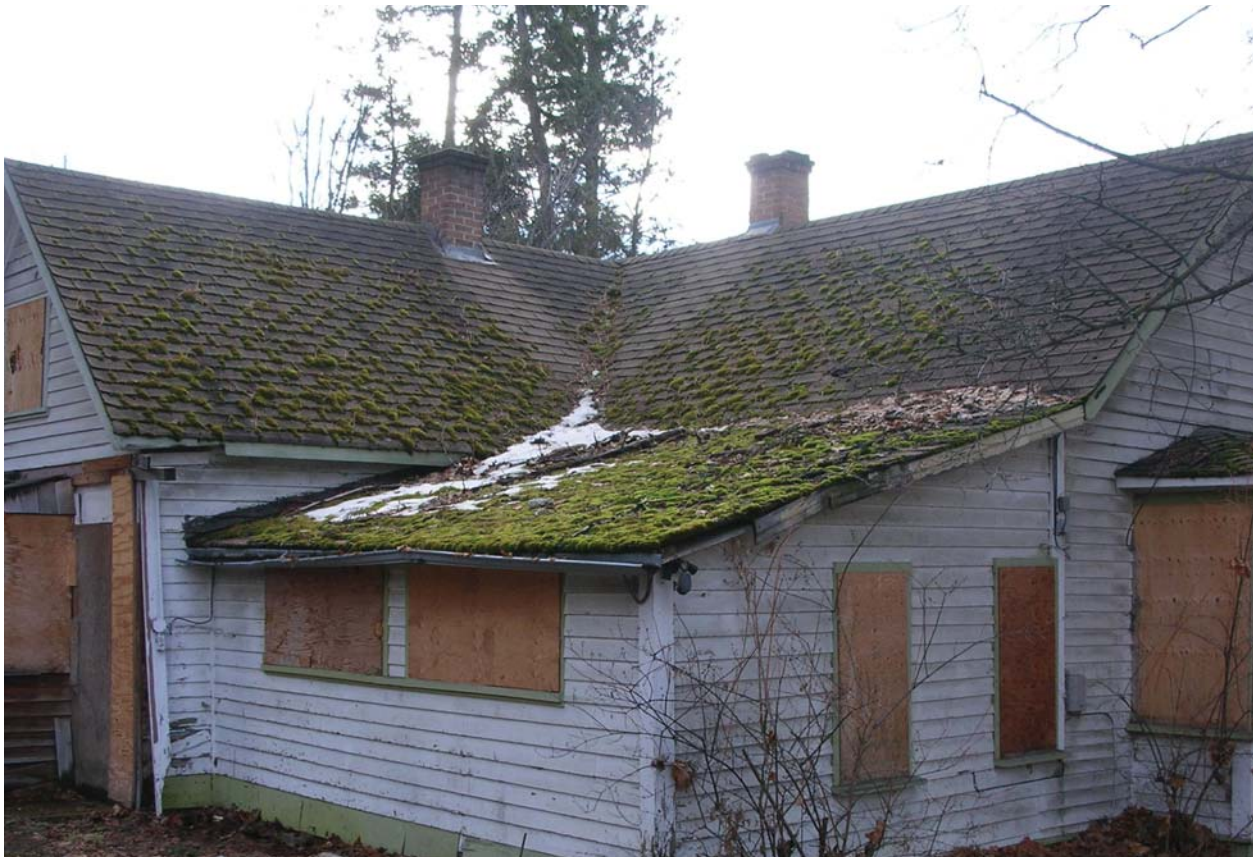
Existing condition of original, primary cross-gabled roof, with shed roof extension of early addition to the northeast portion of the house, as well as two original interior brick masonry chimney stacks along the roof ridges.

- Preserve the roof structure in its current configuration, as expressed by its primary cross-gabled roof structure.
- If required, roofing membrane and cladding system may be rehabilitated. Cedar shingles are the preferred material, but uroid shingles or Aged Cedar Enviroshingles™ are also acceptable.
- Retain the original bargeboards and fascia boards, as well as the soffit any exposed roof elements.
- Design and install adequate rainwater disposal system and ensure proper drainage from the site is maintained. Wood gutters with galvanized steel downspouts are recommended. Aluminum in appropriate colours is also acceptable. Paint or provide specification of drainage system elements according to colour schedule devised by Heritage Consultant.

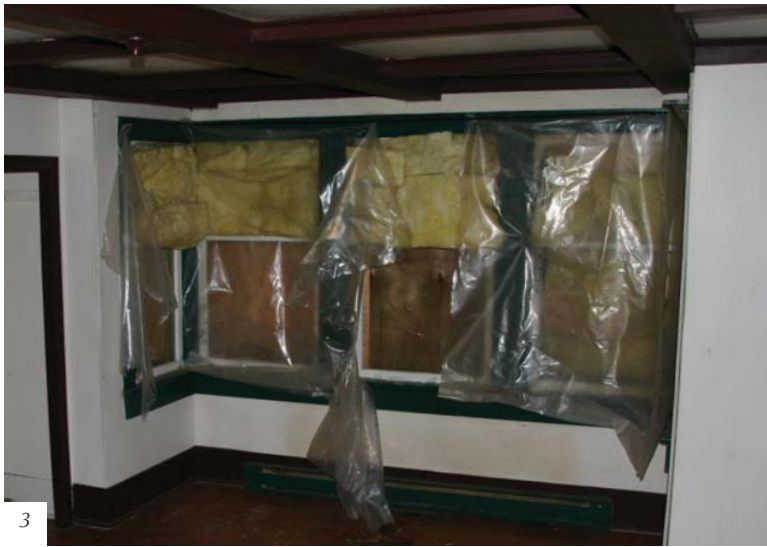
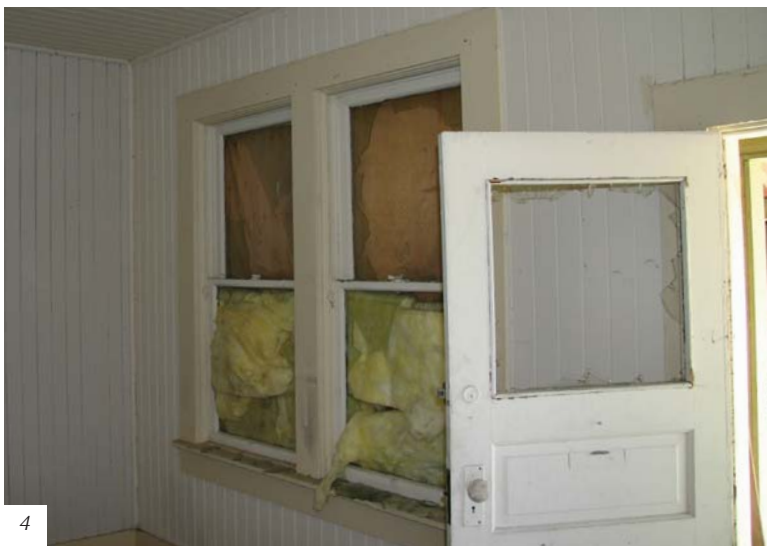
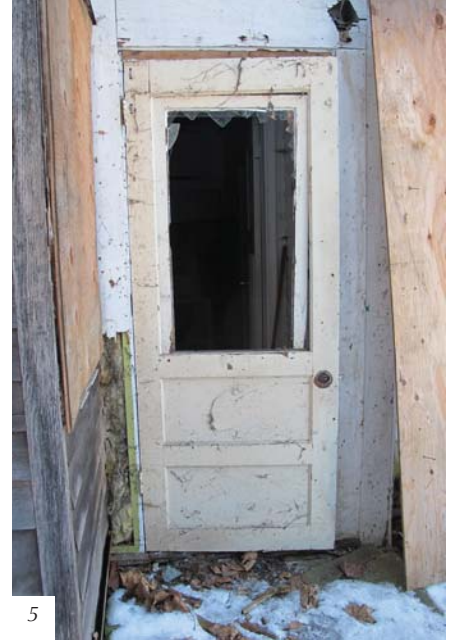
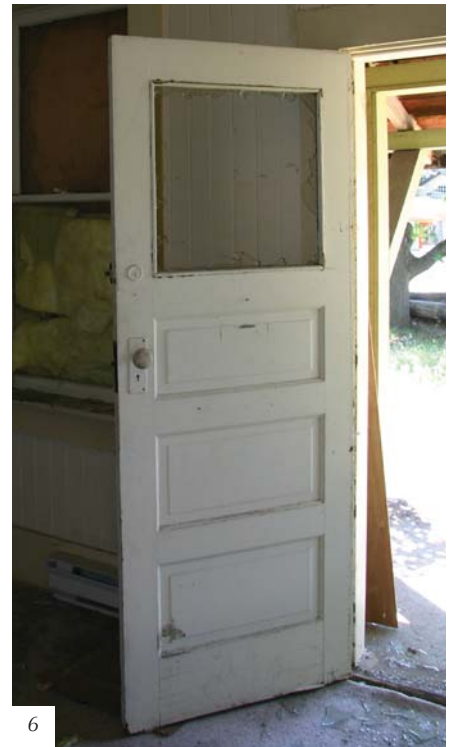
Photos showing existing typical conditions of surviving original wood windows and doors: gable ends at the east/west elevations (1, 2); bay window at north elevation (3); historic front facade at west elevation, showing partial wood door (4); rear exterior door at east elevation (5); main entrance door at west elevation (6).

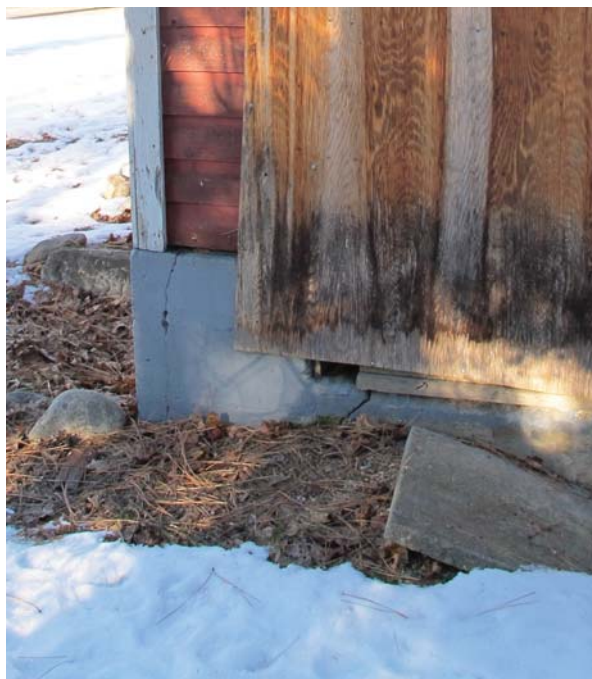
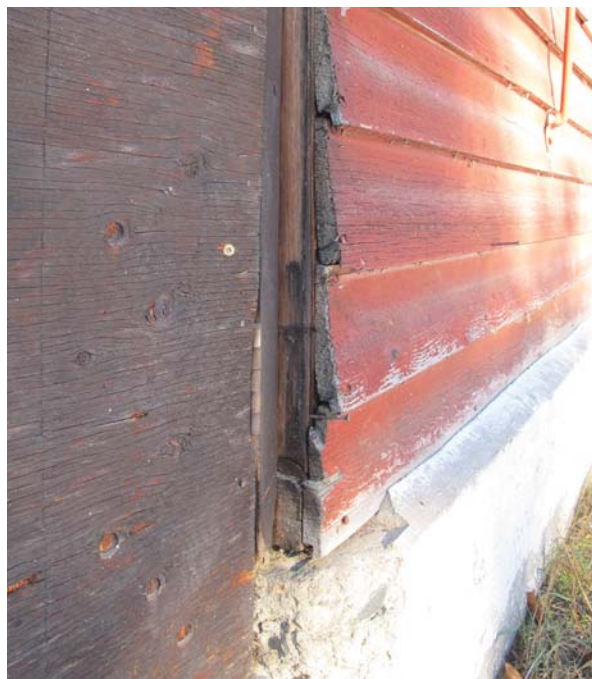
Photos showing typical deteriorated condition of exterior wall cladding above concrete foundation walls. Note profile of original drop siding (top right).

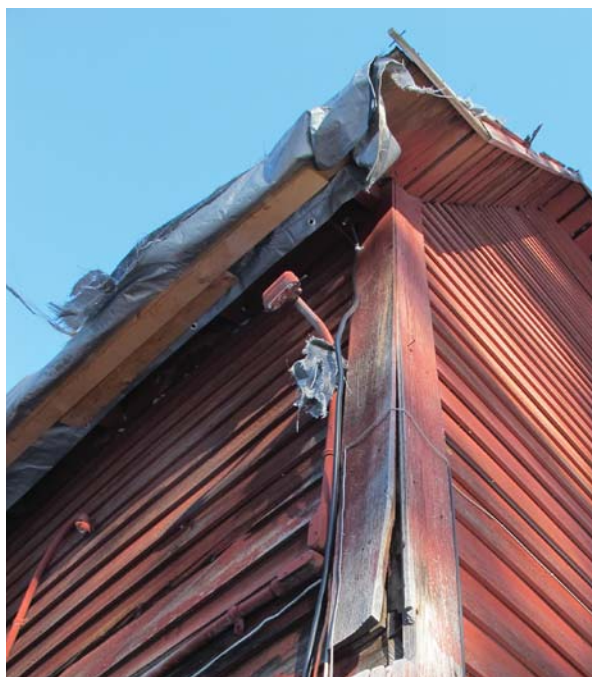
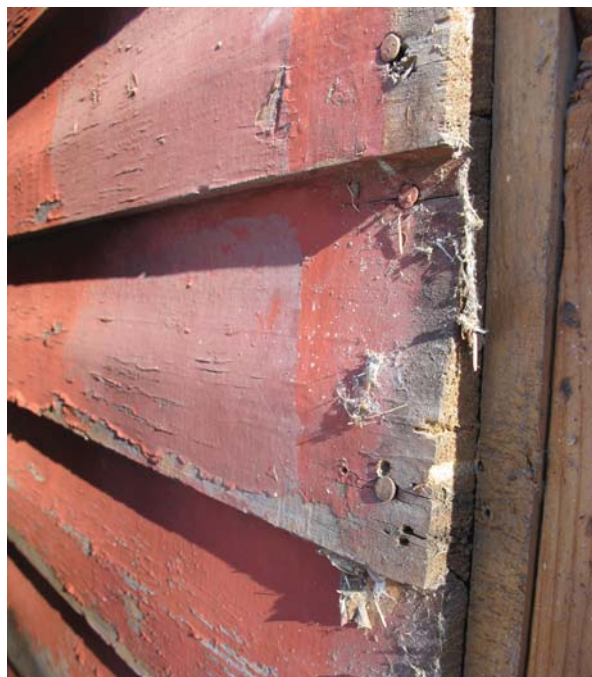
Photos showing typical deteriorated condition of exterior wall cladding, as well as roof soffit and corner board trims.

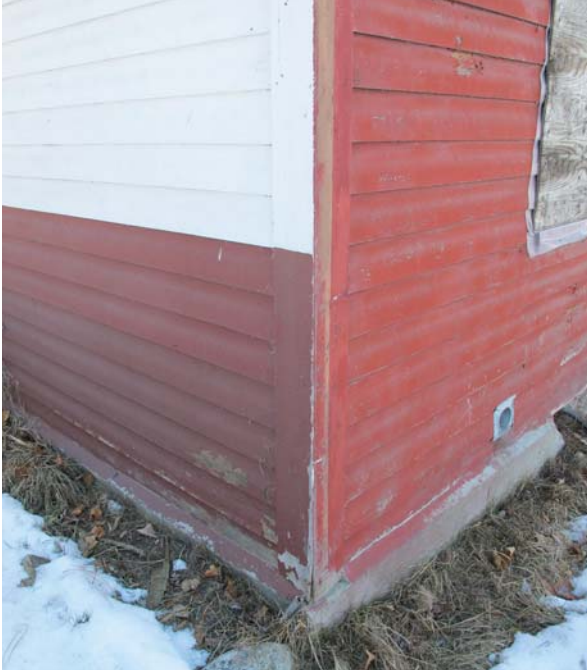
Northeast corner condition of the existing, original exterior walls of the Surtees Barn, showing unsympathetic paint finish.

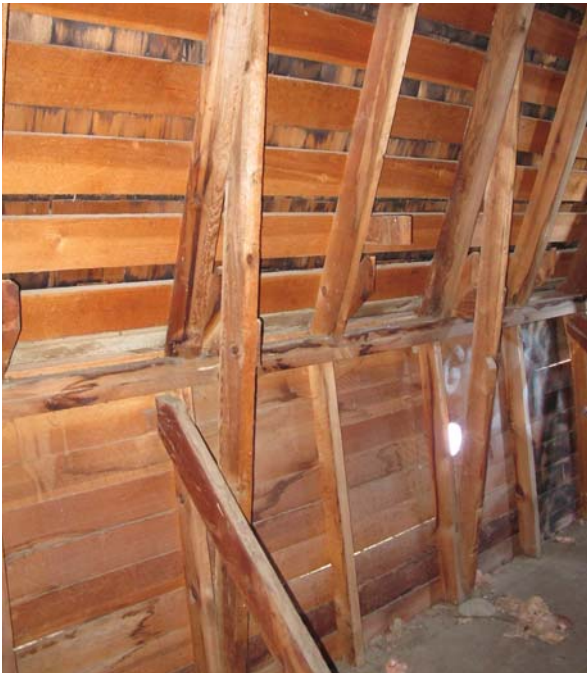
Interior side of the wall-to-roof interface, showing typical existing condition of the original wood materials.

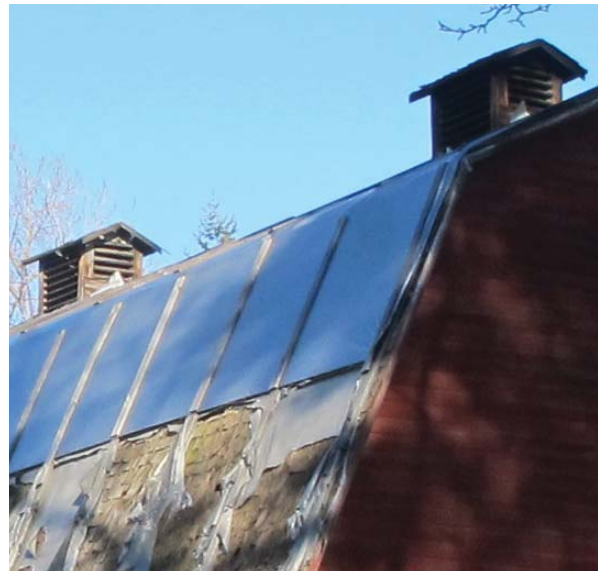
Photo showing typical deteriorated condition of two, existing monitor vents along the roof ridge.

- Preserve the original monitor vents in its original configuration, if possible.
- Original chimneys may require structural stabilization.
- Investigate condition of louvers and siding. If required, they should be repaired and cleaned using gentlest means as possible.
- If the existing monitor vents need to be removed prior to relocation, the existing monitor vents should be carefully documented prior to dismantling. All sound, original materials should be salvaged. Monitor vents should be reinstated above roofline to match original configuration using salvaged original materials as possible, or if necessary, with new materials to match the original. Reconstruction should be discussed with the Heritage Consultant.

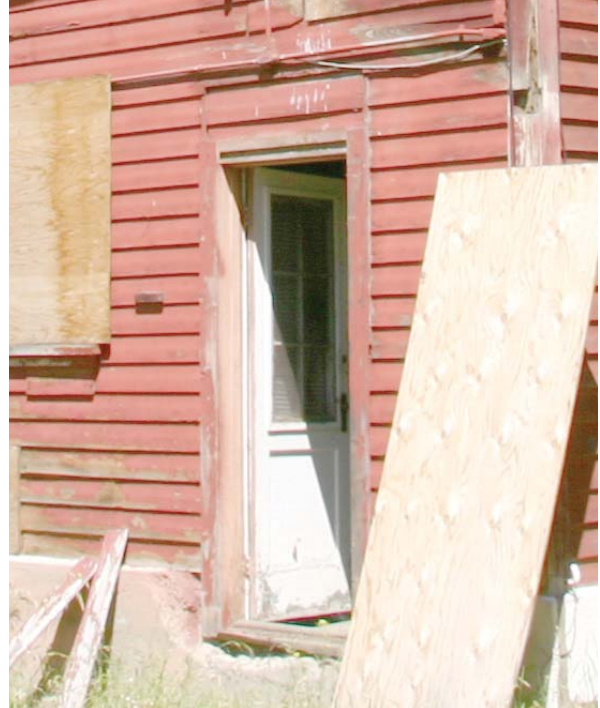
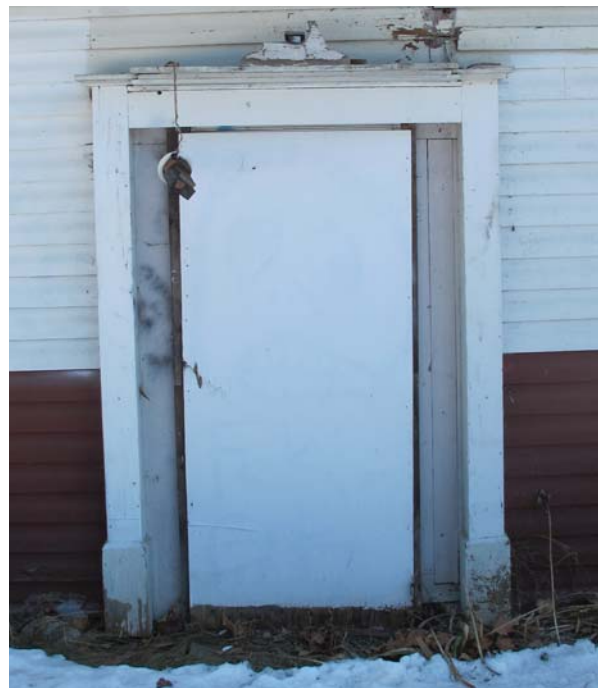
Photos showing original, existing door assembly at west return of south elevation (top), and later door surround trim at east elevation (bottom).
