BYLAW NO. 11408

Heritage Revitalization Agreement Authorization Bylaw HRA17-0001 –

4629 Lakeshore Road

SURTEES HOUSE & BARN

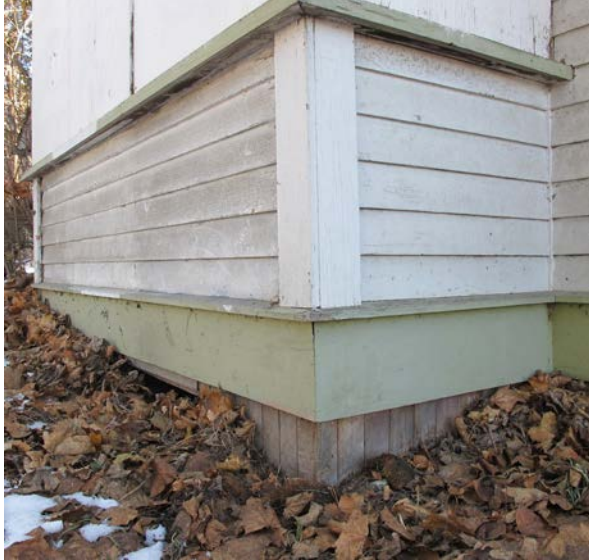
Lower portion of bay window at north elevation, showing wood lapped siding, window sill, and board trims. Note that foundation wall is clad in later vertical siding.

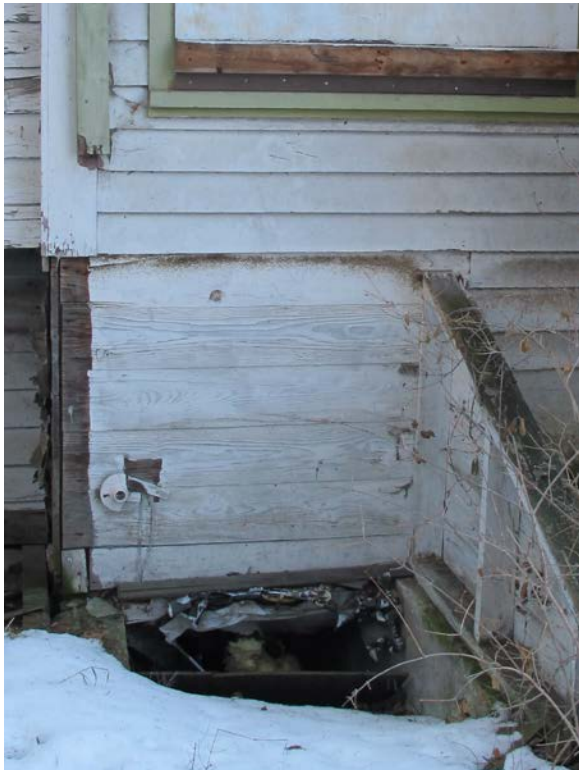
Portion of rear elevation showing opening to unoccupied partial basement, with exposed cast-in-place concrete foundation walls.

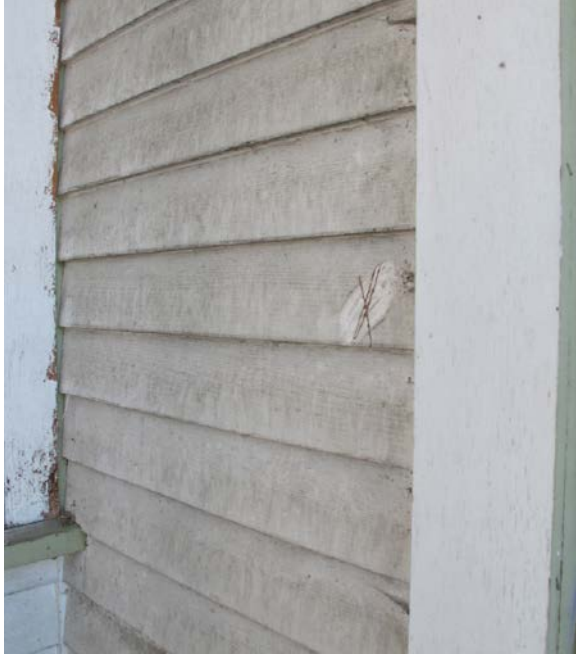
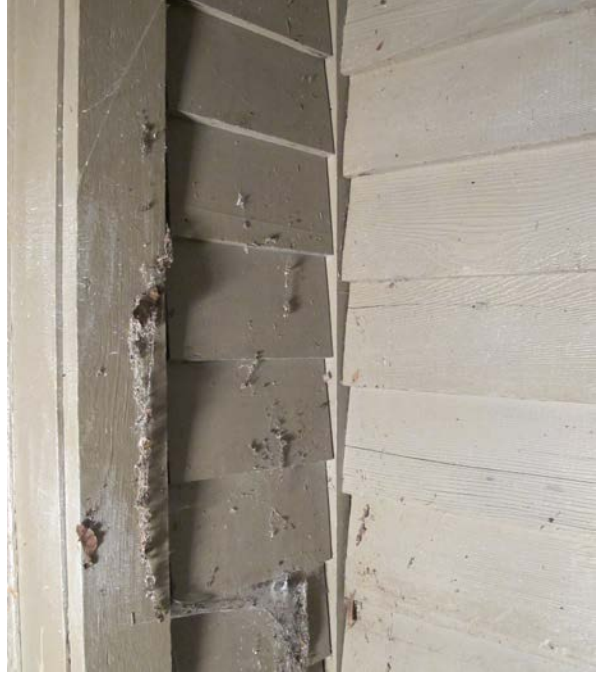
Photo showing existing condition of original exterior wall, with horizontal lapped wood siding and trims at north elevation (top left), and at the interior return walls of the enclosed early addition to the west (top right).

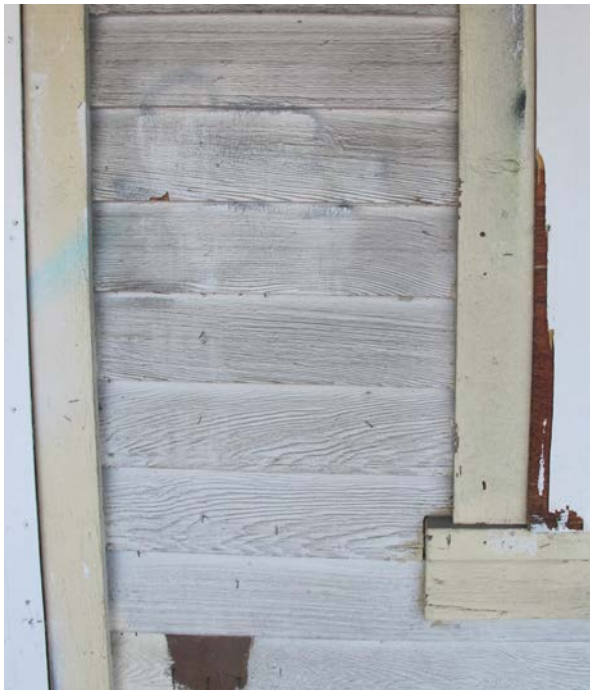
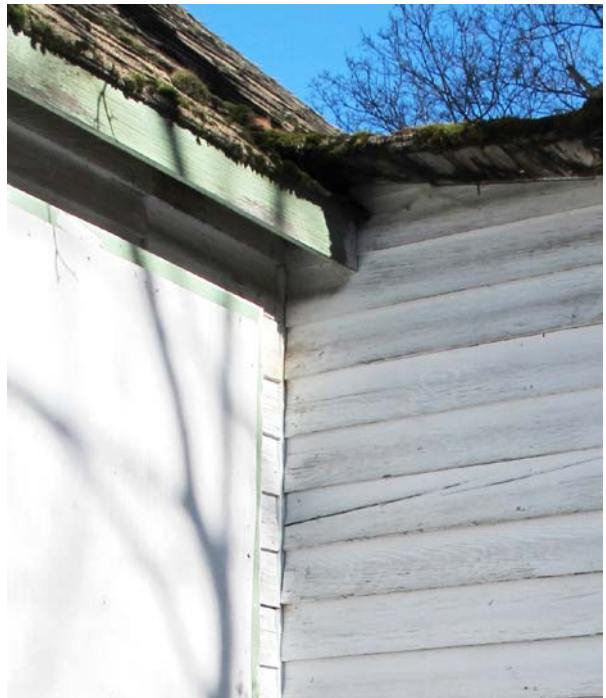
Photos showing original exterior walls with original materials interfaced with later rehabilitation with inappropriate detailing; at historic front facade between door and window opening (bottom left), and at south elevation and return wall of later addition (bottom right).

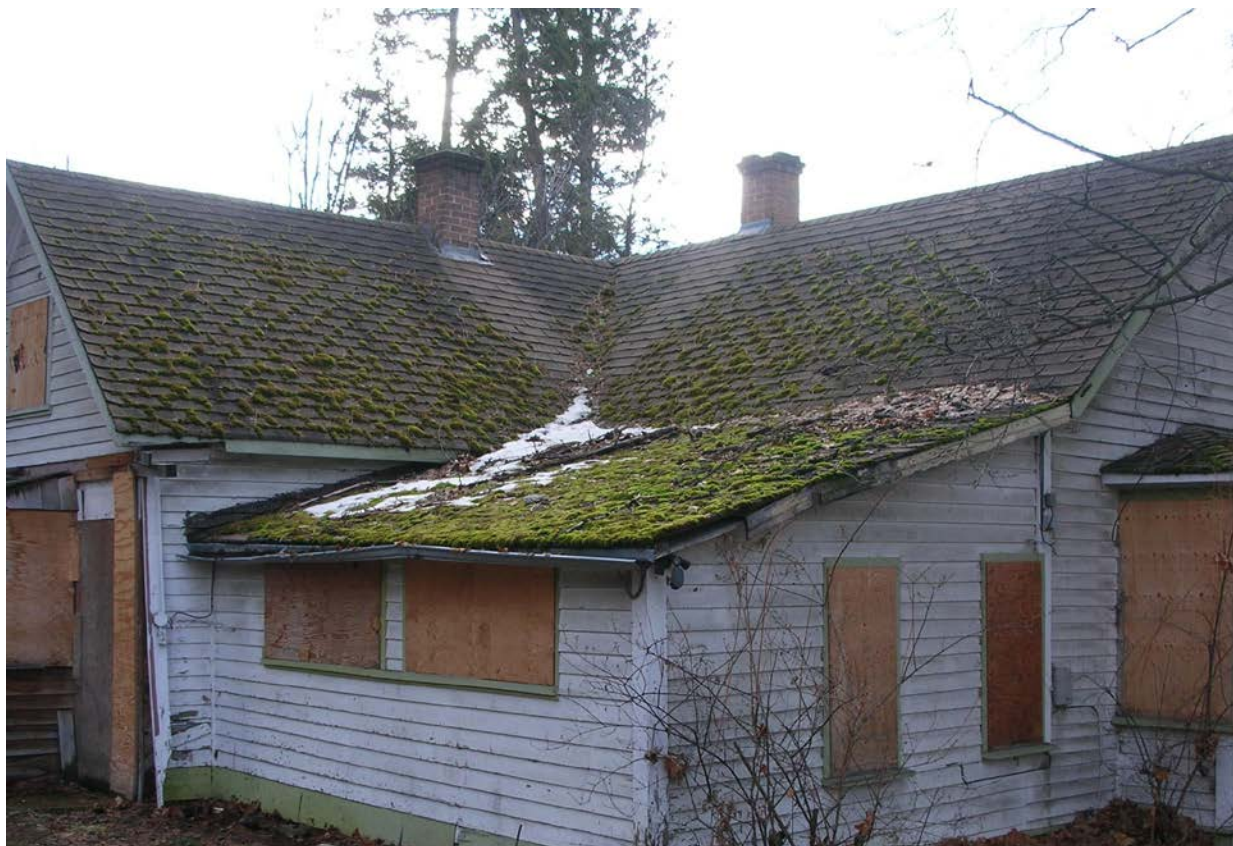
Existing condition of original, primary cross-gabled roof, with shed roof extension of early addition to the northeast portion of the house, as well as two original interior brick masonry chimney stacks along the roof ridges.

- Preserve the roof structure in its current configuration, as expressed by its primary cross-gabled roofstructure.
- If required, roofing membrane and cladding system may be rehabilitated. Cedar shingles are the preferred material, but uroid shingles or Aged Cedar Enviroshingles™ are also acceptable.
- Retain the original bargeboards and fascia boards, as well as the soffit any exposed roof elements.
- Design and install adequate rainwater disposal system and ensure proper drainage from the site is maintained. Wood gutters with galvanized steel downspouts are recommended. Aluminum in appropriate colours is also acceptable. Paint or provide specification of drainage system elements according to colour schedule devised by Heritage Consultant.

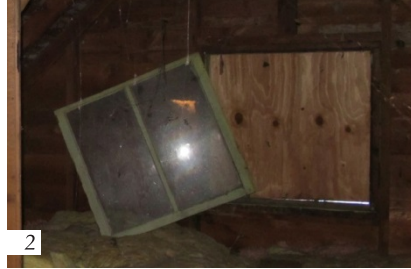
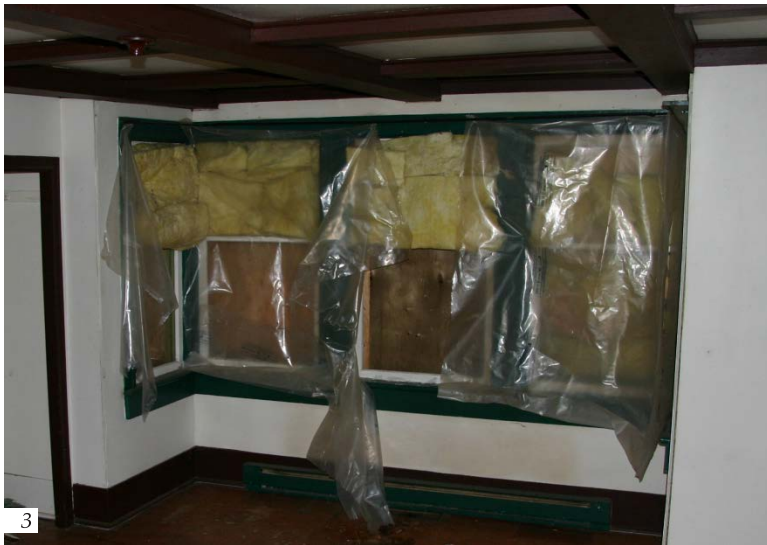
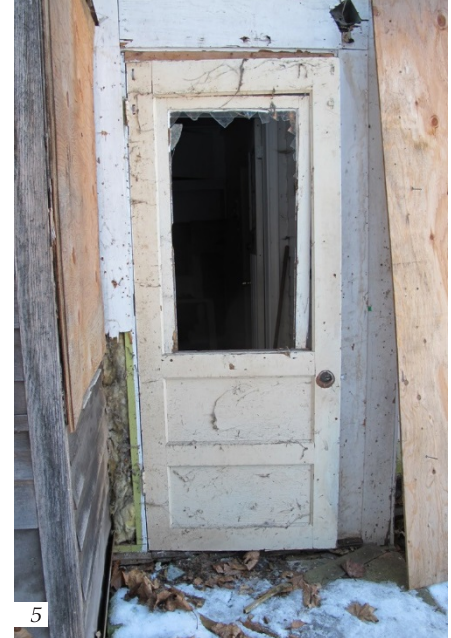
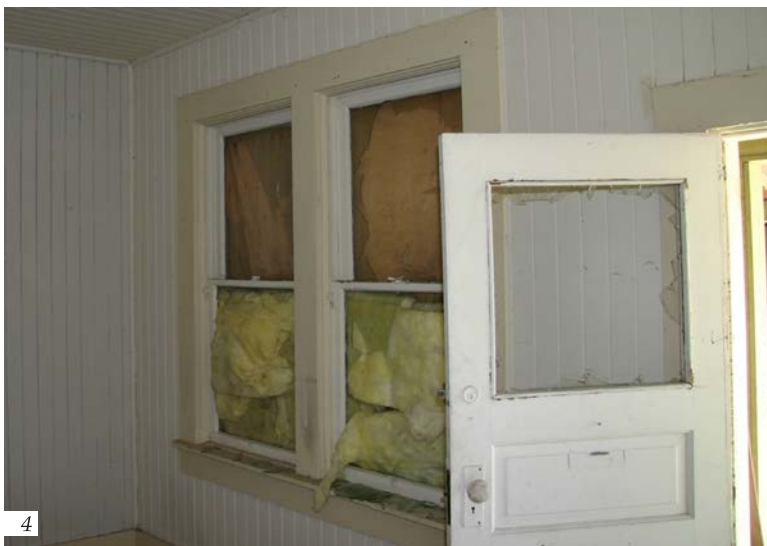
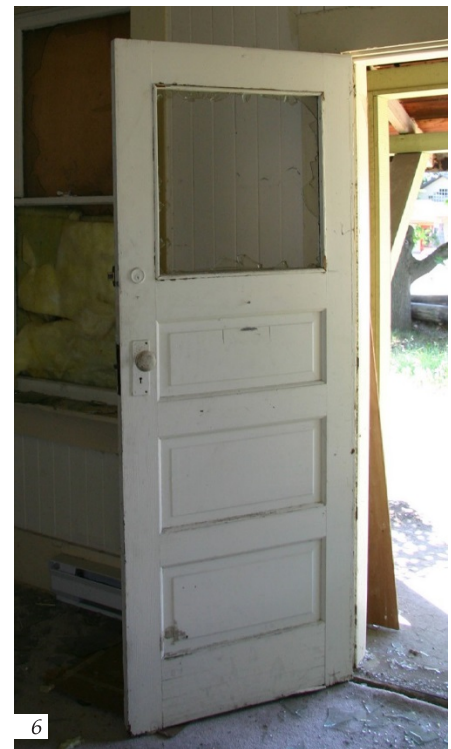
Photos showing existing typical conditions of surviving original wood windows and doors: gable ends at the east/west elevations (1, 2); bay window at north elevation (3); historic front facade at west elevation, showing partial wood door (4); rear exterior door at east elevation (5); main entrance door at west elevation (6).

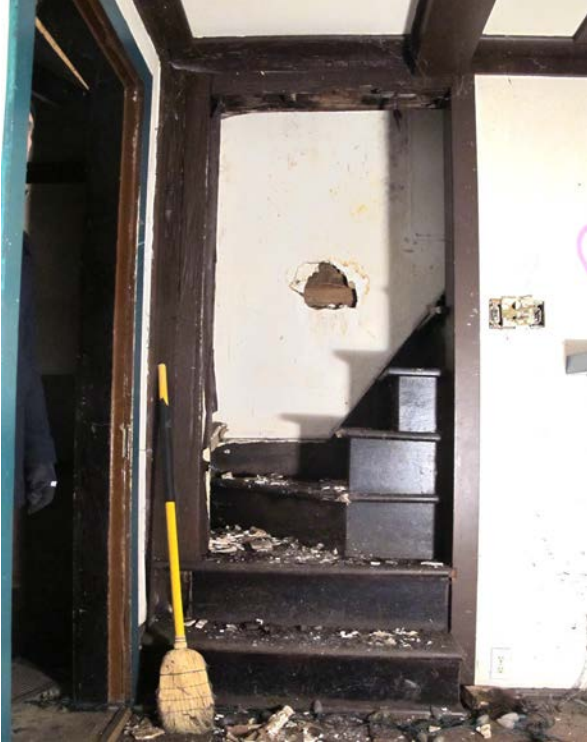
5.8.2 STAIRCASE

The Surtees House features an original, narrow winder staircase that is accessible from the large bedroom to the north, leading up to the attic spaces behind the fireplace. The low-height attic apices may have been used for storage or boarding rooms for servants. The staircase is intact and appears to be in good condition, and may be rehabilitated, as necessary.

Conservation Strategy: Rehabilitation

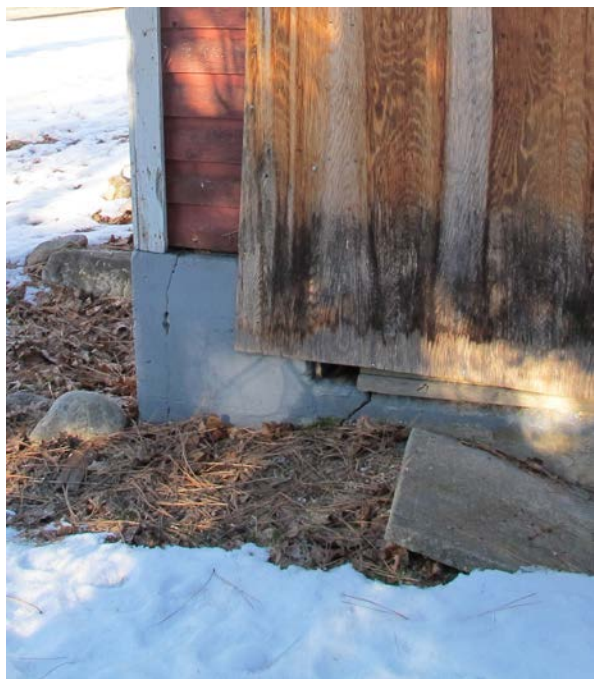
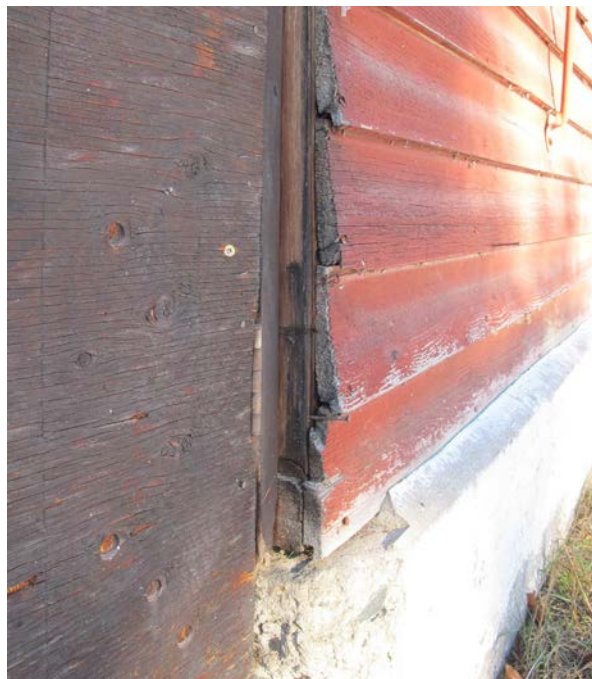
Photos showing typical deteriorated condition of exterior wall cladding above concrete foundation walls. Note profile of original drop siding (top right).

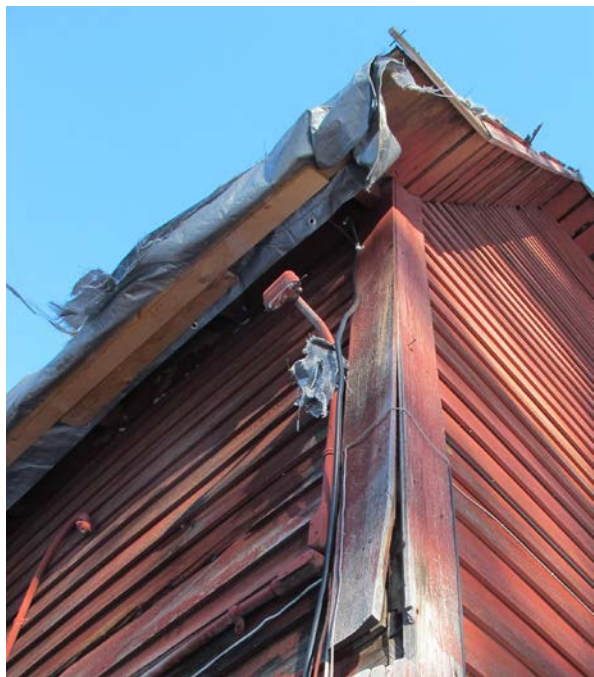
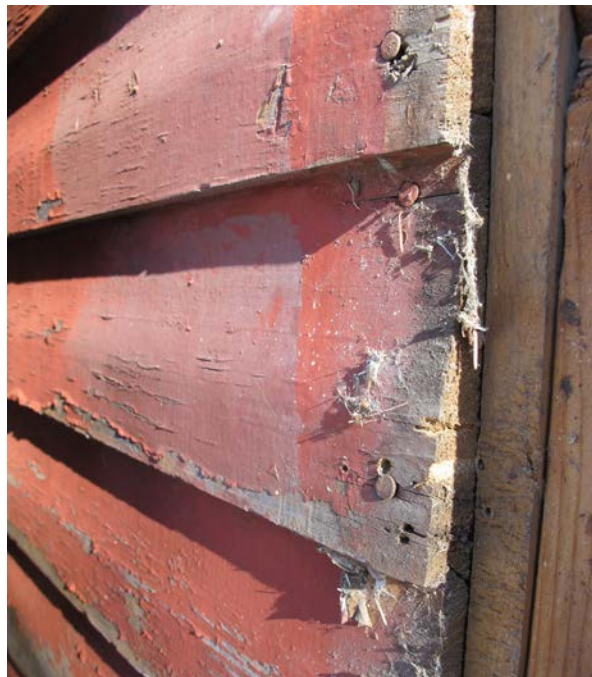
Photos showing typical deteriorated condition of exterior wall cladding, as well as roof soffit and corner board trims.

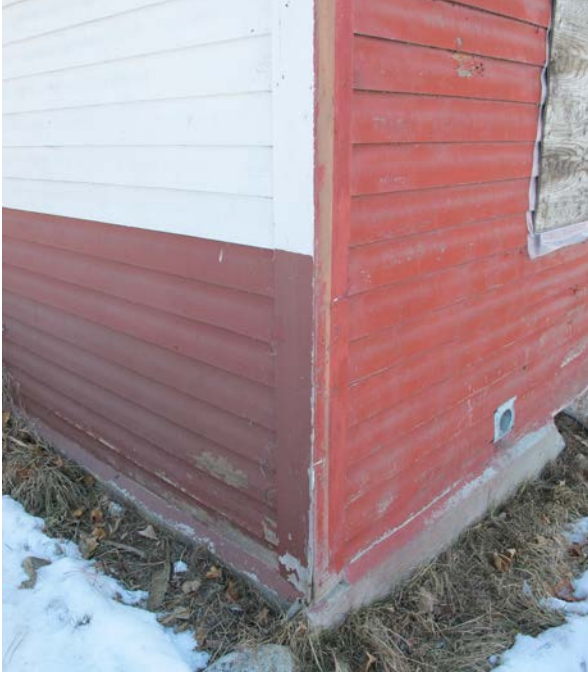
Northeast corner condition of the existing, original exterior walls of the Surtees Barn, showing unsympathetic paint finish.

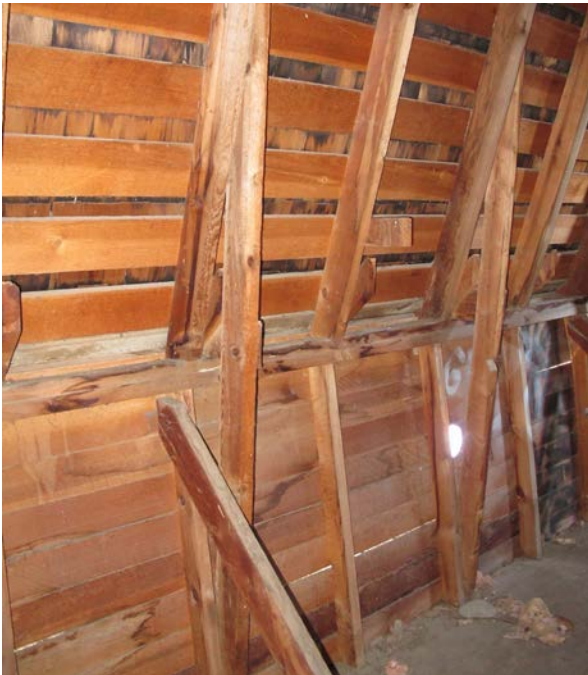
Interior side of the wall-to-roof interface, showing typical existing condition of the original wood materials.

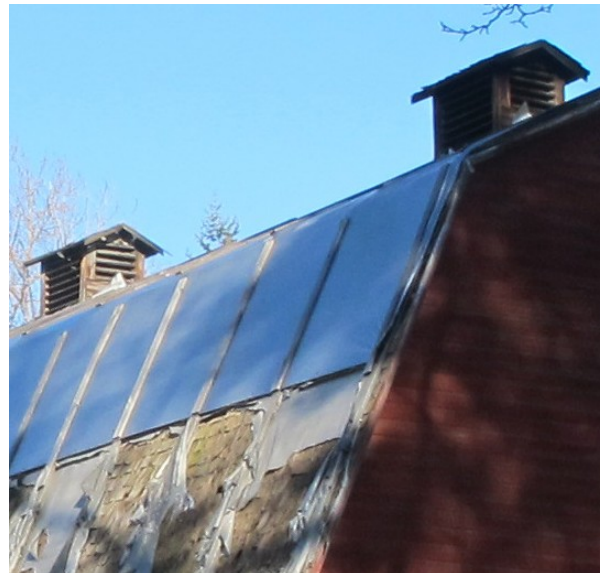
Photo showing typical deteriorated condition of two, existing monitor vents along the roof ridge.

- Preserve the original monitor vents in its original configuration, if possible.
- Original chimneys may require structural stabilization.
- Investigate condition of louvers and siding. If required, they should be repaired and cleaned using gentlest means as possible.
- If the existing monitor vents need to be removed prior to relocation, the existing monitor vents should be carefully documented prior to dismantling. All sound, original materials should be salvaged. Monitor vents should be reinstated above roofline to match original configuration using salvaged original materials as possible, or if necessary, with new materials to match the original. Reconstruction should be discussed with the Heritage Consultant.

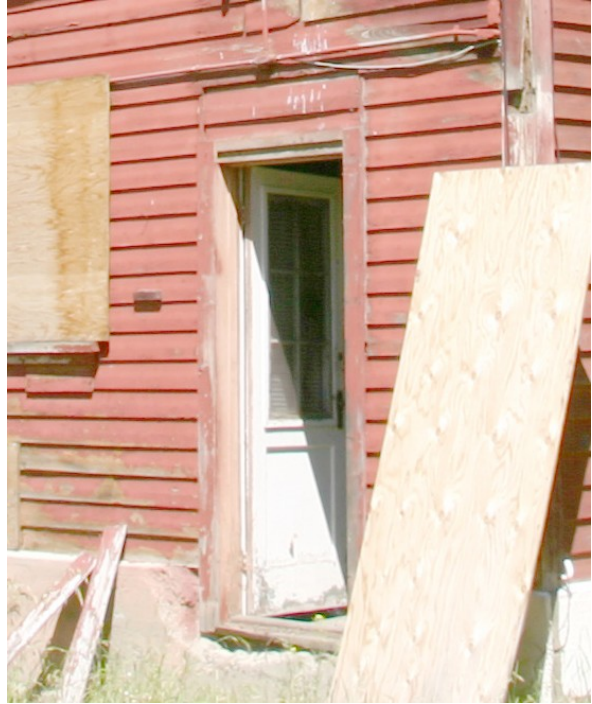
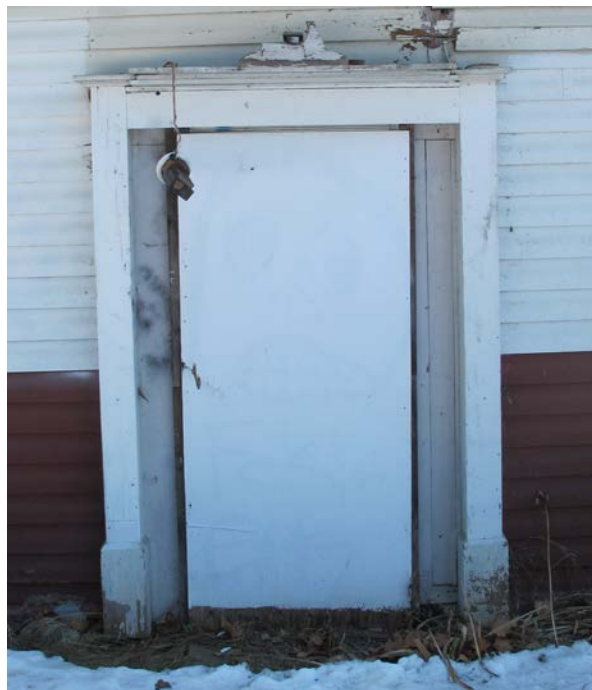
Photos showing original, existing door assembly at west return of south elevation (top), and later door surround trim at east elevation (bottom).

Conservation Strategy: Preservation
