## BYLAW NO. 11408

Heritage Revitalization Agreement Authorization Bylaw HRA17-0001 –

# SURTEES HOUSE & BARN

4629 LAKESHORE ROAD, KELOWNA, BC

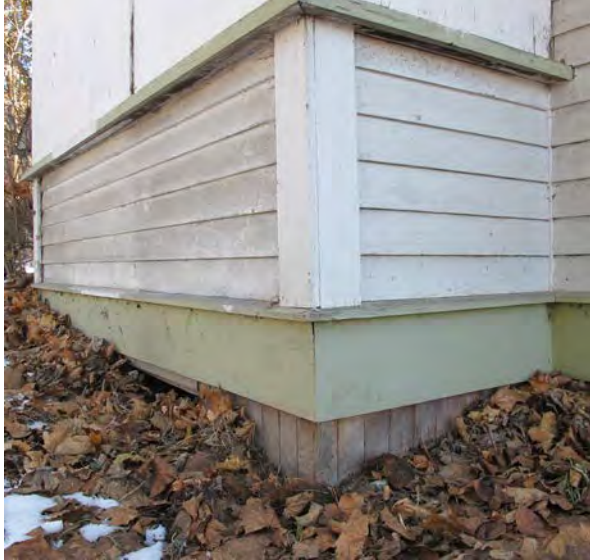
*Lower portion of bay window at north elevation, showing wood lapped siding, window sill, and board trims. Note that foundation wall is clad in later vertical siding.*

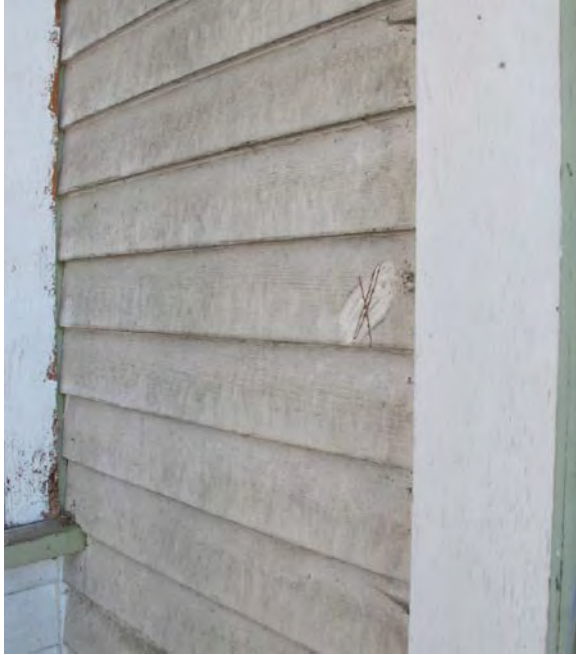
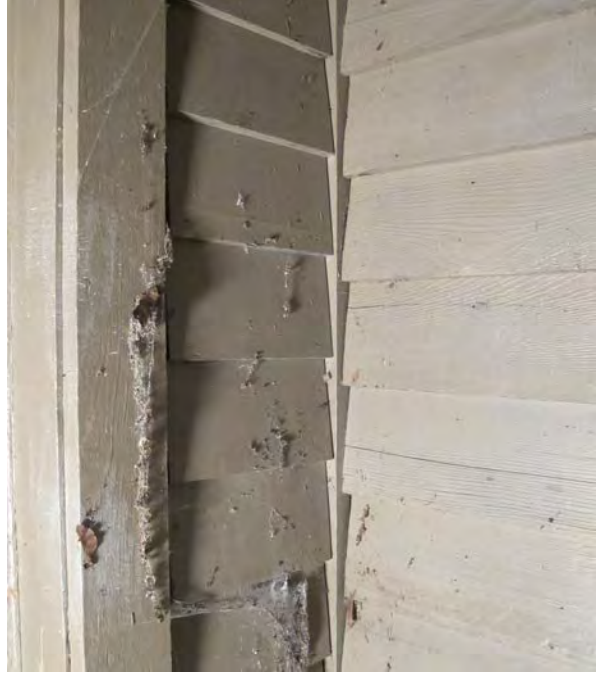
*Photo showing existing condition of original exterior wall, with horizontal lapped wood siding and trims at north elevation (top left), and at the interior return walls of the enclosed early addition to the west (top right).*

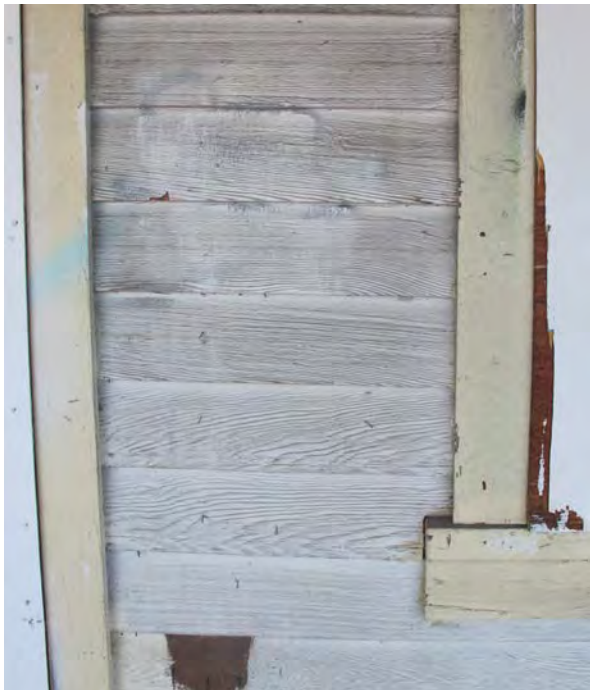
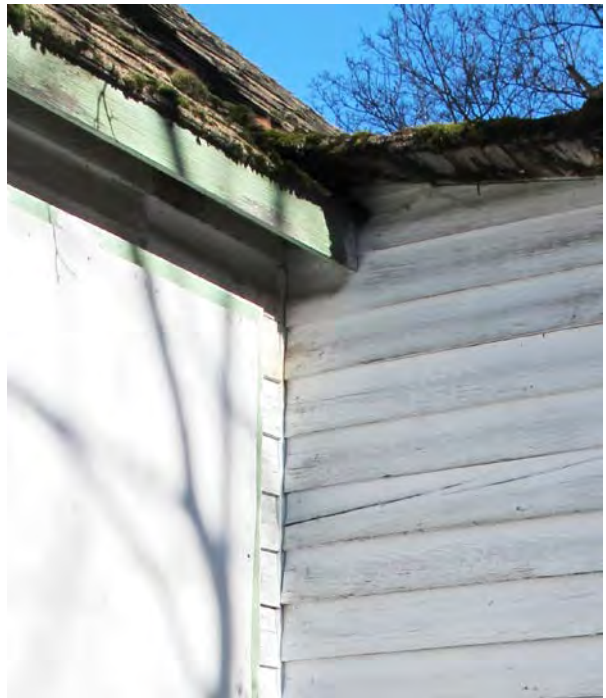
*Photos showing original exterior walls with original materials interfaced with later rehabilitation with inappropriate detailing; at historic front facade between door and window opening (bottom left), and at south elevation and return wall of later addition (bottom right).*

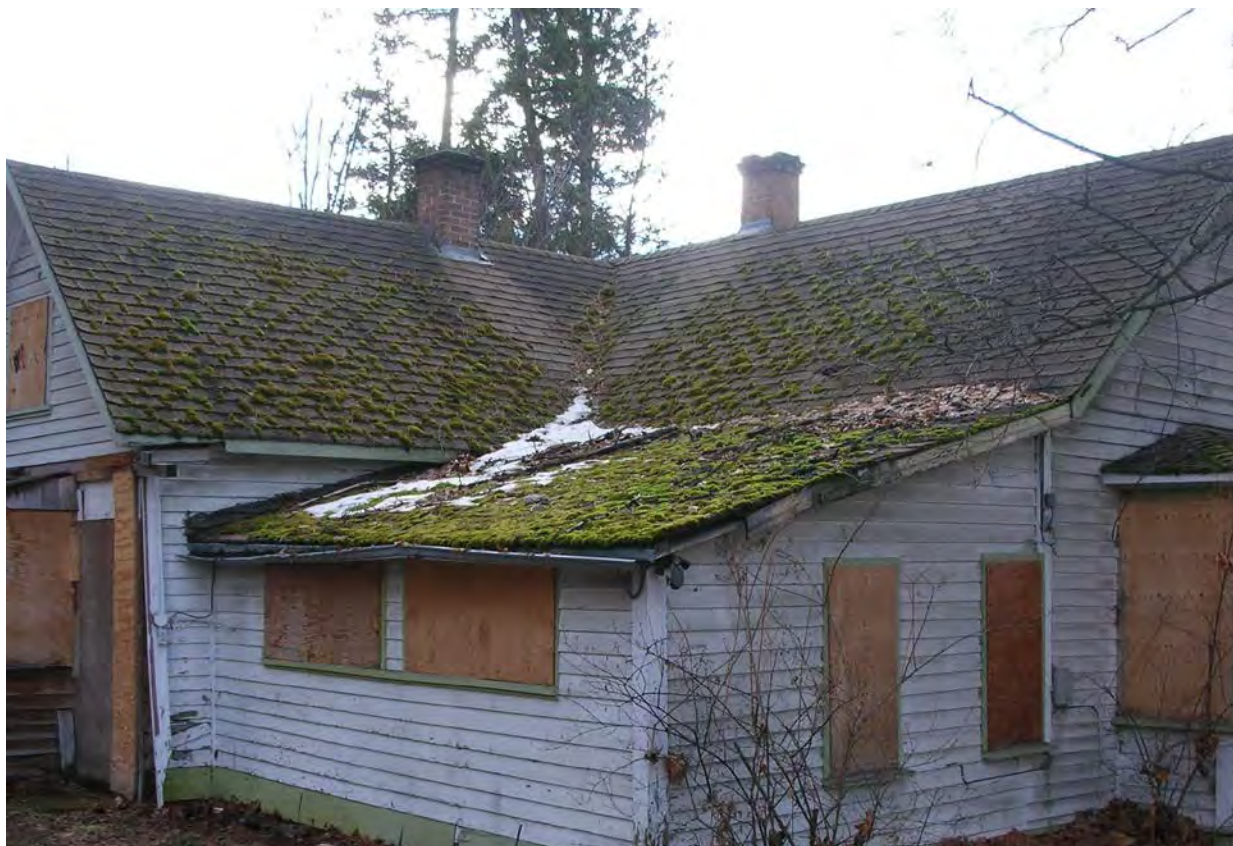
*Existing condition of original, primary cross-gabled roof, with shed roof extension of early addition to the northeast portion of the house, as well as two original interior brick masonry chimney stacks along the roof ridges.*

- Preserve the roof structure in its current configuration, as expressed by its primary cross-gabled roofstructure.
- If required, roofing membrane and cladding system may be rehabilitated. Cedar shingles are the preferred material, but uroid shingles or Aged Cedar Enviroshingles™ are also acceptable.
- Retain the original bargeboards and fascia boards, as well as the soffit any exposed roof elements.
- Design and install adequate rainwater disposal system and ensure proper drainage from the site is maintained. Wood gutters with galvanized steel downspouts are recommended. Aluminum in appropriate colours is also acceptable. Paint or provide specification of drainage system elements according to colour schedule devised by Heritage Consultant.

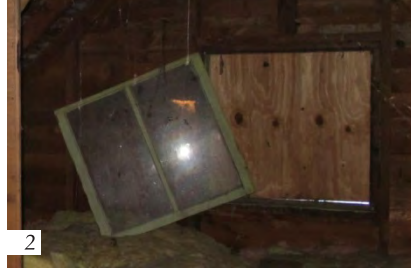
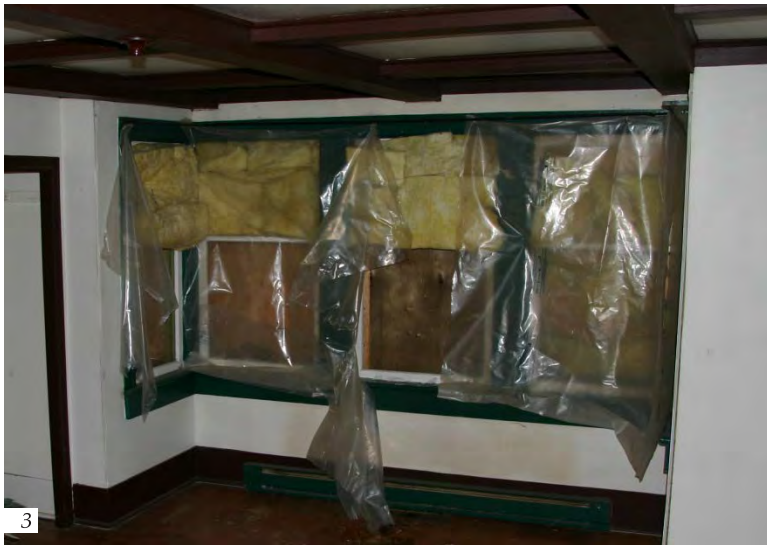
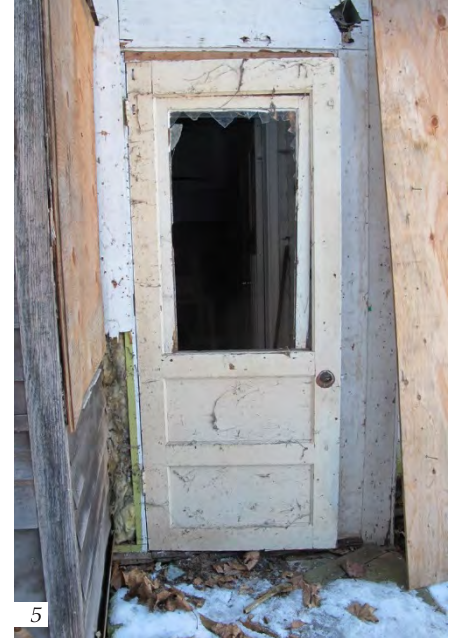
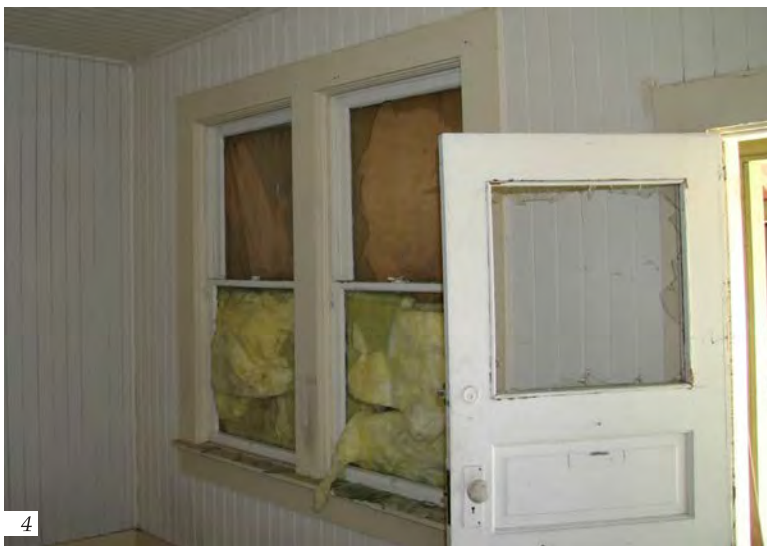
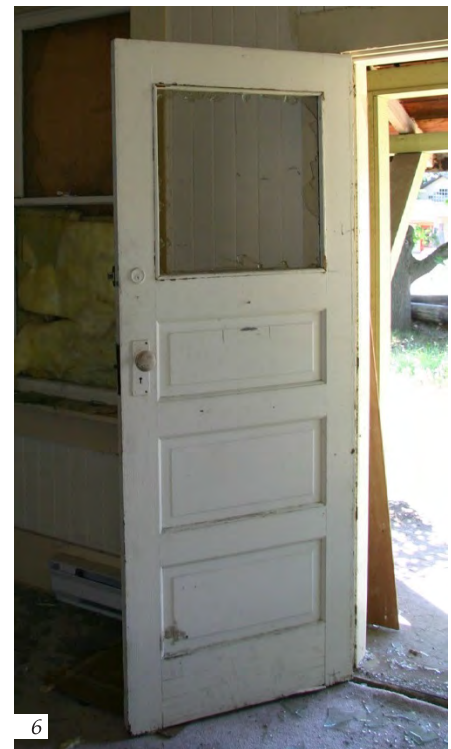
Photos showing existing typical conditions of surviving original wood windows and doors: gable ends at the east/west elevations (1, 2); bay window at north elevation (3); historic front facade at west elevation, showing partial wood door (4); rear exterior door at east elevation (5); main entrance door at west elevation (6).

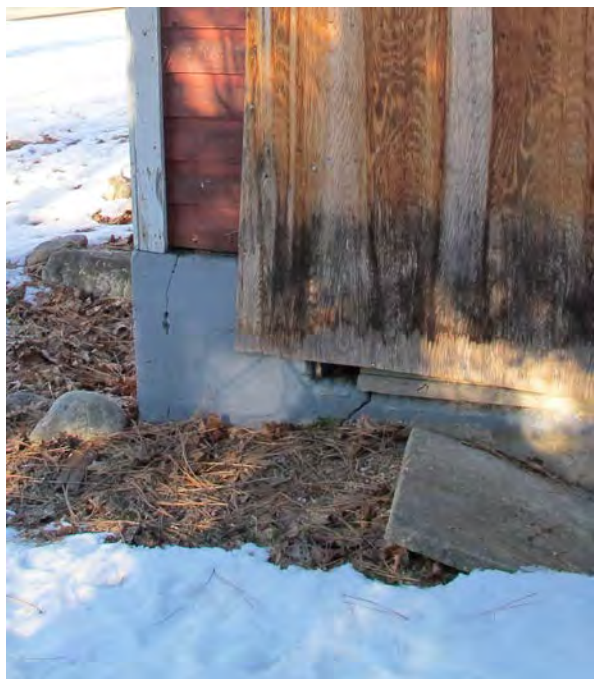
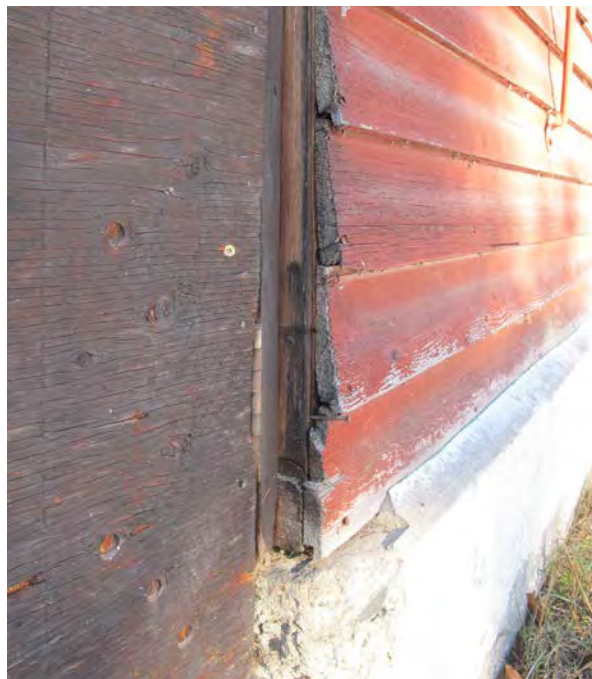
*Photos showing typical deteriorated condition of exterior wall cladding above concrete foundation walls. Note profile of original drop siding (top right).*

- Cleaning procedures should be undertaken with non-destructive methods. Areas with biological growth should be cleaned using a soft, natural bristle brush, without water, to remove dirt and other material. If a more intense cleaning is required, this can be accomplished with warm water, mild detergent (such as D/2 Biological Solution®) and a soft bristle brush. High-pressure power washing, abrasive cleaning or sandblasting should not be allowed under any circumstances.

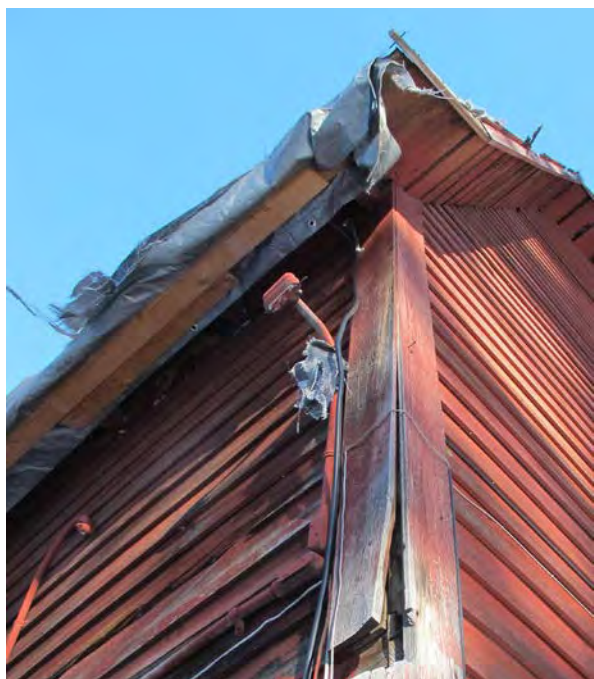
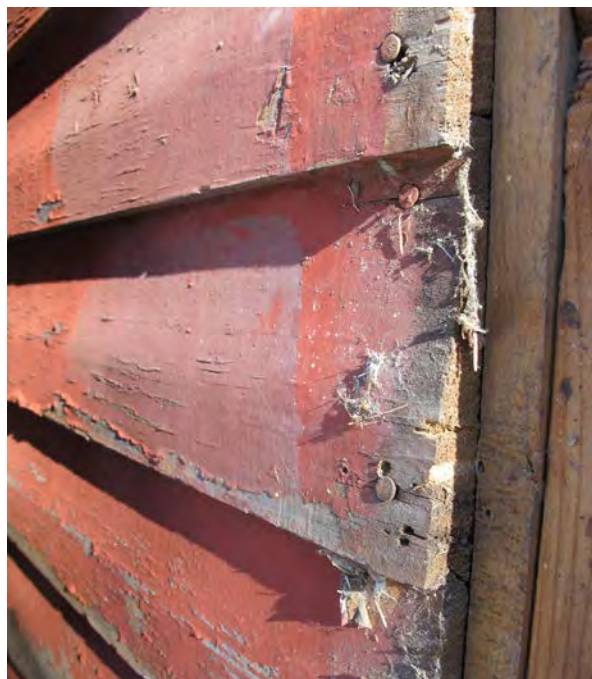
*Photos showing typical deteriorated condition of exterior wall cladding, as well as roof soffit and corner board trims.*

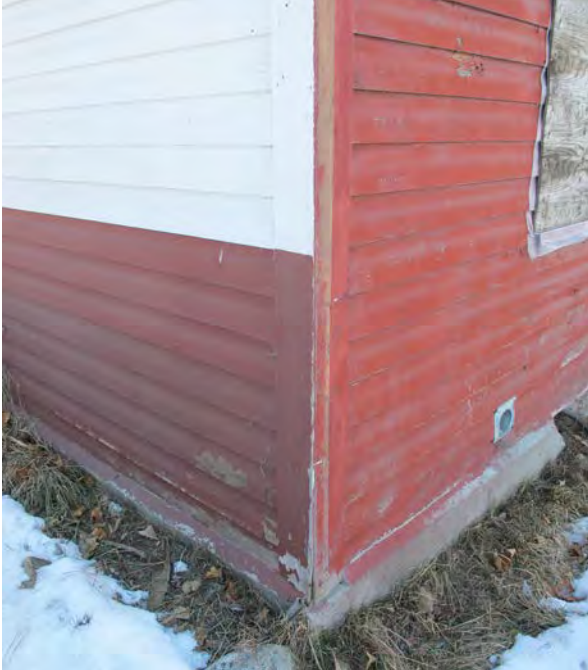
*Northeast corner condition of the existing, original exterior walls of the Surtees Barn, showing unsympathetic paint finish.*

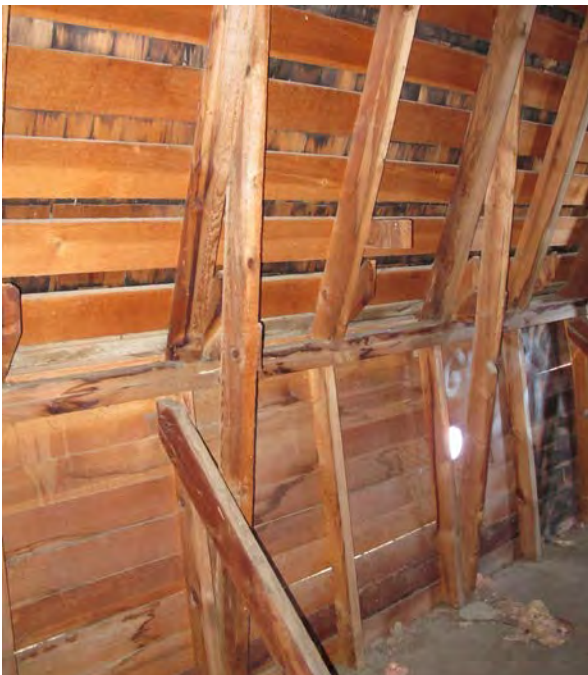
*Interior side of the wall-to-roof interface, showing typical existing condition of the original wood materials.*

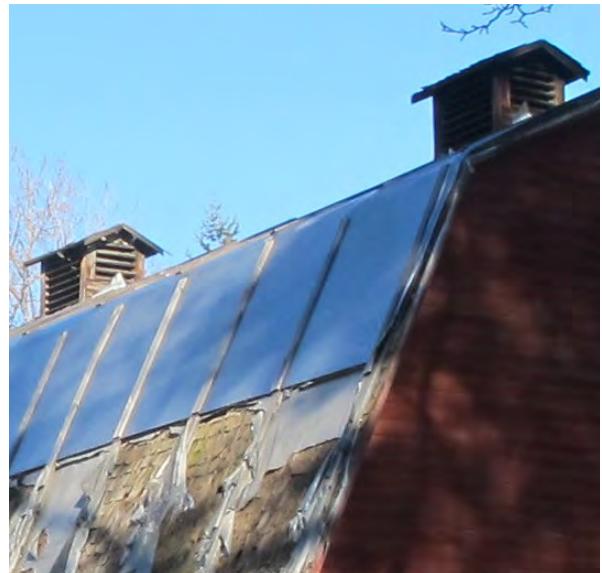
*Photo showing typical deteriorated condition of two, existing monitor vents along the roof ridge.*

- Preserve the original monitor vents in its original configuration, if possible.
- Original chimneys may require structural stabilization.
- Investigate condition of louvers and siding. If required, they should be repaired and cleaned using gentlest means as possible.
- If the existing monitor vents need to be removed prior to relocation, the existing monitor vents should be carefully documented prior to dismantling. All sound, original materials should be salvaged. Monitor vents should be reinstated above roofline to match original configuration using salvaged original materials as possible, or if necessary, with new materials to match the original. Reconstruction should be discussed with the Heritage Consultant.

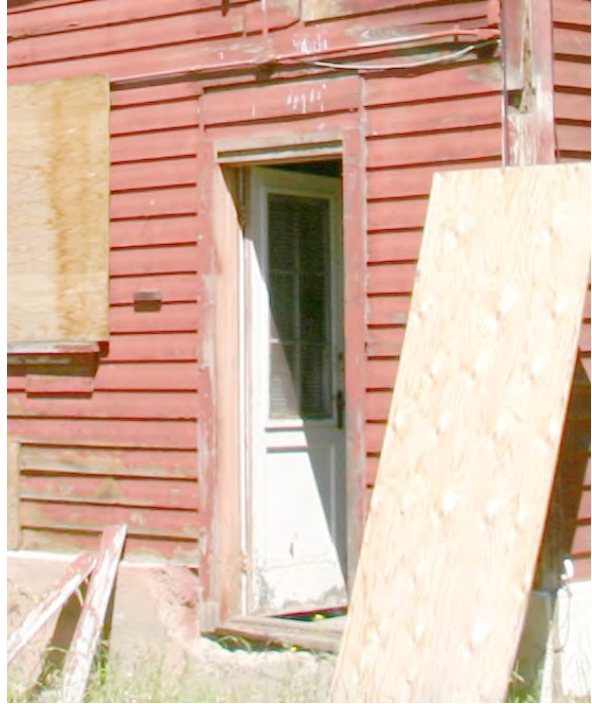
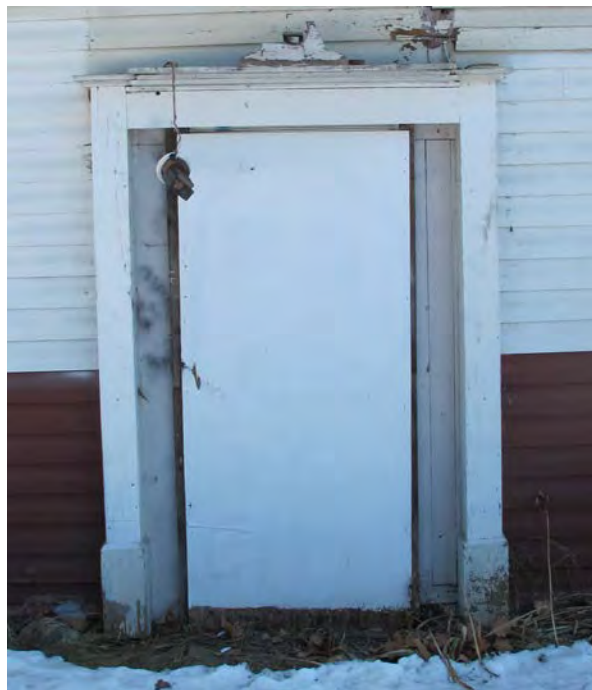
*Photos showing original, existing door assembly at west return of south elevation (top), and later door surround trim at east elevation (bottom).*
