# CITY OF KELOWNA

## BYLAW NO. 11408

Heritage Revitalization Agreement Authorization Bylaw HRA17-0001 –

# SURTEES HOUSE & BARN

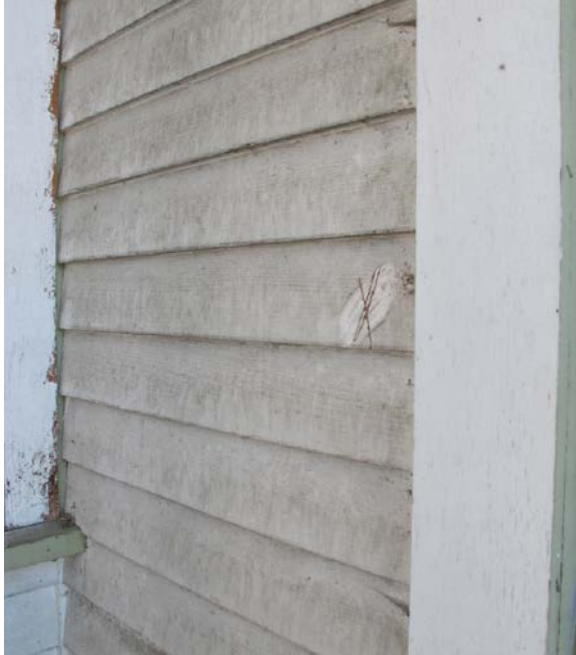
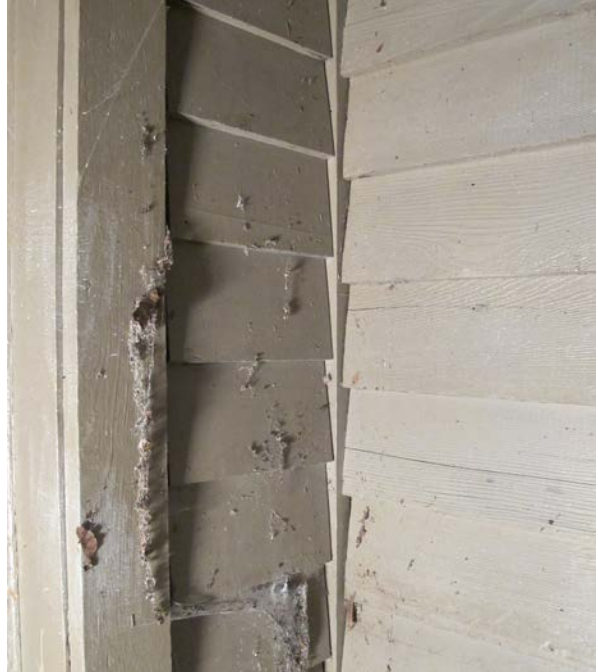
*Photo showing existing condition of original exterior wall, with horizontal lapped wood siding and trims at north elevation (top left), and at the interior return walls of the enclosed early addition to the west (top right).*

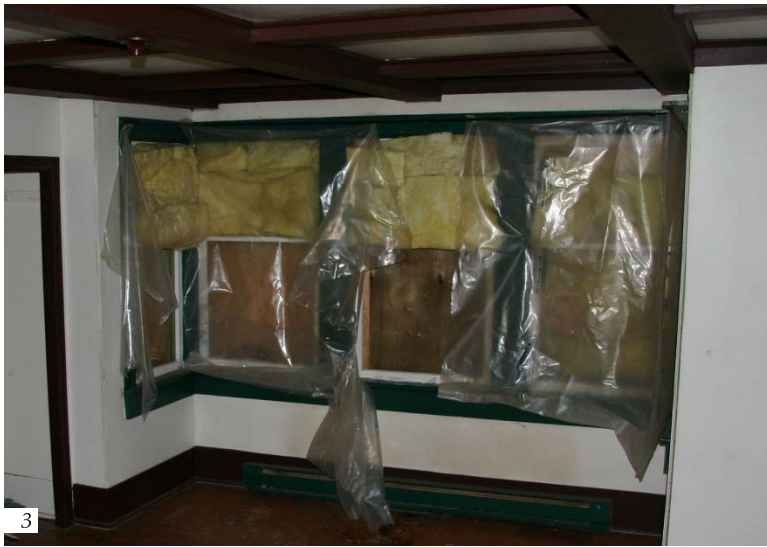
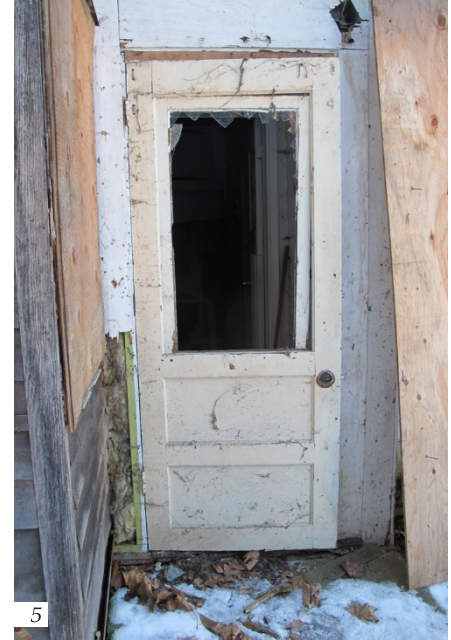
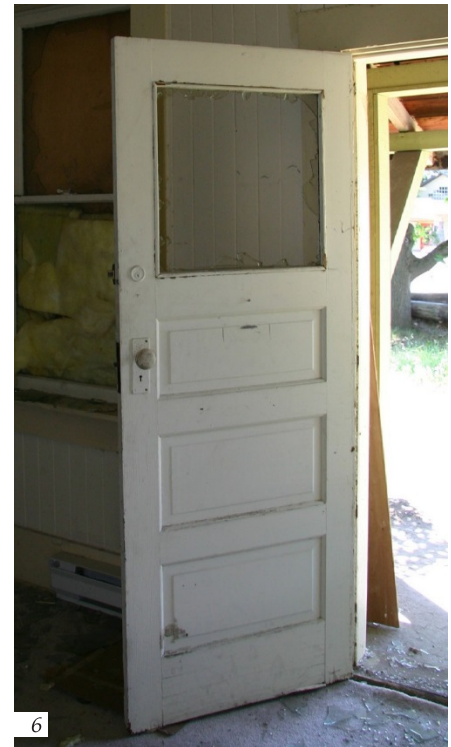
Photos showing existing typical conditions of surviving original wood windows and doors: gable ends at the east/west elevations (1, 2); bay window at north elevation (3); historic front facade at west elevation, showing partial wood door (4); rear exterior door at east elevation (5); main entrance door at west elevation (6).

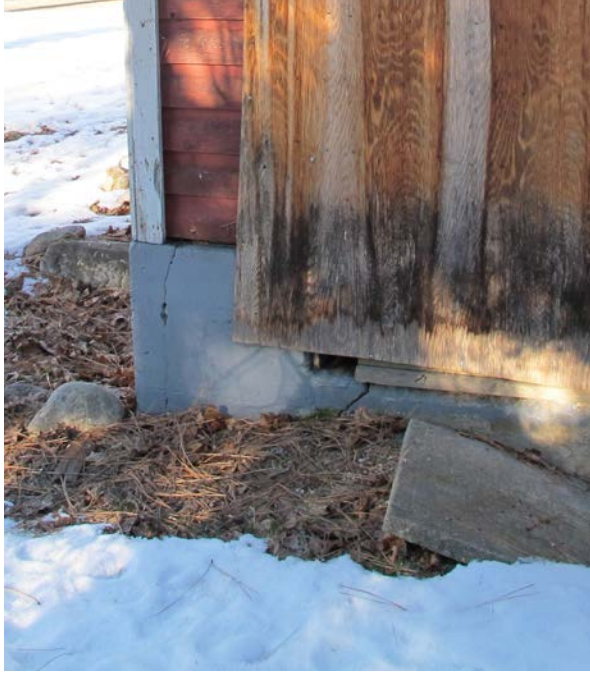
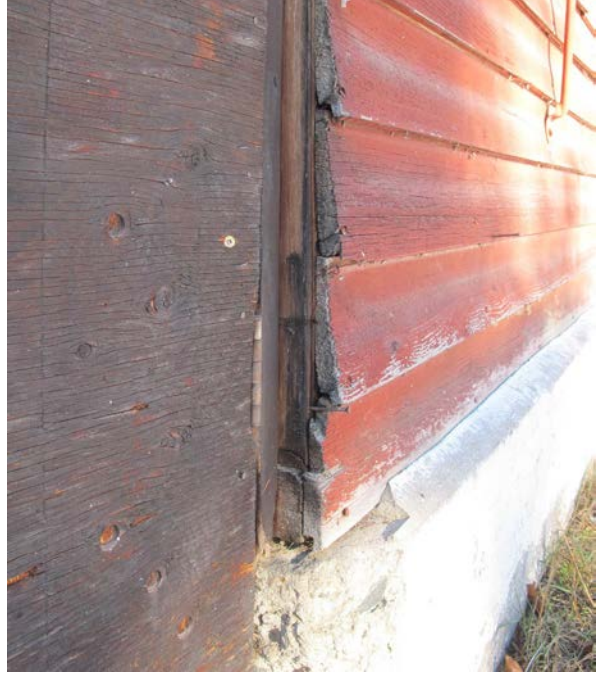
*Photos showing typical deteriorated condition of exterior wall cladding above concrete foundation walls. Note profile of original drop siding (top right).*

- Cleaning procedures should be undertaken with non-destructive methods. Areas with biological growth should be cleaned using a soft, natural bristle brush, without water, to remove dirt and other material. If a more intense cleaning is required, this can be accomplished with warm water, mild detergent (such as D/2 Biological Solution®) and a soft bristle brush. High-pressure power washing, abrasive cleaning or sandblasting should not be allowed under any circumstances.

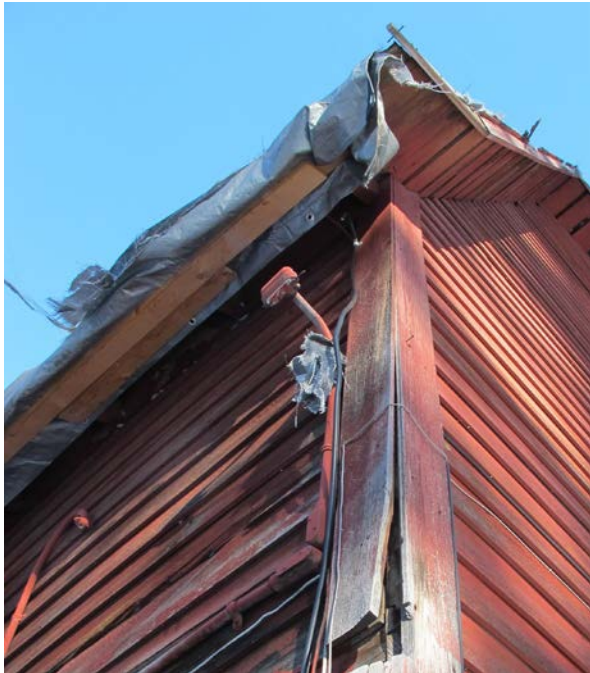
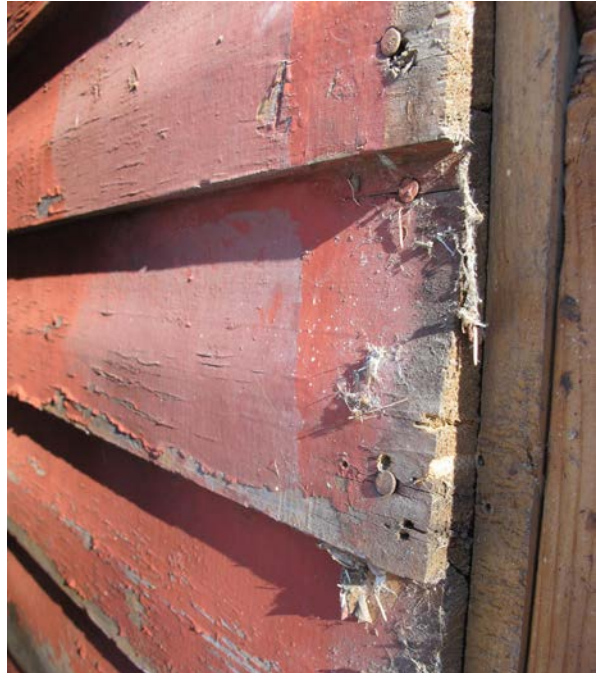
*Photos showing typical deteriorated condition of exterior wall cladding, as well as roof soffit and corner board trims.*

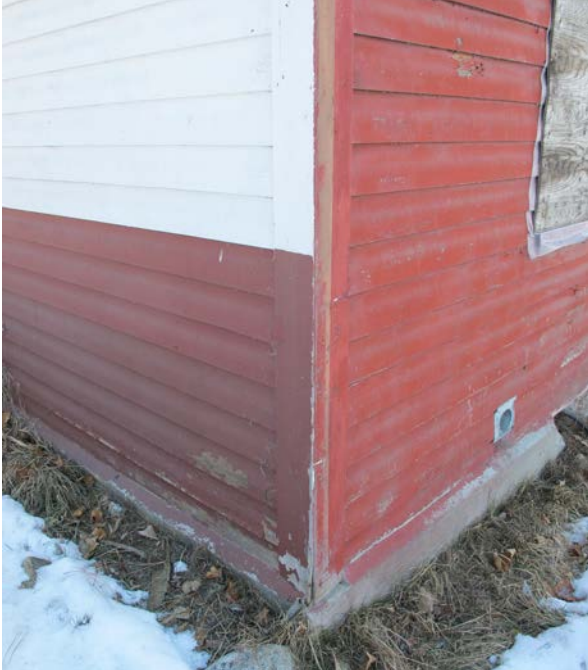
*Northeast corner condition of the existing, original exterior walls of the Surtees Barn, showing unsympathetic paint finish.*

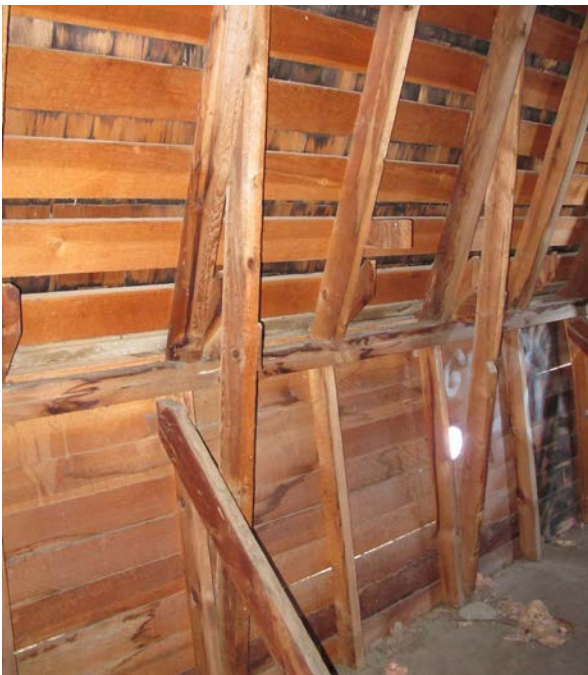
*Interior side of the wall-to-roof interface, showing typical existing condition of the original wood materials.*

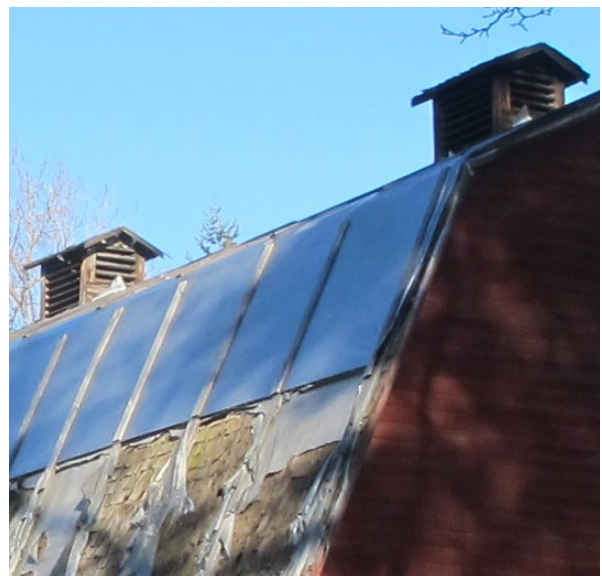
*Photo showing typical deteriorated condition of two, existing monitor vents along the roof ridge.*

- Preserve the original monitor vents in its original configuration, if possible.
- Original chimneys may require structural stabilization.
- Investigate condition of louvers and siding. If required, they should be repaired and cleaned using gentlest means as possible.
- If the existing monitor vents need to be removed prior to relocation, the existing monitor vents should be carefully documented prior to dismantling. All sound, original materials should be salvaged. Monitor vents should be reinstated above roofline to match original configuration using salvaged original materials as possible, or if necessary, with new materials to match the original. Reconstruction should be discussed with the Heritage Consultant.

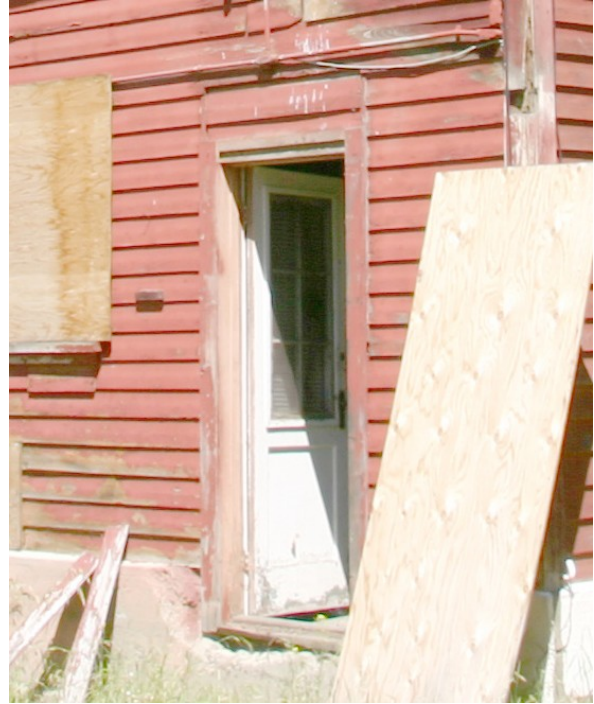
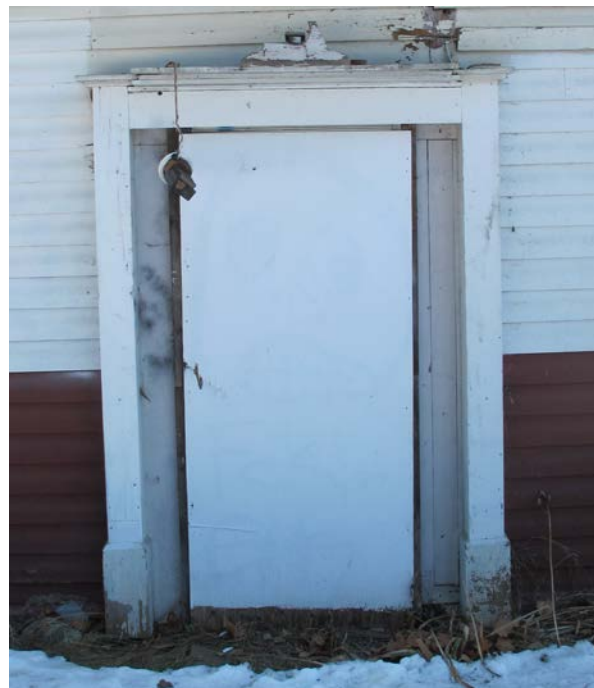
*Photos showing original, existing door assembly at west return of south elevation (top), and later door surround trim at east elevation (bottom).*
