Heritage Advisory Committee

AGENDA

SURTEES HOUSE & BARN

4629 LAKESHORE ROAD, KELOWNA, BC

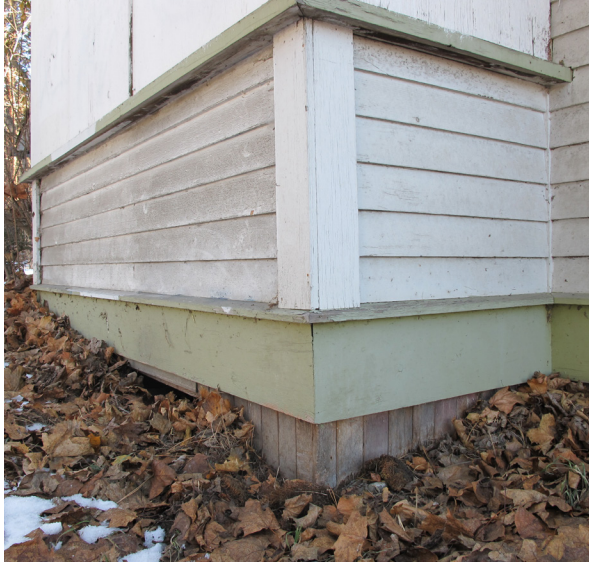
Lower portion of bay window at north elevation, showing wood lapped siding, window sill, and board trims. Note that foundation wall is clad in later vertical siding.

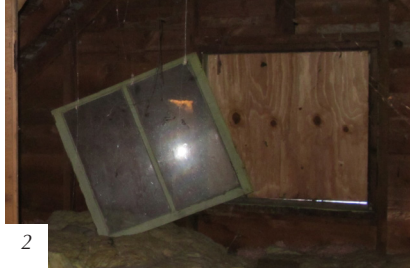
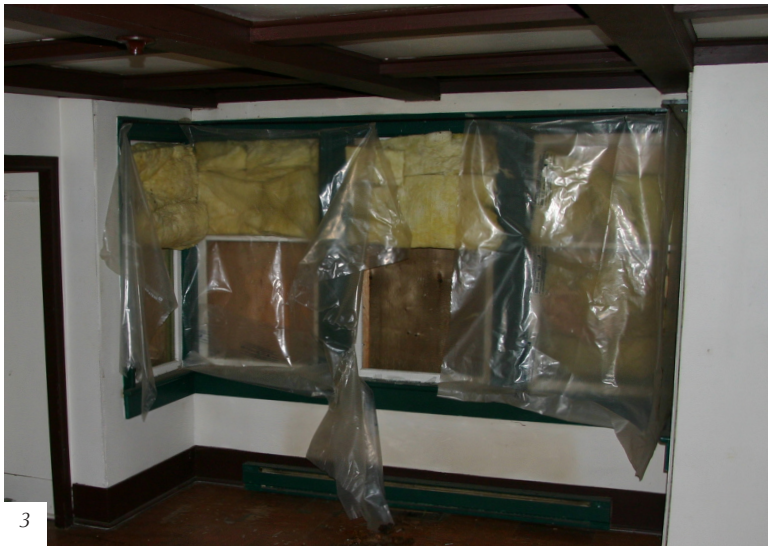
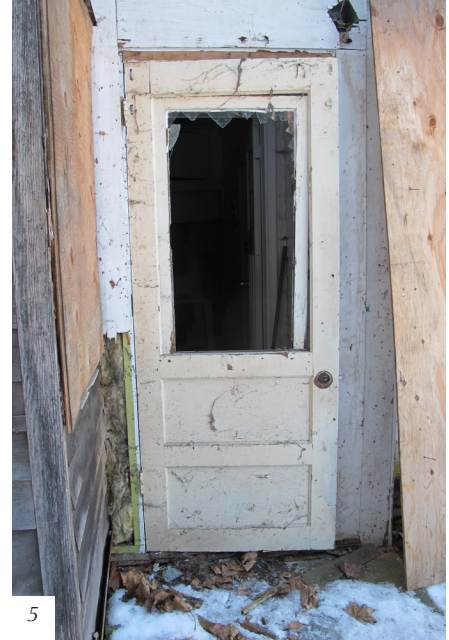
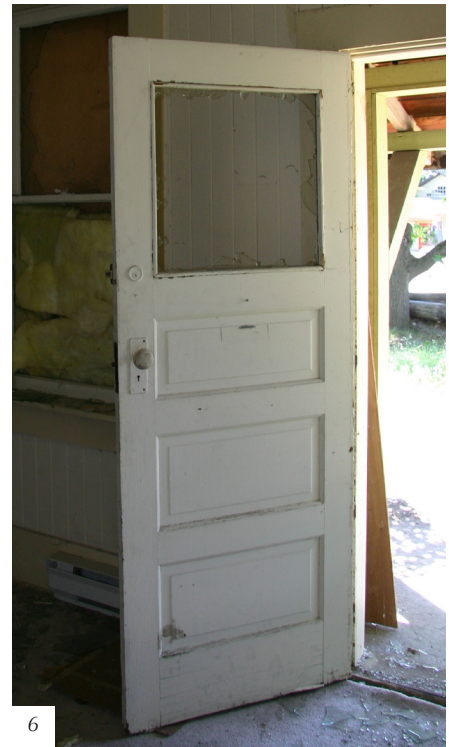
Photos showing existing typical conditions of surviving original wood windows and doors: gable ends at the east/west elevations (1, 2); bay window at north elevation (3); historic front facade at west elevation, showing partial wood door (4); rear exterior door at east elevation (5); main entrance door at west elevation (6).

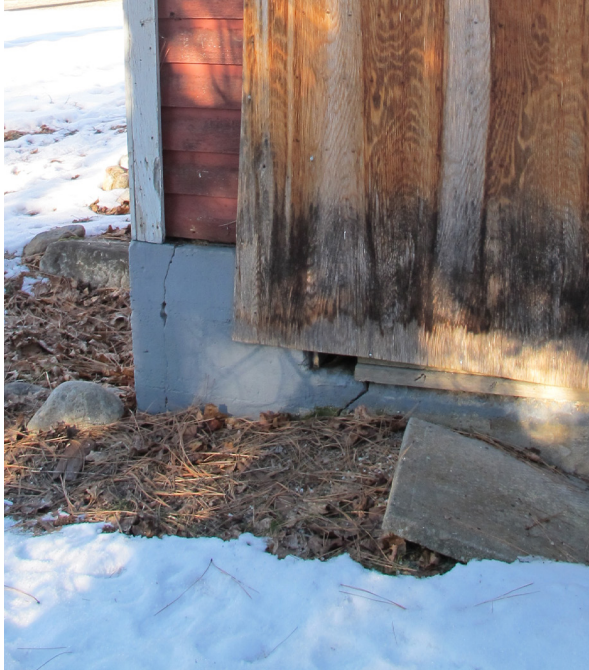
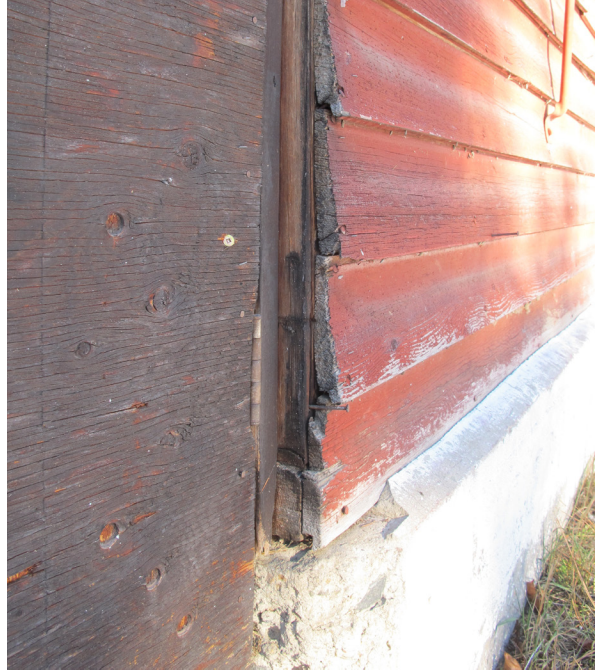
Photos showing typical deteriorated condition of exterior wall cladding above concrete foundation walls. Note profile of original drop siding (top right).

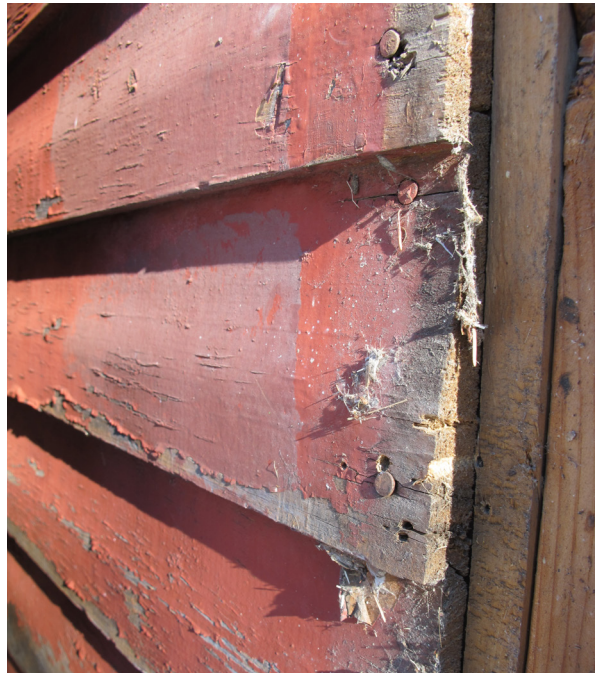
Photos showing typical deteriorated condition of exterior wall cladding, as well as roof soffit and corner board trims.

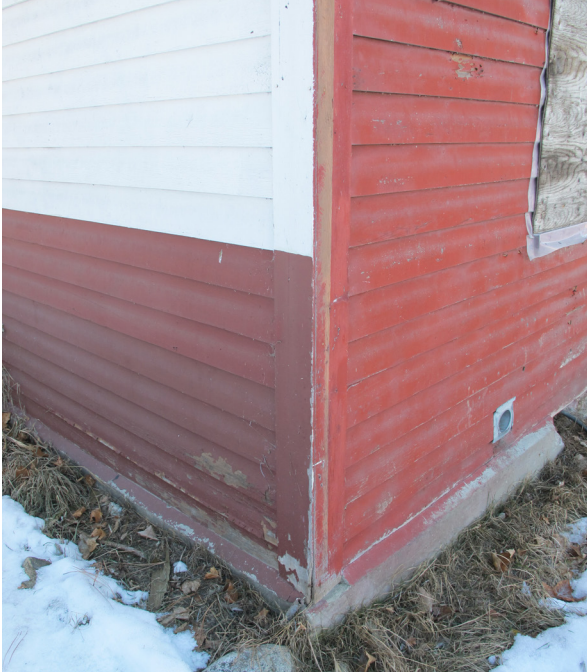
Northeast corner condition of the existing, original exterior walls of the Surtees Barn, showing unsympathetic paint finish.

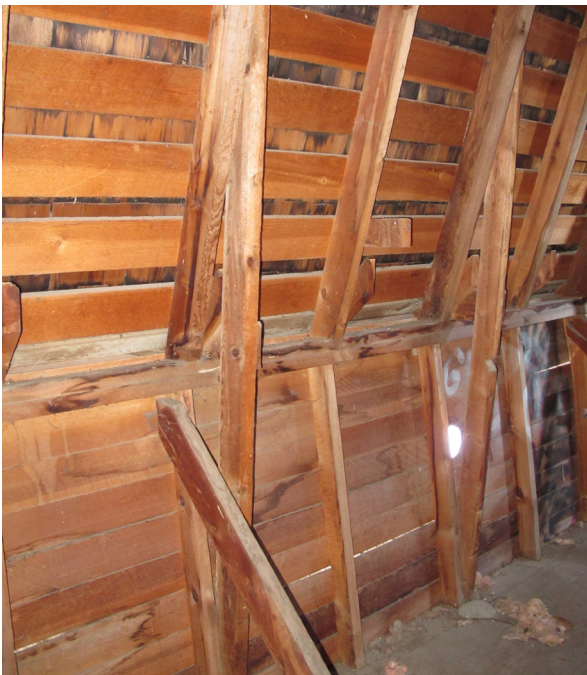
Interior side of the wall-to-roof interface, showing typical existing condition of the original wood materials.

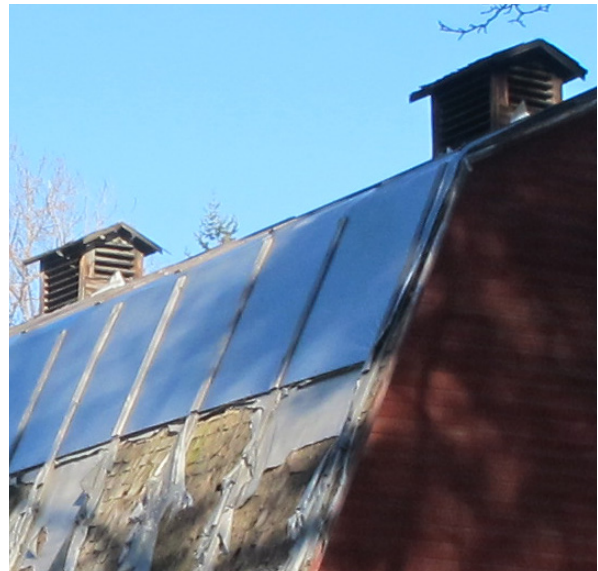
Photo showing typical deteriorated condition of two, existing monitor vents along the roof ridge.

- Preserve the original monitor vents in its original configuration, if possible.
- Original chimneys may require structural stabilization.
- Investigate condition of louvers and siding. If required, they should be repaired and cleaned using gentlest means as possible.
- If the existing monitor vents need to be removed prior to relocation, the existing monitor vents should be carefully documented prior to dismantling. All sound, original materials should be salvaged. Monitor vents should be reinstated above roofline to match original configuration using salvaged original materials as possible, or if necessary, with new materials to match the original. Reconstruction should be discussed with the Heritage Consultant.
