RE: Sticks & Stones Rebuild Proposal at 1983 Abbott Street - Kelowna

Abbott Street Structural Assessment

Job Number: 18-04285 1983 Abbott Street Kelowna, BC

Subject: Structural Assessment of Existing Heritage House at 1983 Abbott Street, Kelowna, BC

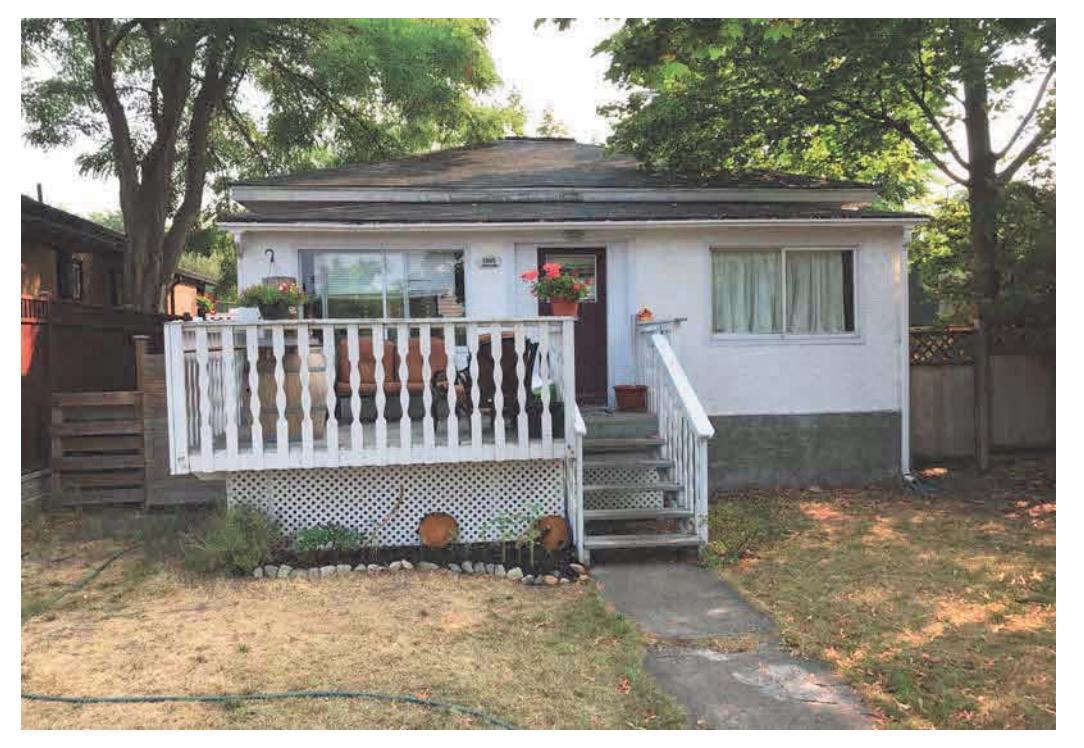
Fig.1 – Front View of Property

The house is a 1-storey house completed around 1915 – built upon a shallow crawl space, as was typical of the time. It appears that a few additions have been made to the main entrance

way and possibly the rear mud room as well.

The floor system has settled significantly with noticeable "dips" as you walk from the front through to the back of the house.

There is additional evidence of water staining on the ceiling and the owner has indicated that he has repaired the drywall ceiling in one of the bedrooms.

The bathroom ceiling also has some evidence of water staining and there is a lack of ceiling mounted fans, which does not allow moist air to ventilate to the exterior.

The exterior roof overhangs along the sides of the house do not have any eavestroughs attached.

The exterior roof has areas of "sagging" indicating some possible water damage.

2. Exterior Foundation – The exterior foundation wasn't exposed and it wasn't possible to verify that the foundation was constructed of permanent wood foundations. However, there were noticeable dips and drops in the floor system indicating possible foundation settlements along the exterior bearing points, possibly confirming PWF construction. PWF construction would likely be prone to wood rot after 100 years, especially since there are no eavestroughs visible on either side of the roof. This allows rain water to accumulate against the PWF. Frost protection and drain tile installations could not be verified and are most likely substandard which could also contribute to the uneven floor joist system.

3. Roof Joists – Although the roof joists pass the current ultimate and serviceability limit states design requirements, it is obvious that long term creep has resulted in serviceability failure as obvious dips are visible in the roof structure; as would be expected after 100 years of service. It was impossible to verify if this deflection failure is due to long term creep or damage from water penetration into the roof as KO was unable to access the attic areas. However, water staining of the ceiling indicates that these structural elements have been exposed to high amounts of moisture.

KO Structural would recommend re-building this residence instead of repairing the deficiencies and bringing the existing building up to current codes.

While it's always possible to repair the structure, the cost of repair is too extravagant and the final result would be a poorly laid out residence.
