**Re: Surtees House and Barn
4629 Lakeshore Road**

SURTEES HOUSE & BARN

4629 LAKESHORE ROAD, KELOWNA, BC

SURTEES HOUSE
CONSERVATION PLAN

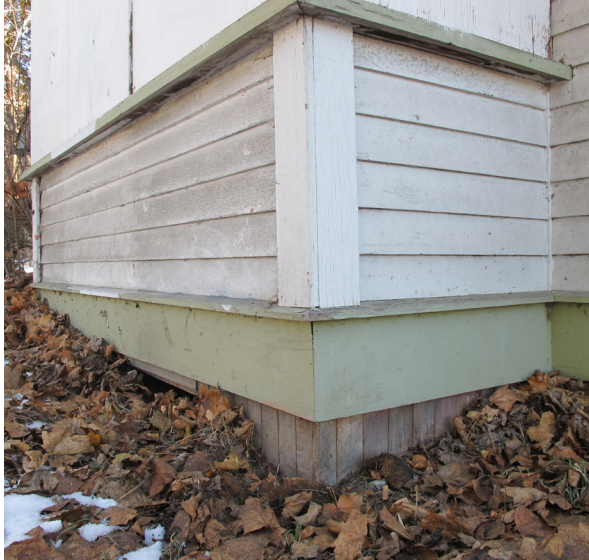
Lower portion of bay window at north elevation, showing wood lapped siding, window sill, and board trims. Note that foundation wall is clad in later vertical siding.

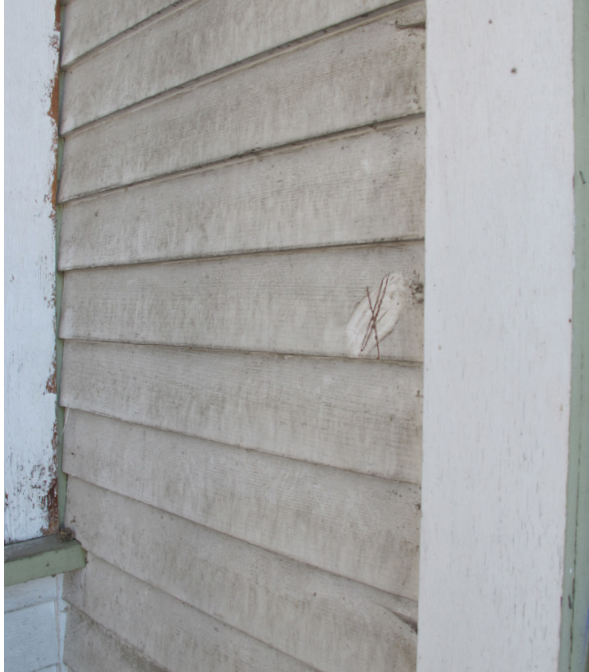
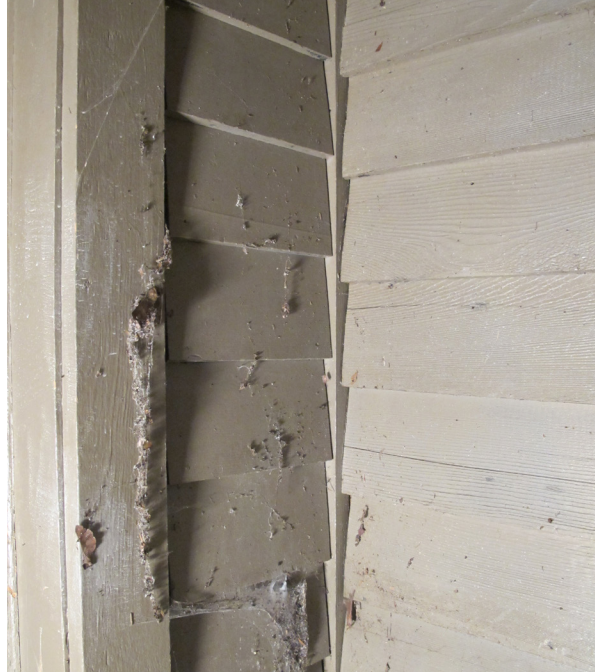
Photo showing existing condition of original exterior wall, with horizontal lapped wood siding and trims at north elevation (top left), and at the interior return walls of the enclosed early addition to the west (top right).

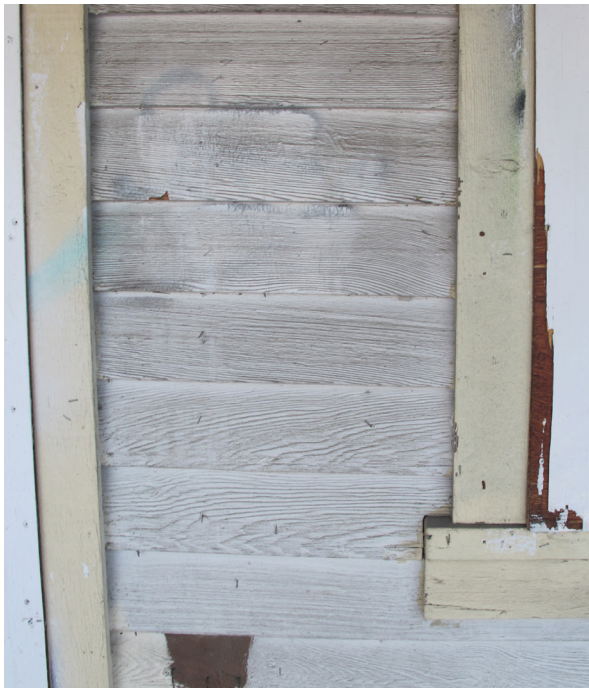
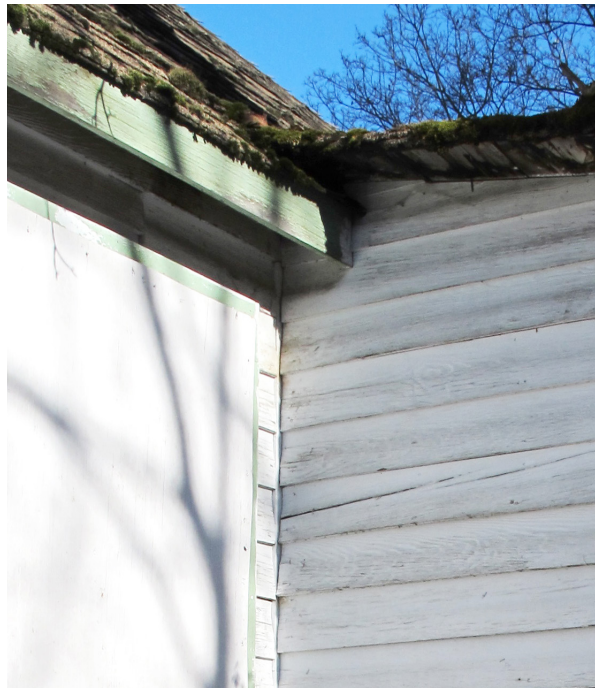
Photos showing original exterior walls with original materials interfaced with later rehabilitation with inappropriate detailing; at historic front facade between door and window opening (bottom left), and at south elevation and return wall of later addition (bottom right).

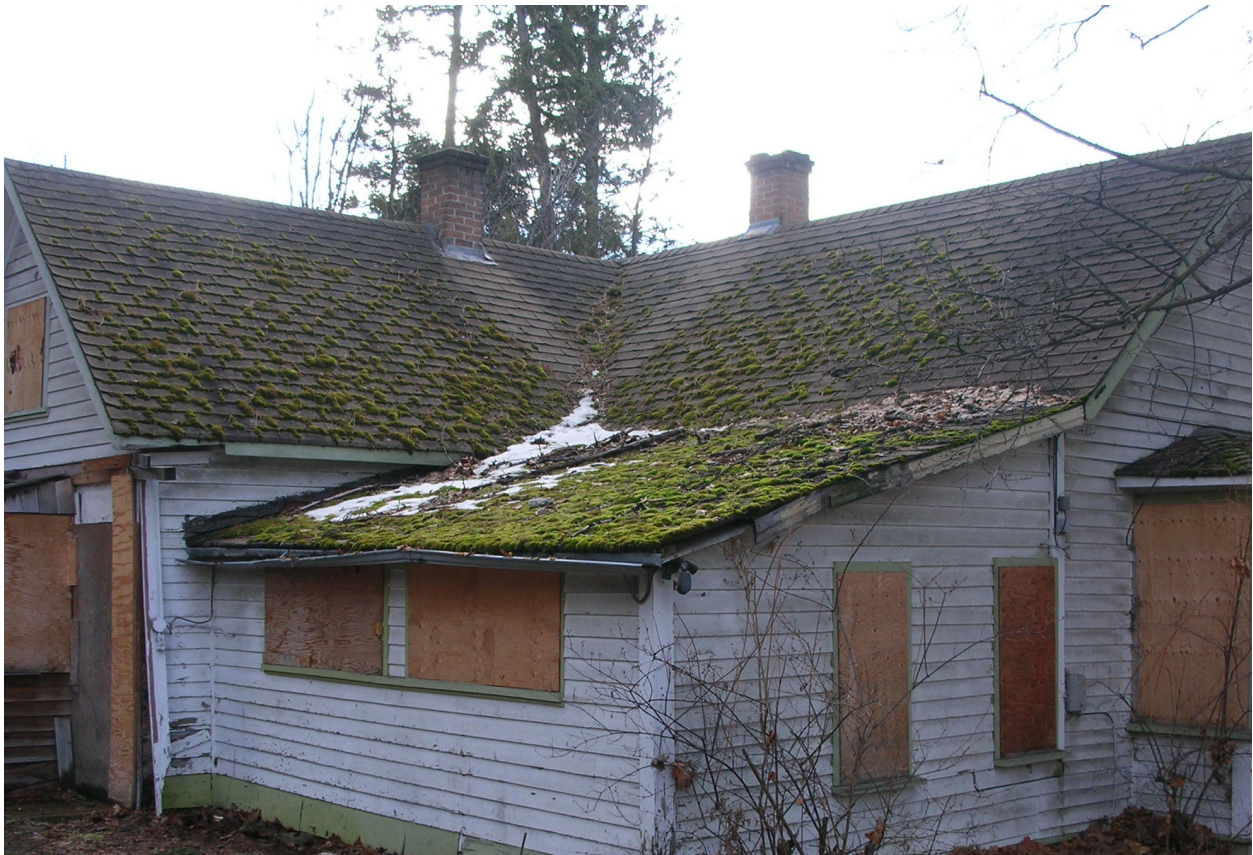
Existing condition of original, primary cross-gabled roof, with shed roof extension of early addition to the northeast portion of the house, as well as two original interior brick masonry chimney stacks along the roof ridges.

- Preserve the roof structure in its current configuration, as expressed by its primary cross-gabled roof structure.
- If required, roofing membrane and cladding system may be rehabilitated. Cedar shingles are the preferred material, but uroid shingles or Aged Cedar Enviroshingles™ are also acceptable.
- Retain the original bargeboards and fascia boards, as well as the soffit any exposed roof elements.
- Design and install adequate rainwater disposal system and ensure proper drainage from the site is maintained. Wood gutters with galvanized steel downspouts are recommended. Aluminum in appropriate colours is also acceptable. Paint or provide specification of drainage system elements according to colour schedule devised by Heritage Consultant.

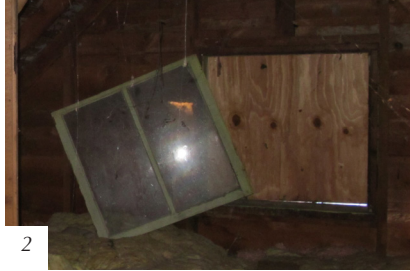
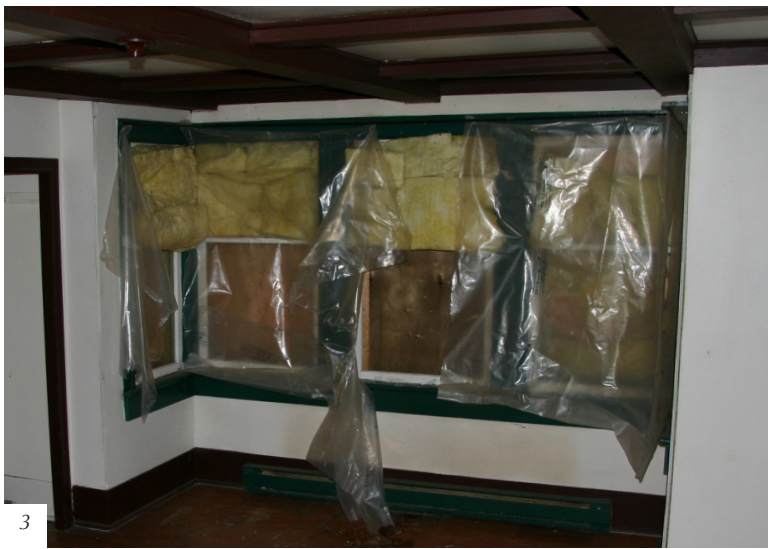
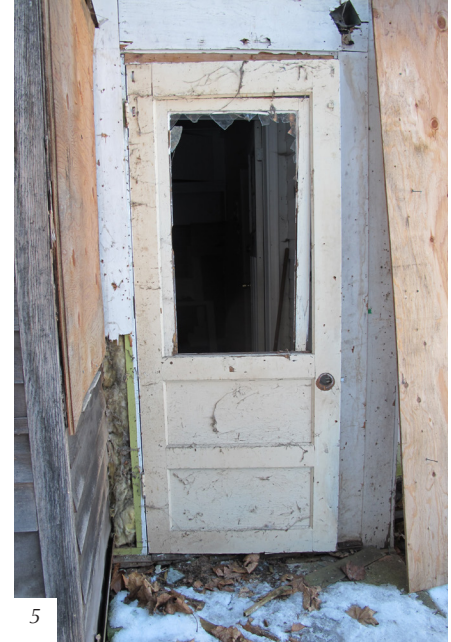
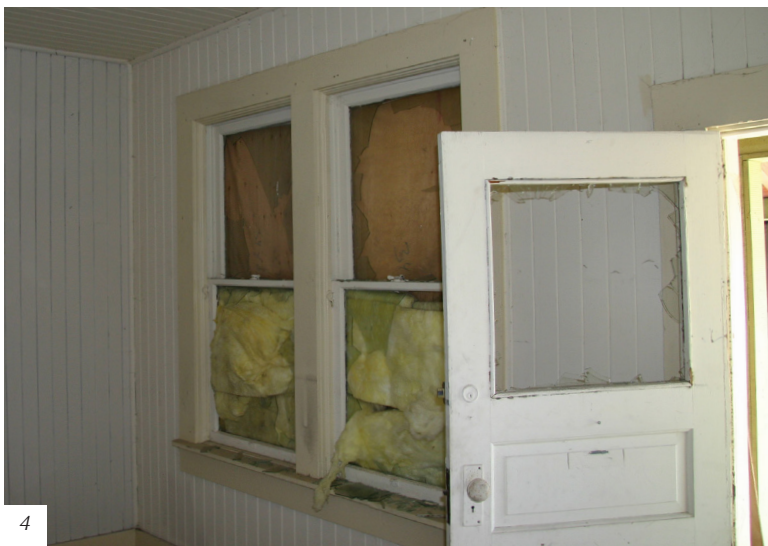
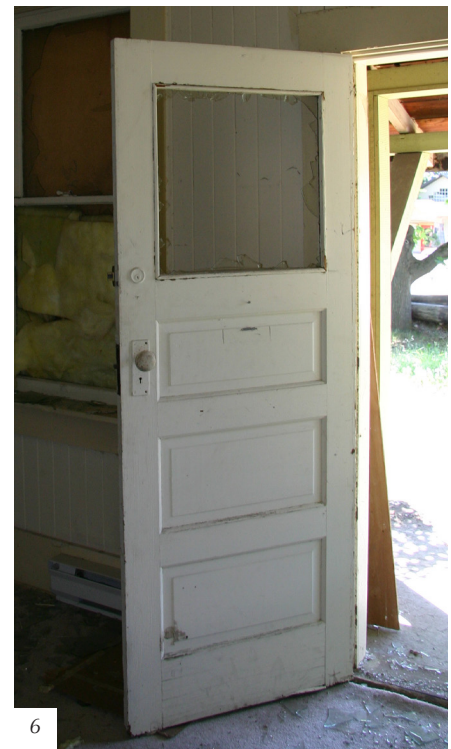
Photos showing existing typical conditions of surviving original wood windows and doors: gable ends at the east/west elevations (1, 2); bay window at north elevation (3); historic front facade at west elevation, showing partial wood door (4); rear exterior door at east elevation (5); main entrance door at west elevation (6).

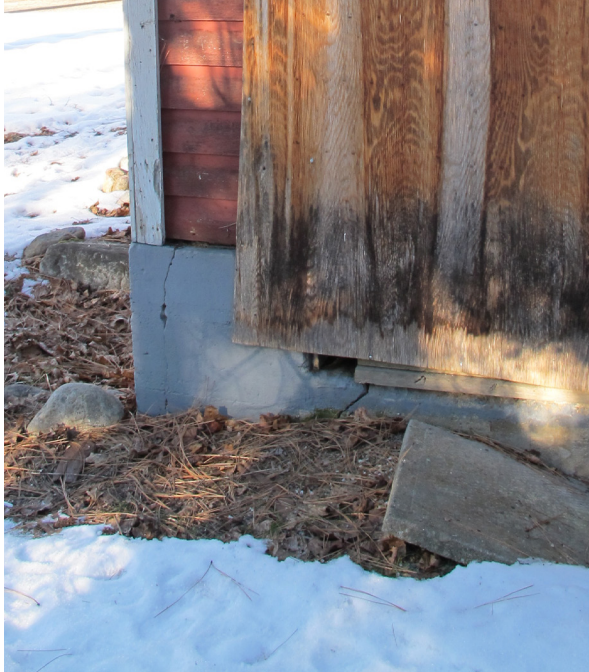
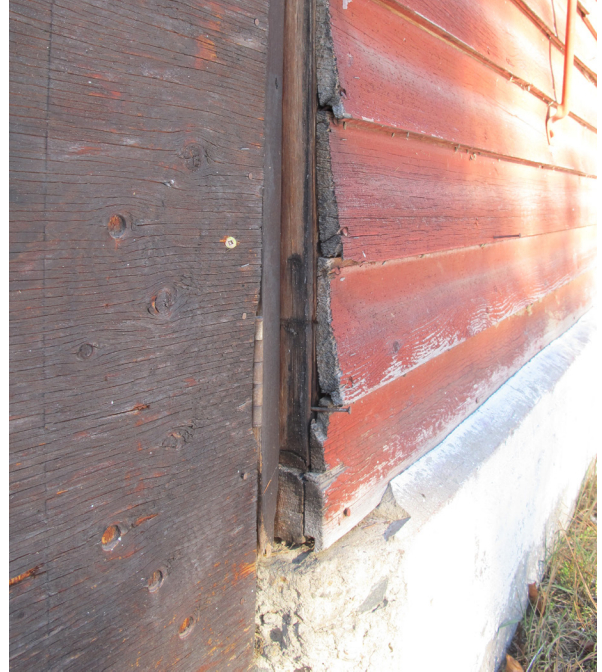
Photos showing typical deteriorated condition of exterior wall cladding above concrete foundation walls. Note profile of original drop siding (top right).

- Cleaning procedures should be undertaken with non-destructive methods. Areas with biological growth should be cleaned using a soft, natural bristle brush, without water, to remove dirt and other material. If a more intense cleaning is required, this can be accomplished with warm water, mild detergent (such as D/2 Biological Solution®) and a soft bristle brush. High-pressure power washing, abrasive cleaning or sandblasting should not be allowed under any circumstances.

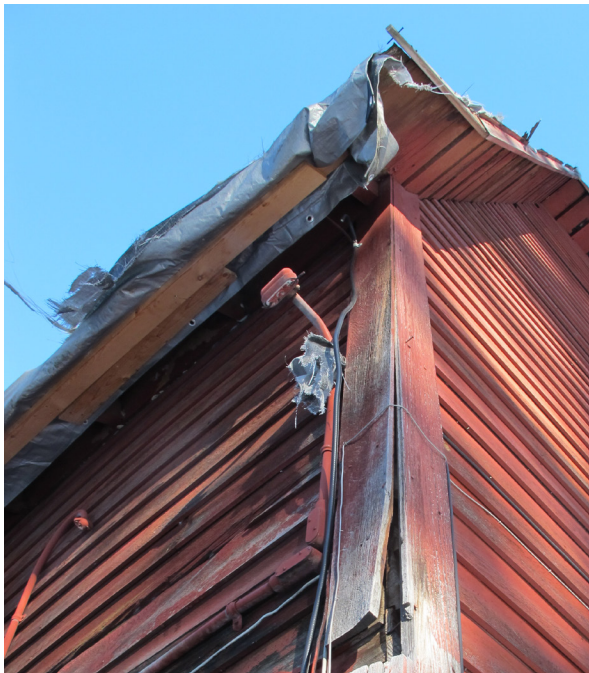
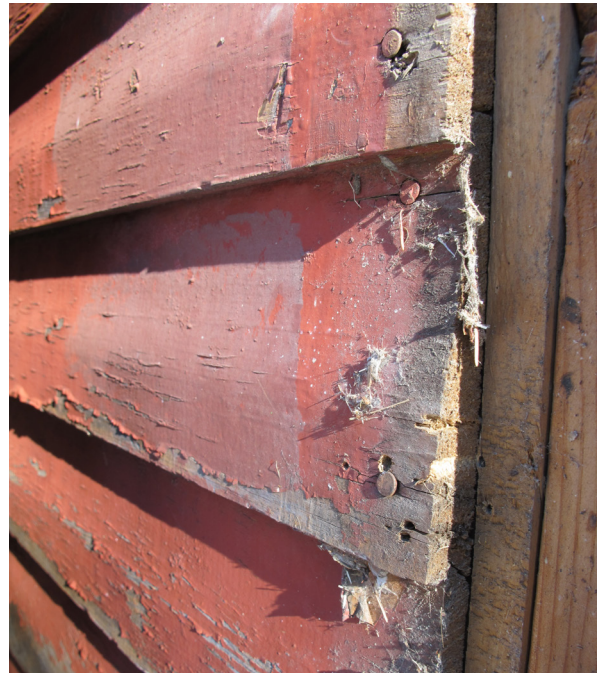
Photos showing typical deteriorated condition of exterior wall cladding, as well as roof soffit and corner board trims.

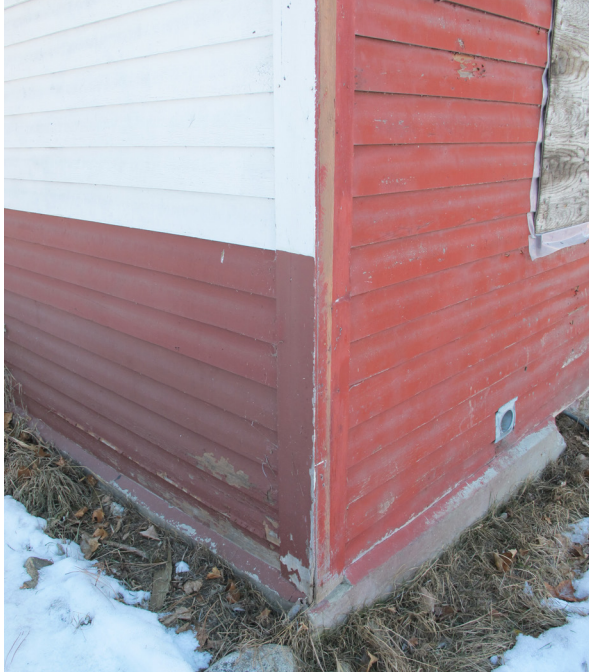
Northeast corner condition of the existing, original exterior walls of the Surtees Barn, showing unsympathetic paint finish.

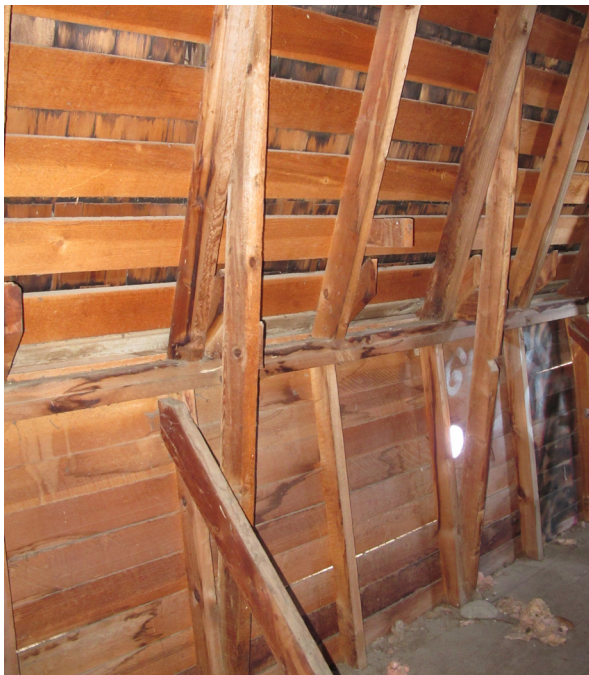
Interior side of the wall-to-roof interface, showing typical existing condition of the original wood materials.

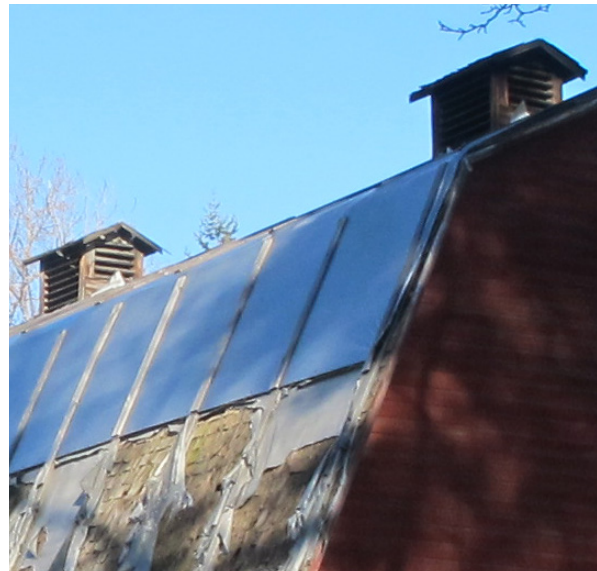
Photo showing typical deteriorated condition of two, existing monitor vents along the roof ridge.

- Preserve the original monitor vents in its original configuration, if possible.
- Original chimneys may require structural stabilization.
- Investigate condition of louvers and siding. If required, they should be repaired and cleaned using gentlest means as possible.
- If the existing monitor vents need to be removed prior to relocation, the existing monitor vents should be carefully documented prior to dismantling. All sound, original materials should be salvaged. Monitor vents should be reinstated above roofline to match original configuration using salvaged original materials as possible, or if necessary, with new materials to match the original. Reconstruction should be discussed with the Heritage Consultant.
