Heritage Advisory Committee

AGENDA

3.1 Pandosy St, 2169, Heritage Register Request - Removal - Garry Tomporowski, GTA Architecture Ltd.

Subject: Heritage Register Request - Removal

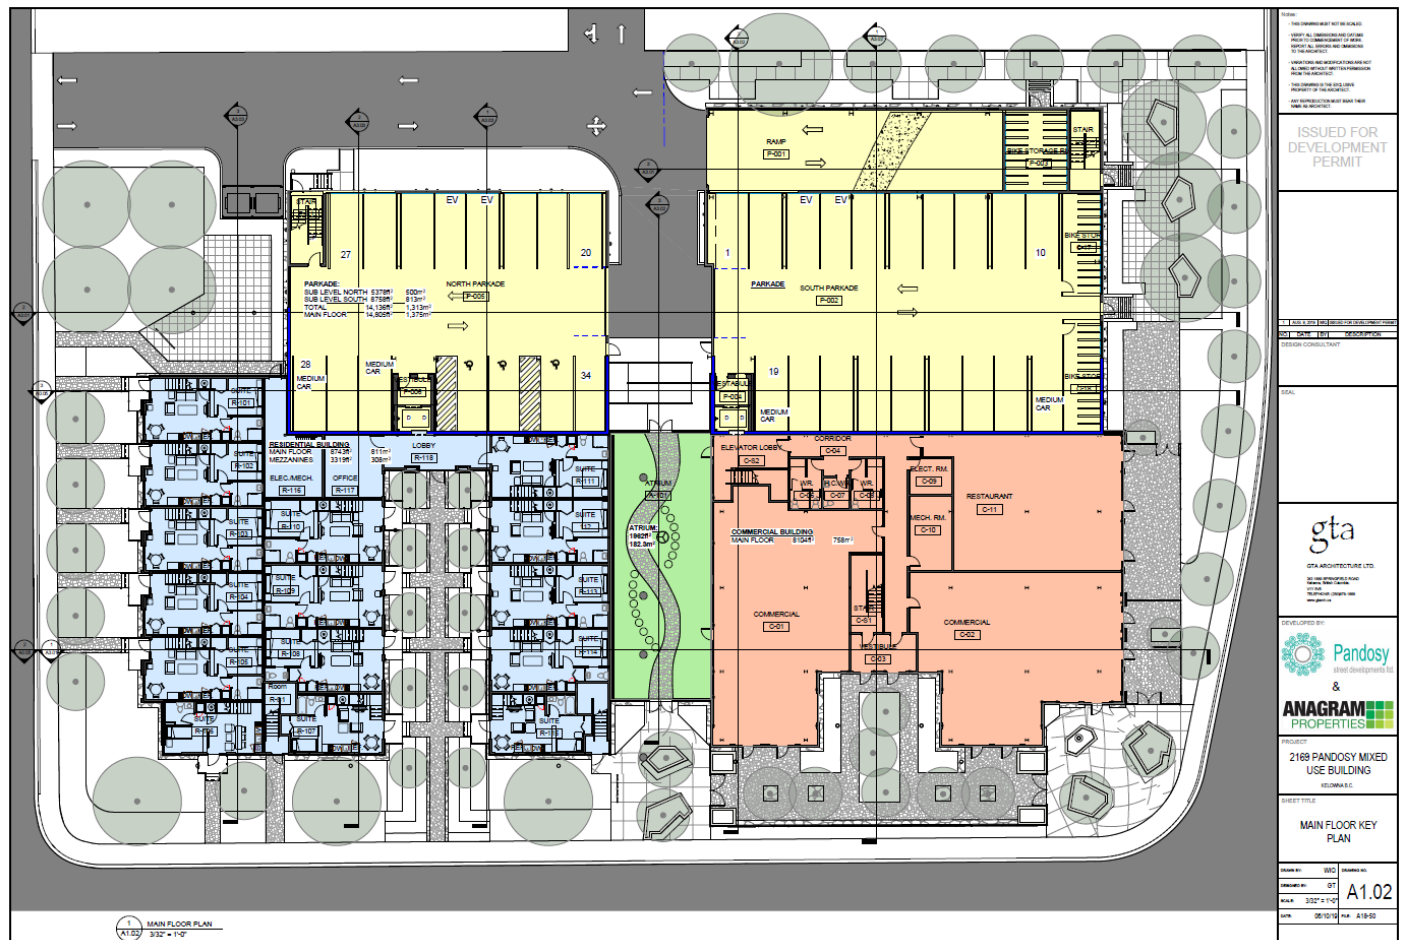
The proposed site plan is shown below.

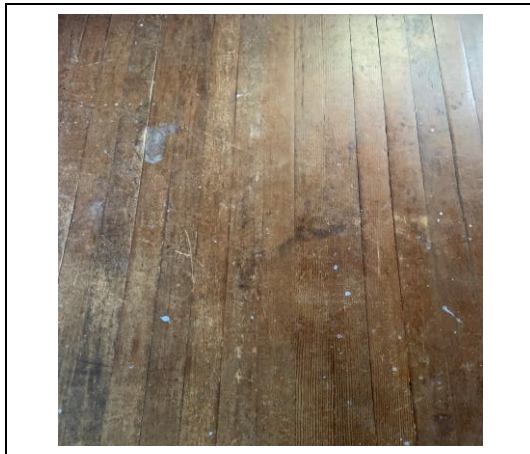
Collett House – fir flooring

Flooring – the owner has already indicated that these will be salvaged for use in the new building – perhaps in the proposed restaurant at the least. This reuse of such materials is not unlike the salvage and reuse of the old floor joists in the Laurel Packinghouse which were re-sawn into engineered flooring.

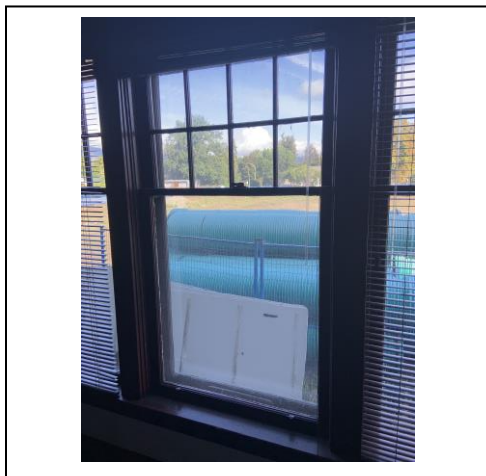
Collett House window

Windows – There are a couple of options that may be considered for the windows. First, there may be an opportunity to design one or more of these into the new building itself. If this is not practical, then the windows could be used as a design element in an interpretive display on the history of the Collett House and/or the neighbourhood. Finally, if windows cannot be used in any manner then they should be offered to salvage for other heritage groups or to individuals doing a heritage restoration.

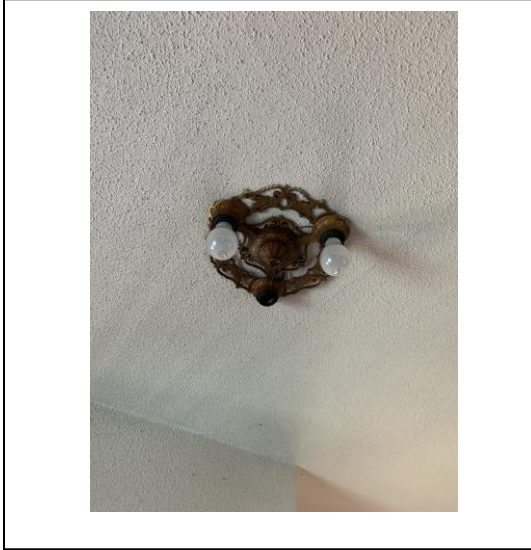
Collett House ceiling light fixture

Lighting fixtures – Salvaged for re-wiring and re-use in the new facility, these fixtures can add a lot of atmosphere. This is a similar exercise used in the Laurel Packinghouse in its structural upgrade in 2010 when the old industrial ‘dog-dish’ lights were re-wired to CSA standards for less cost than buying new fixtures!

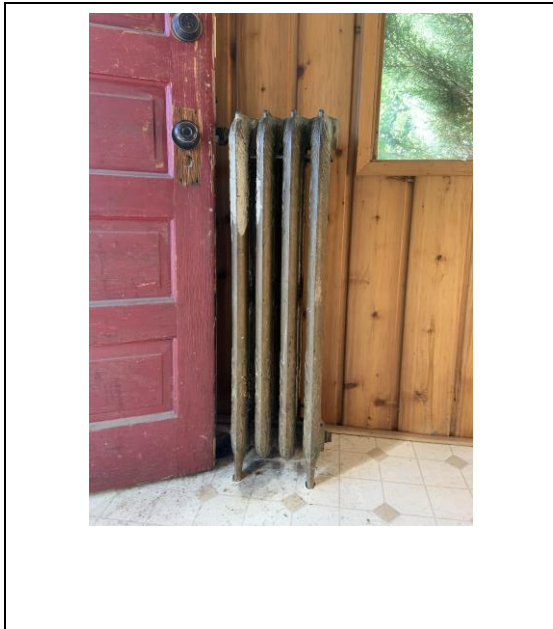
Heating register

Other materials – There are a couple of other opportunities for use of materials salvaged from the Collett House. First, the hot water registers could be removed and refinished for use in office or reception furniture – they could, for example, be used as ‘legs’ for an entrance table or other feature design element in the new building. In addition, old wiring fixtures such as the ‘nobbing and tubing’ ceramics could be repurposed for other features such as pen holders at a reception desk.

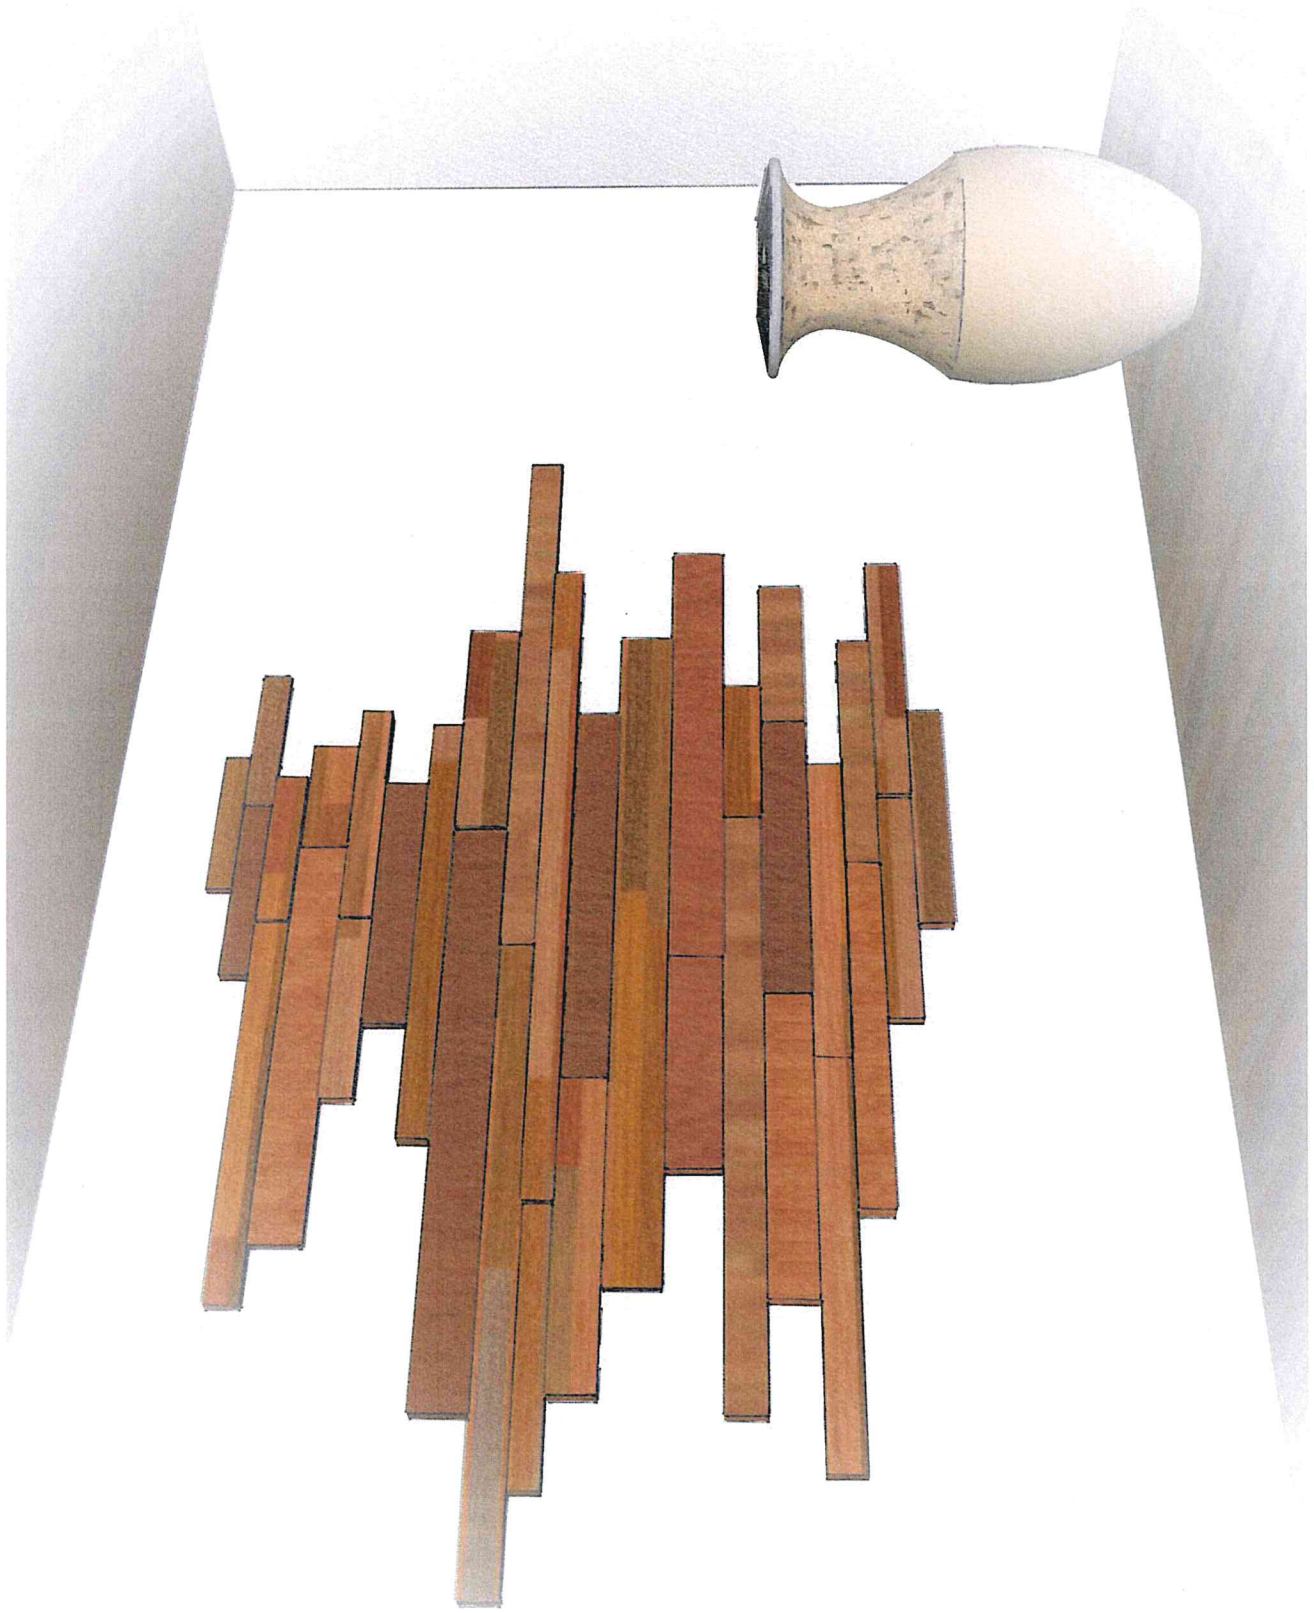
REUSED WOOD, TRIM, CASINGS, ETC. WALL ART PIECE

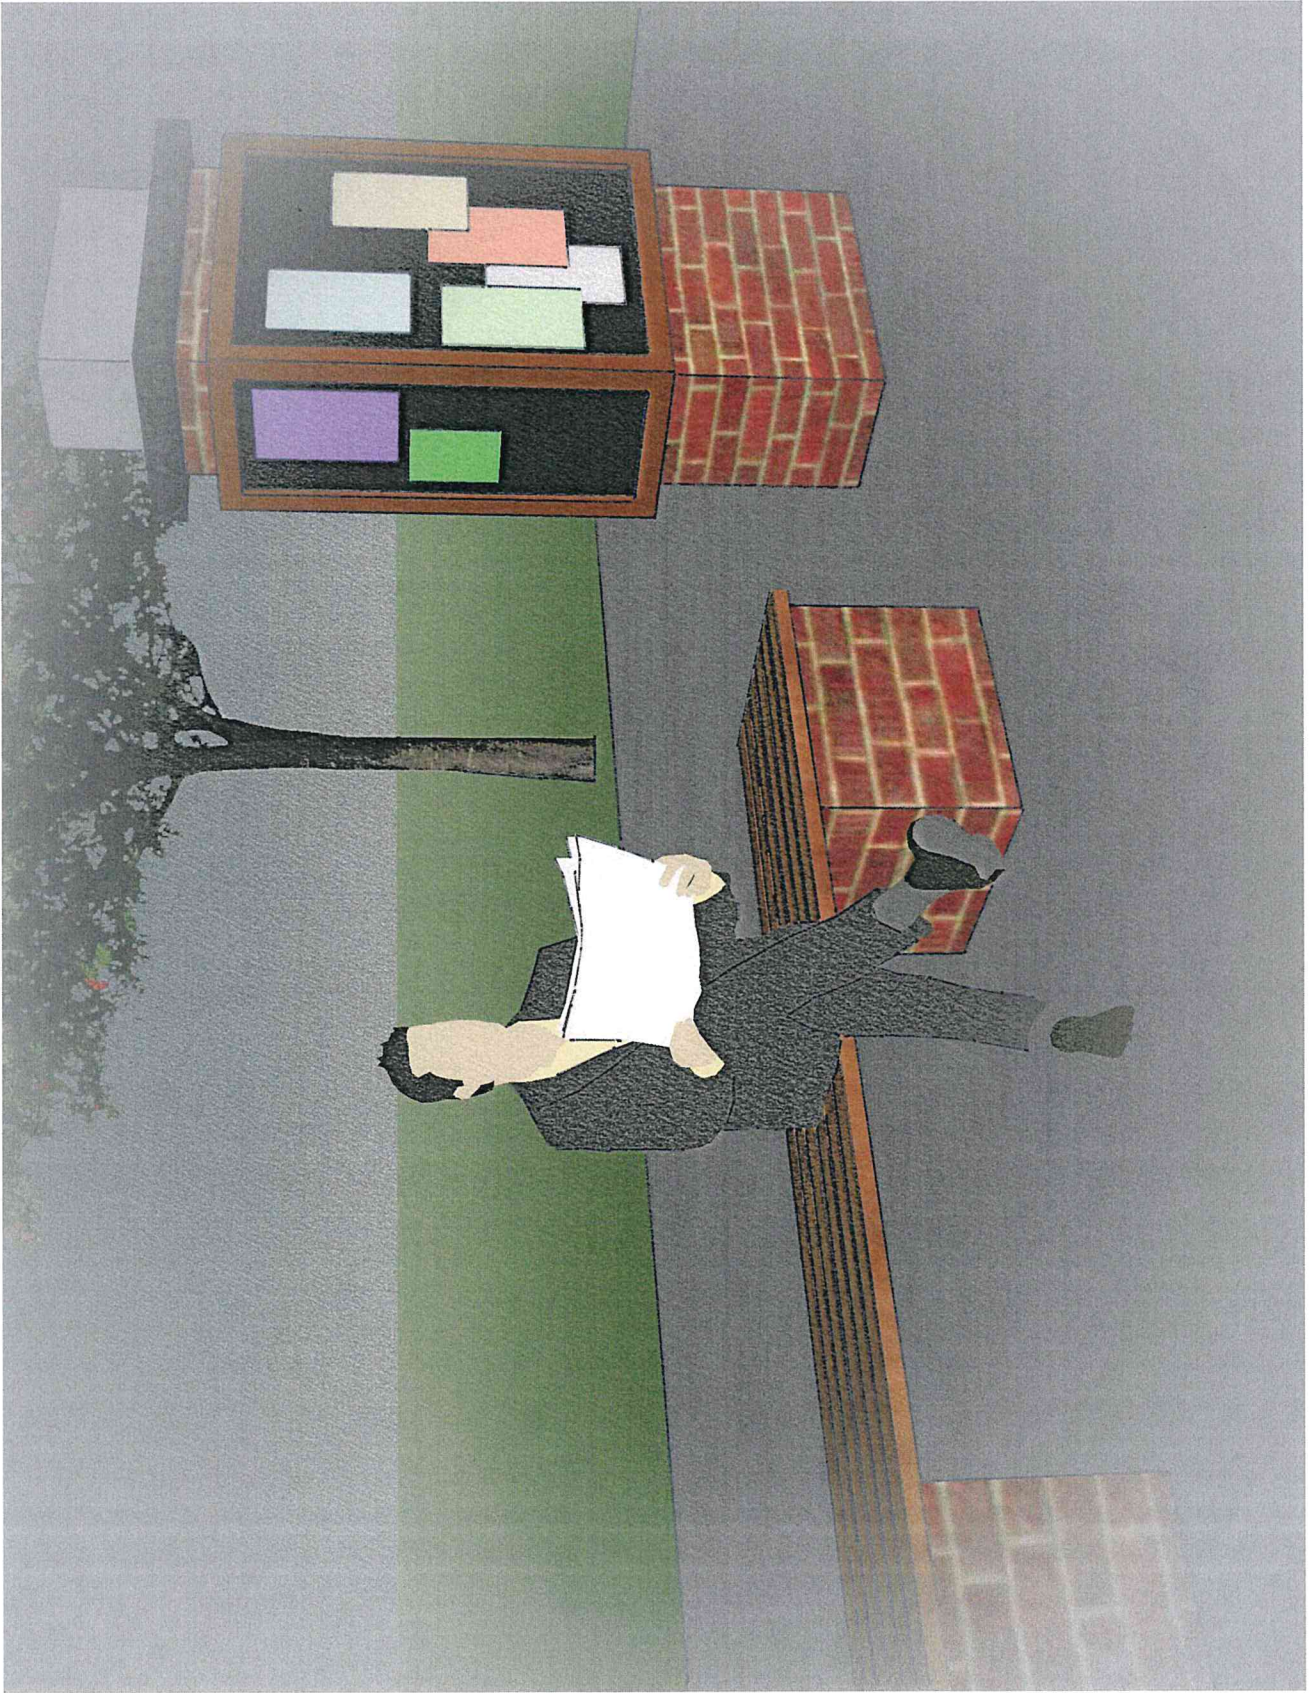
RECLAIMED BRICK PEDESTALS WITH REUSED WOOD BENCH
RECLAIMED CHIMNEY SIGNPOST

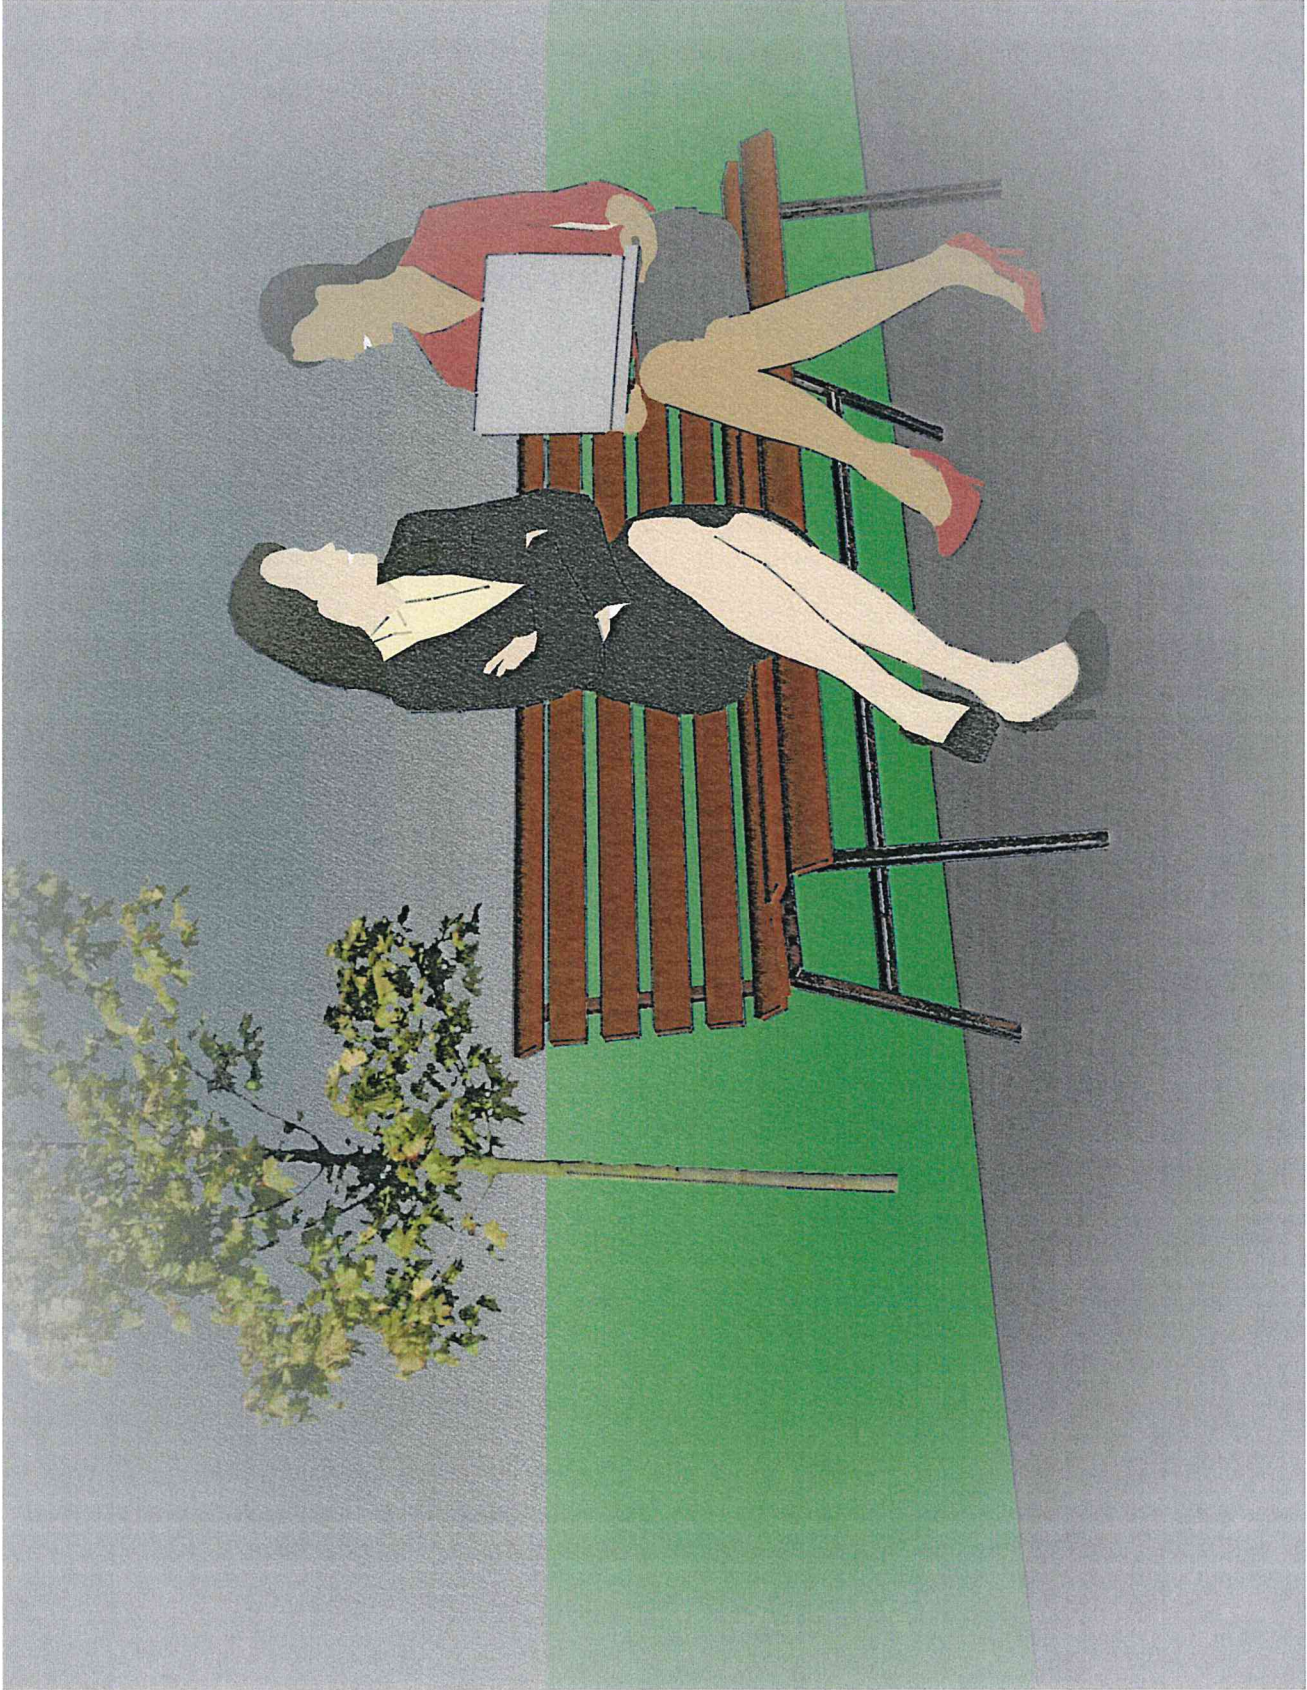
REUSED WOOD TRIMS, BASE BOARDS, CASINGS ETC. ON PRE-MADE BENCH FRAME

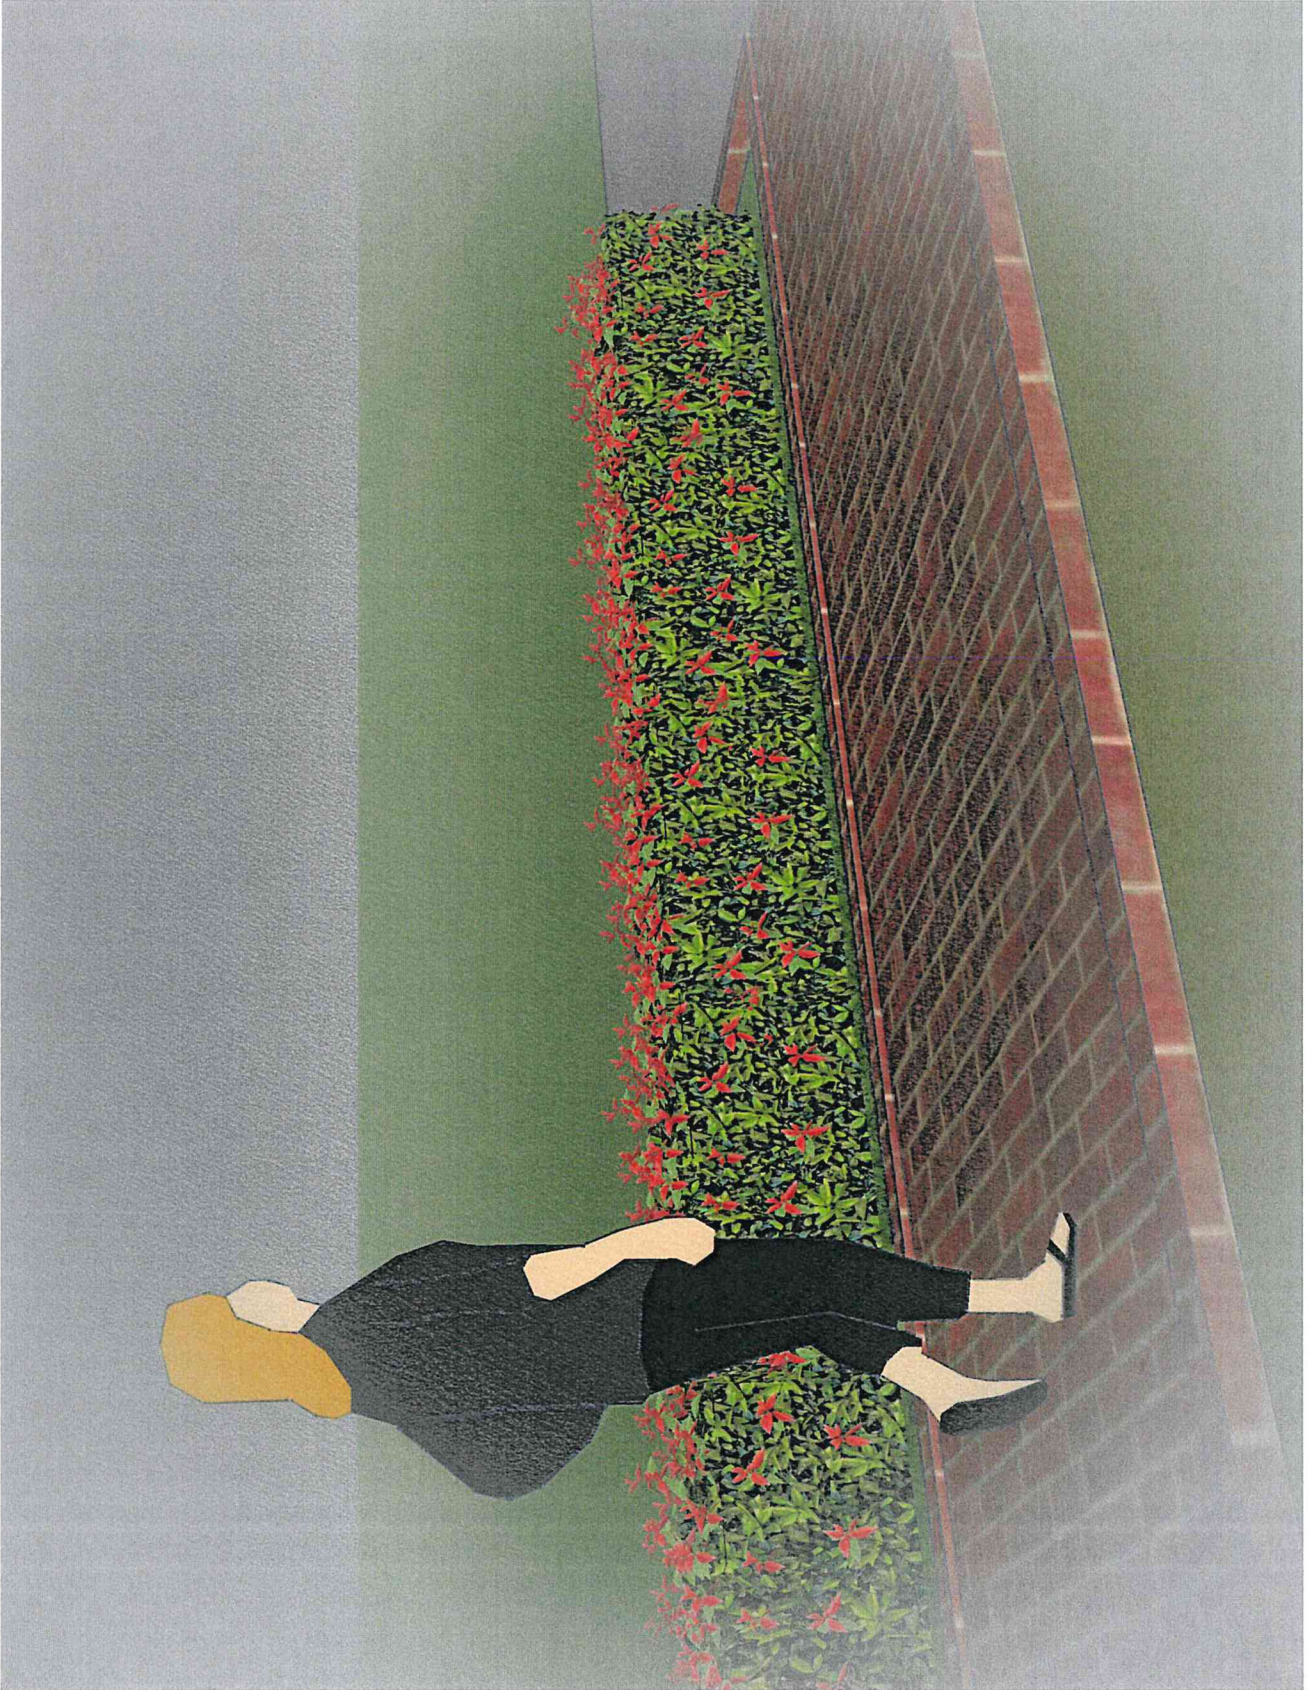
RECLAIMED BRICK WALKWAY

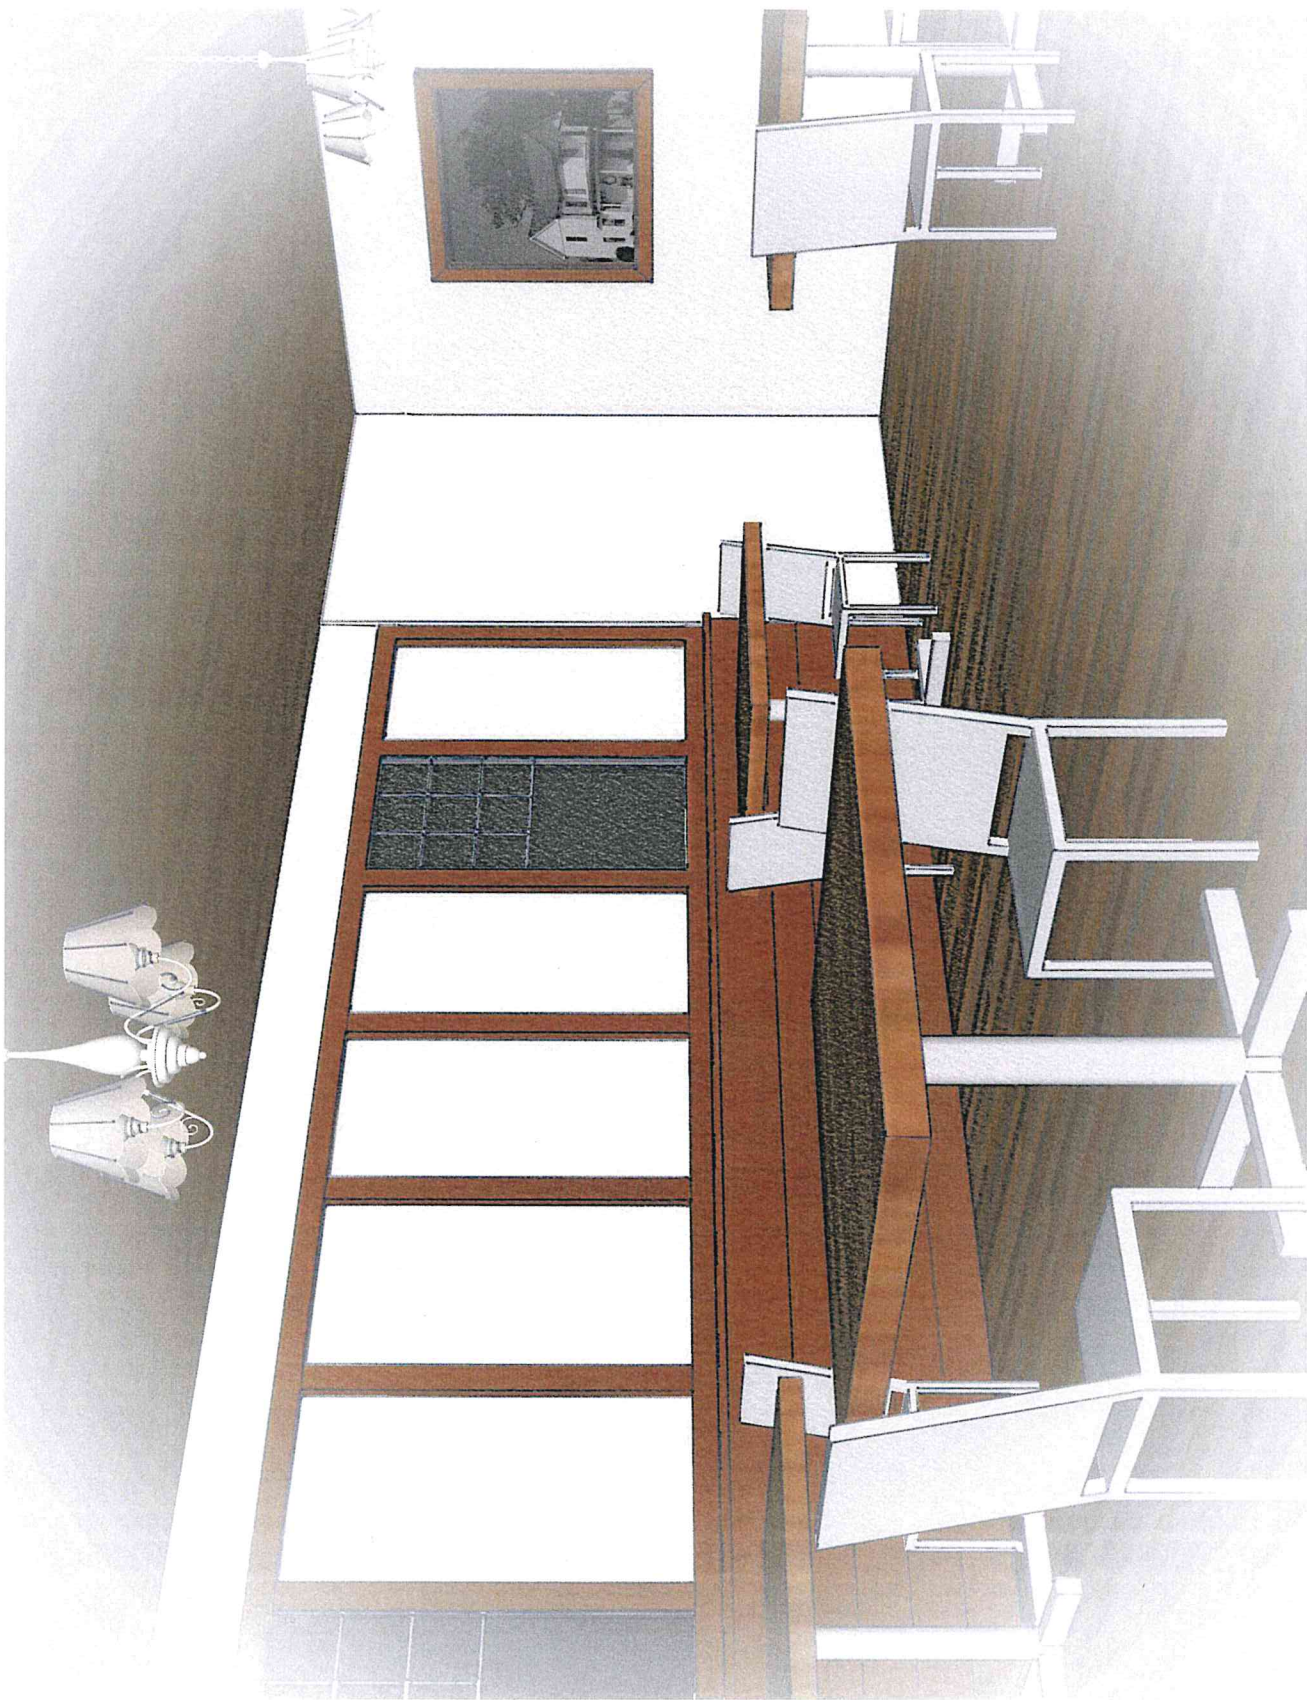
2ND FLOOR EXTERIOR WALL USED AS FEATURE WALL IN RESTAURANT
REFURBISHED LIGHT FIXTURES

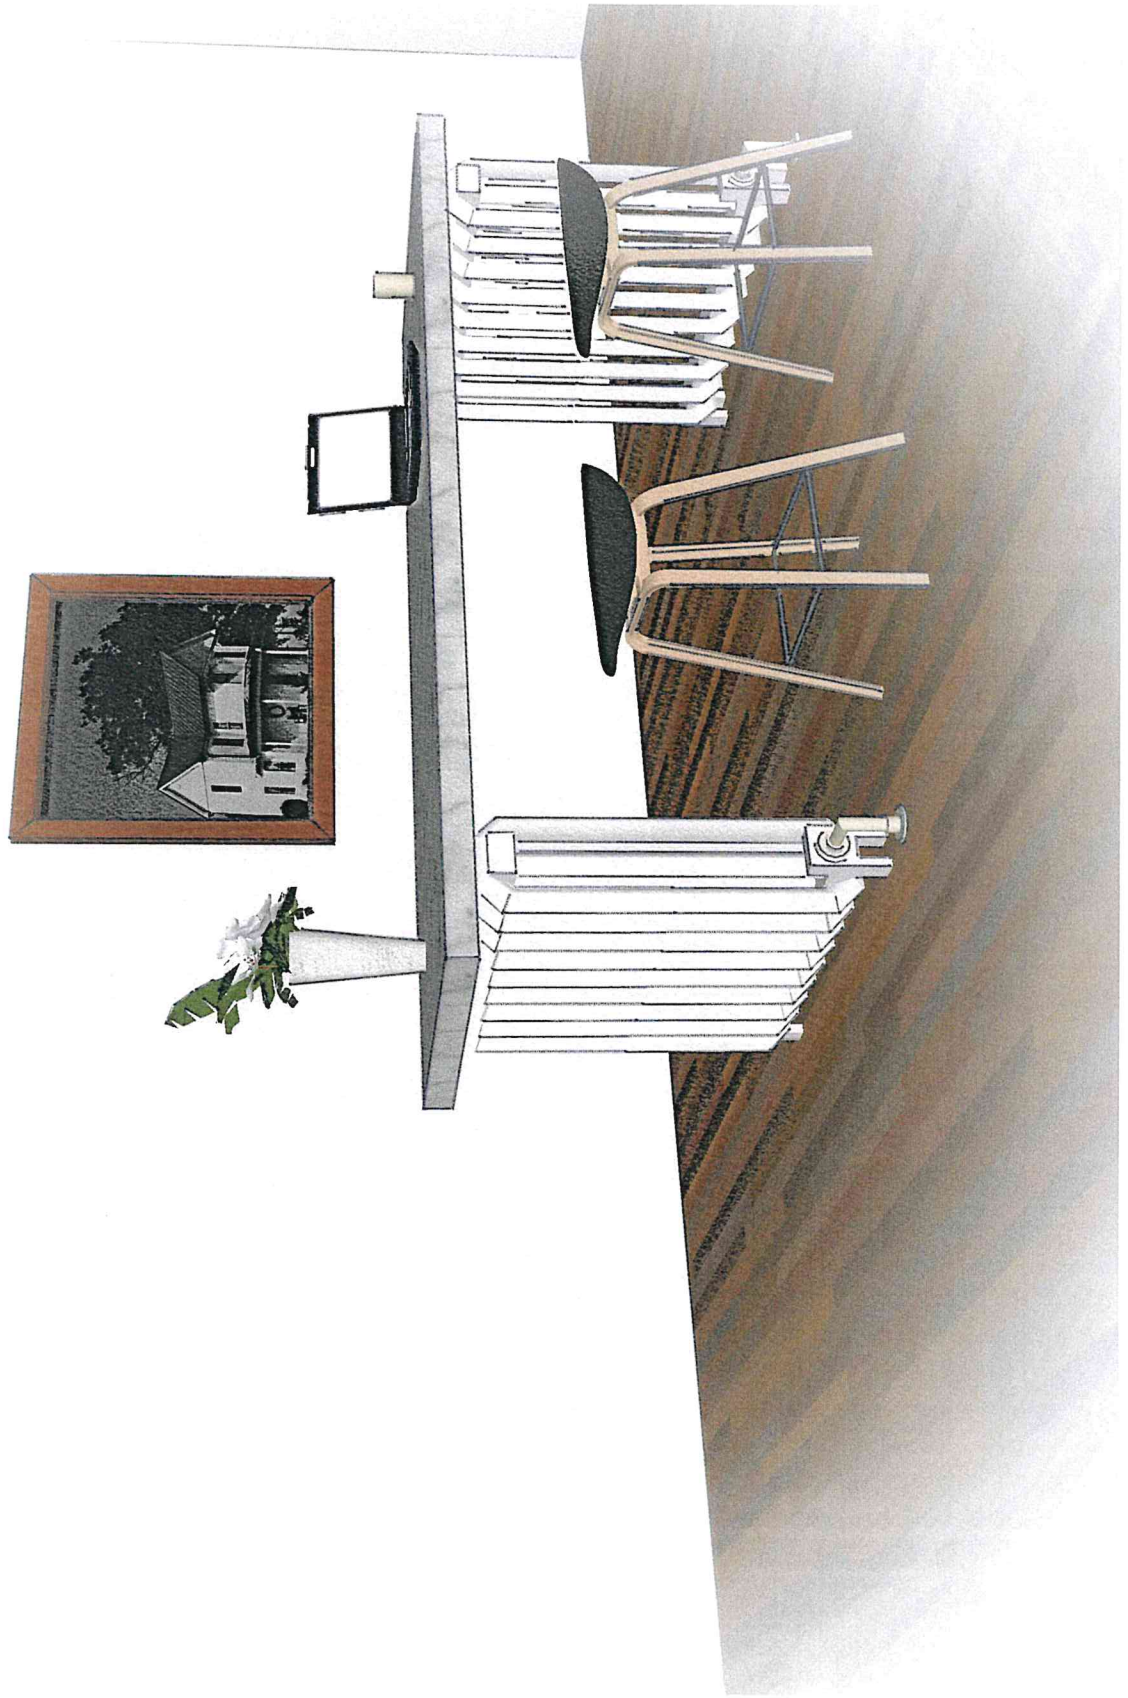
RECLAIMED RADIATORS TO BE USED AS TABLE LEGS
REUSED WOOD TRIM PICTURE FRAMES

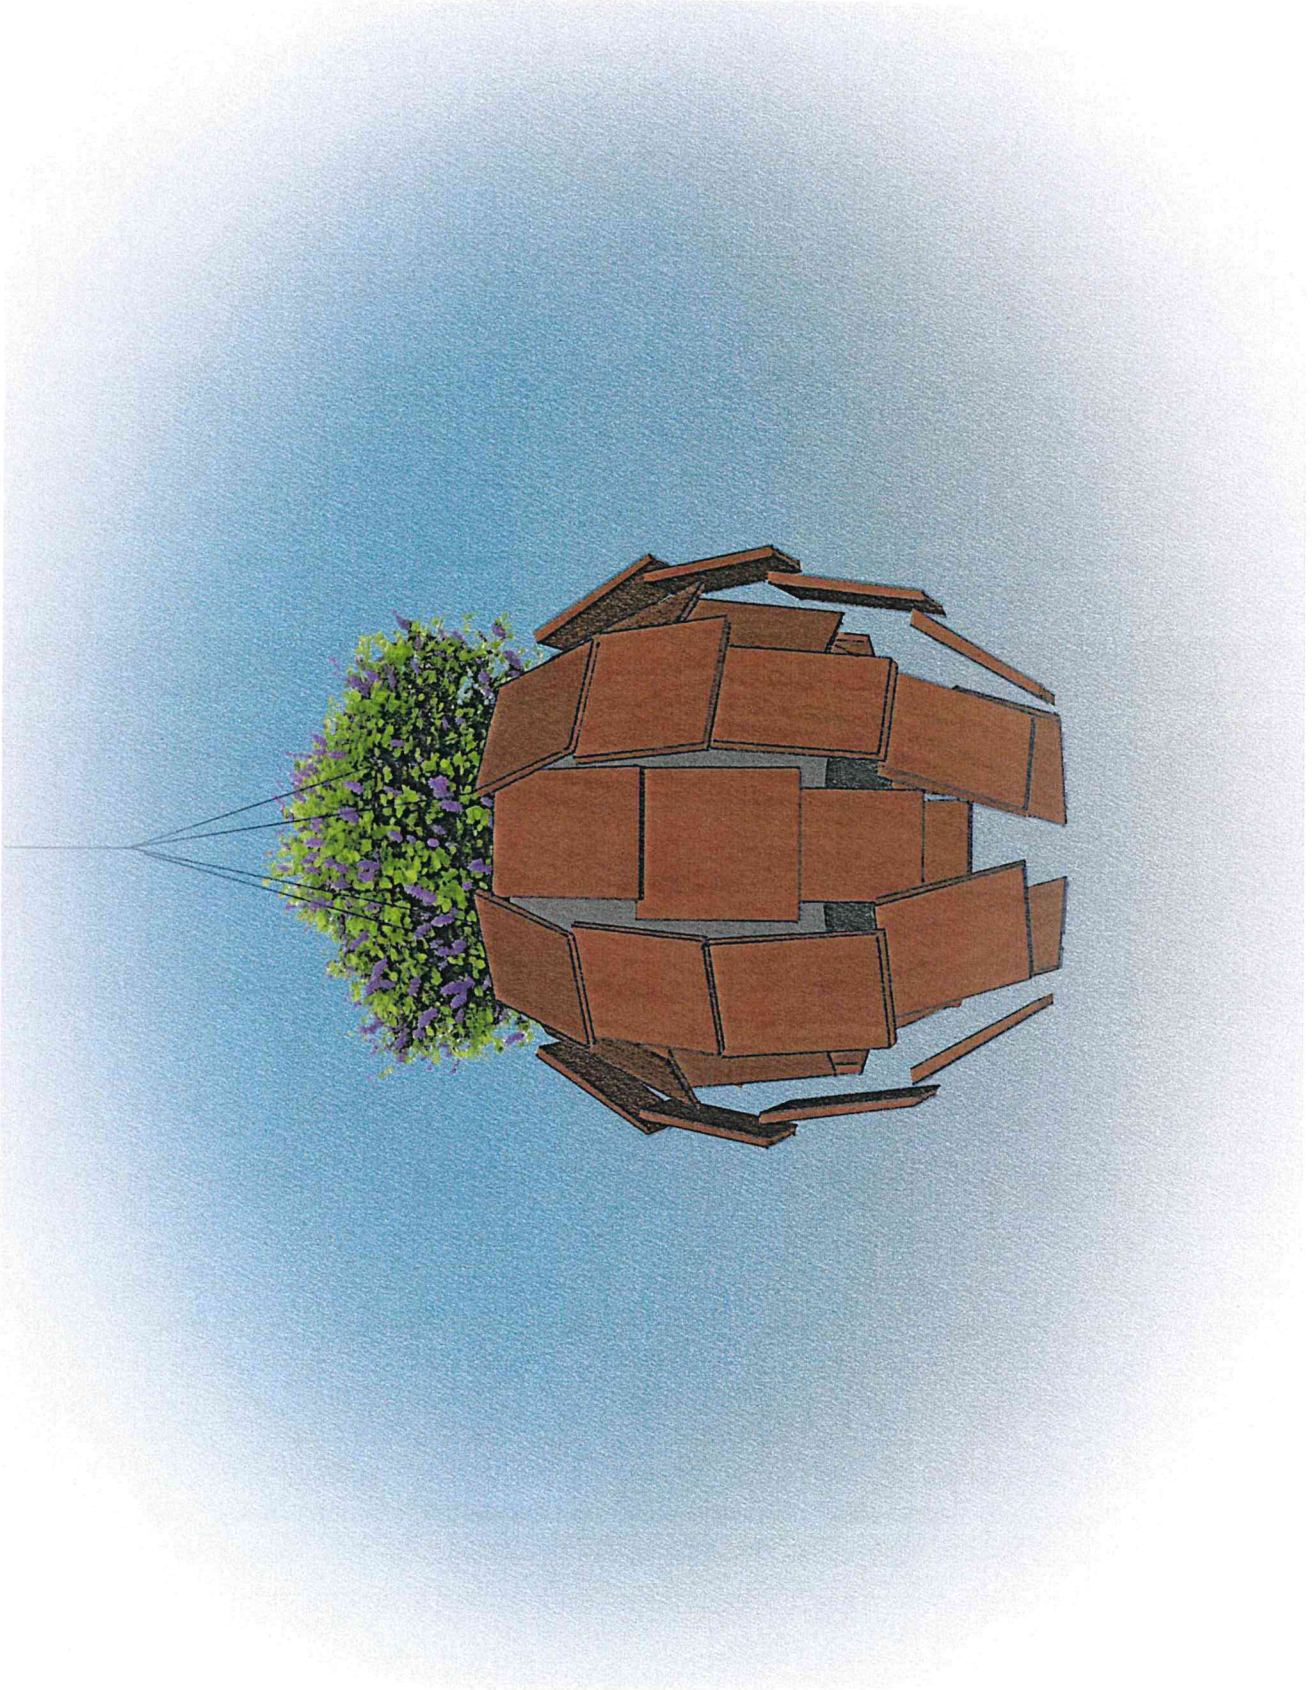
REUSED SHINGLES TO CLAD HANGING PLANTERS

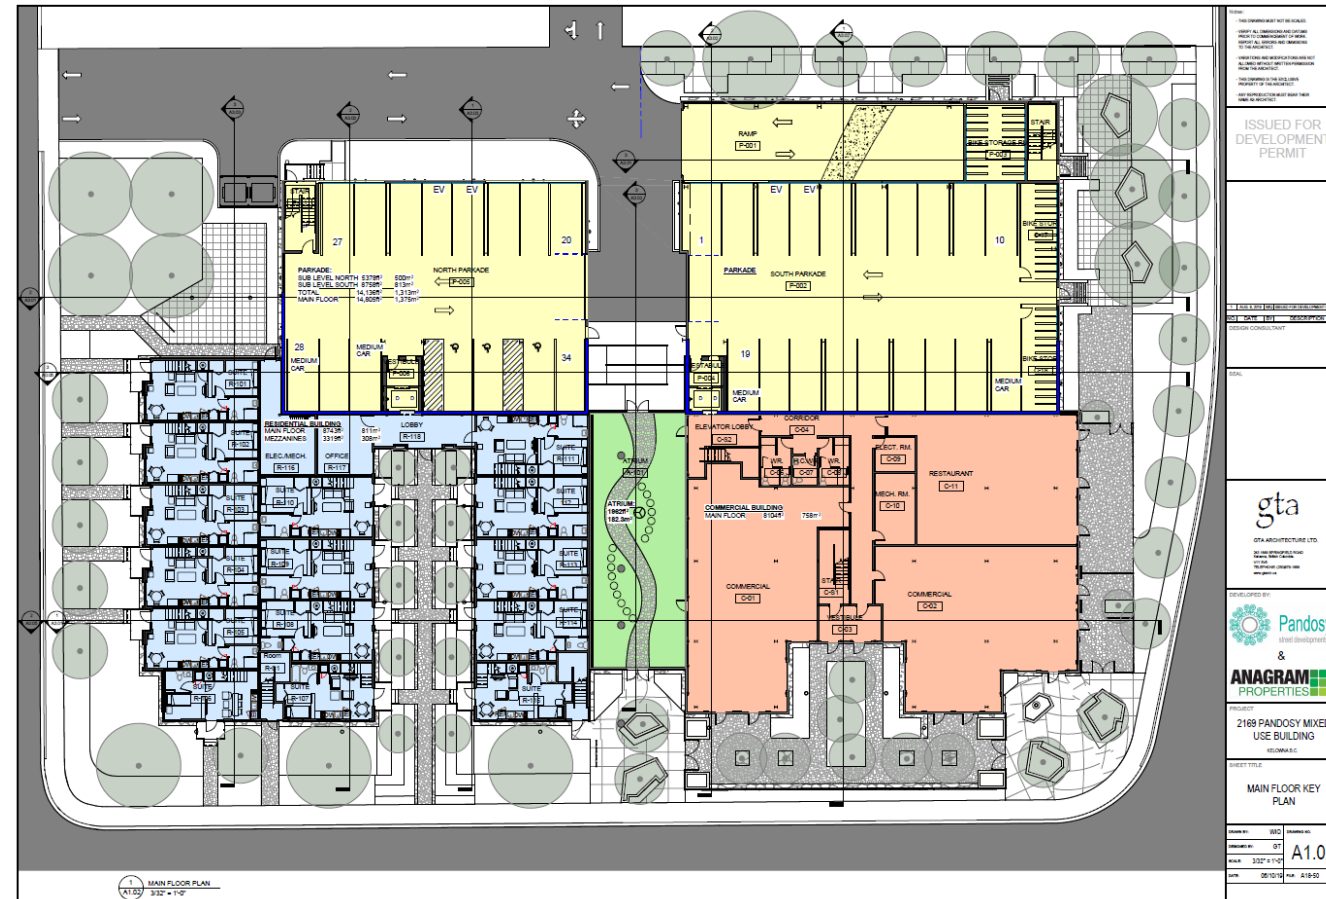
► Proposed site plan
