# Agricultural Advisory Committee

## AGENDA

**3.1. Old Vernon Road 982, A19-0018 - Jeetender S. Kandola & Manraf K. Kondola**

To consider an application to the Agricultural Land Commission (ALC) for a Non-Farm Use (NFU) under Section 20(2) of the ALC Act, to allow i) a composting operation and ii) storage for tree service companies for a portion of the subject property.

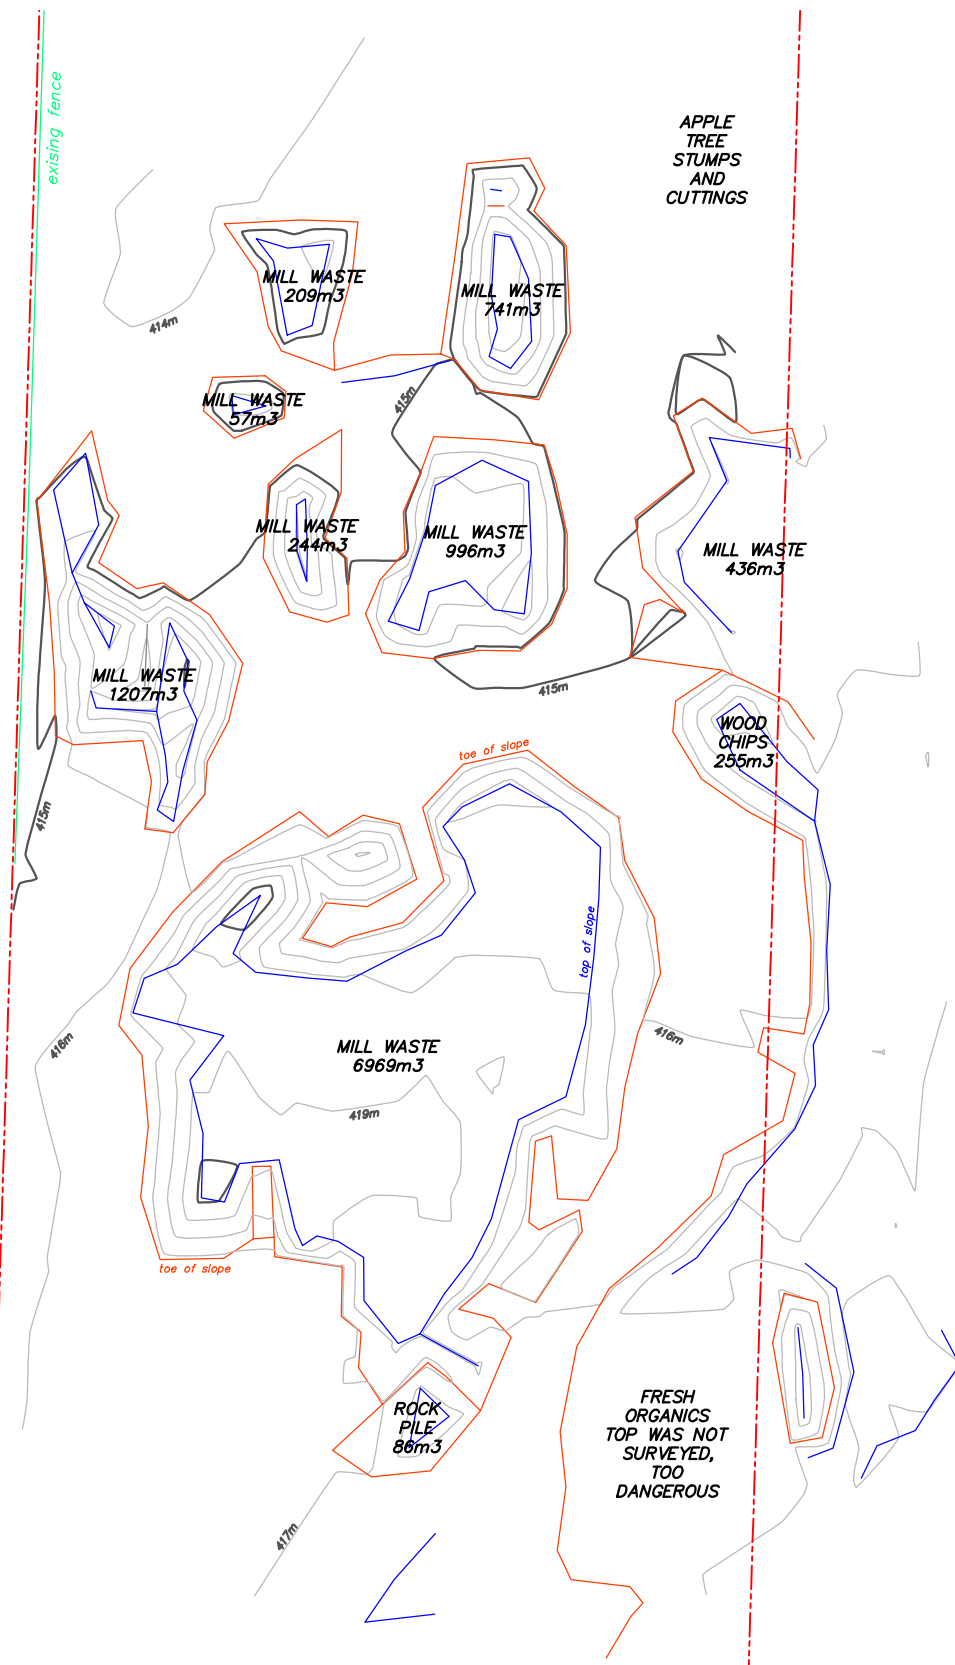
APPLE TREE STUMPS AND CUTTINGS

FRESH ORGANICS TOP WAS NOT SURVEYED, TOO DANGEROUS

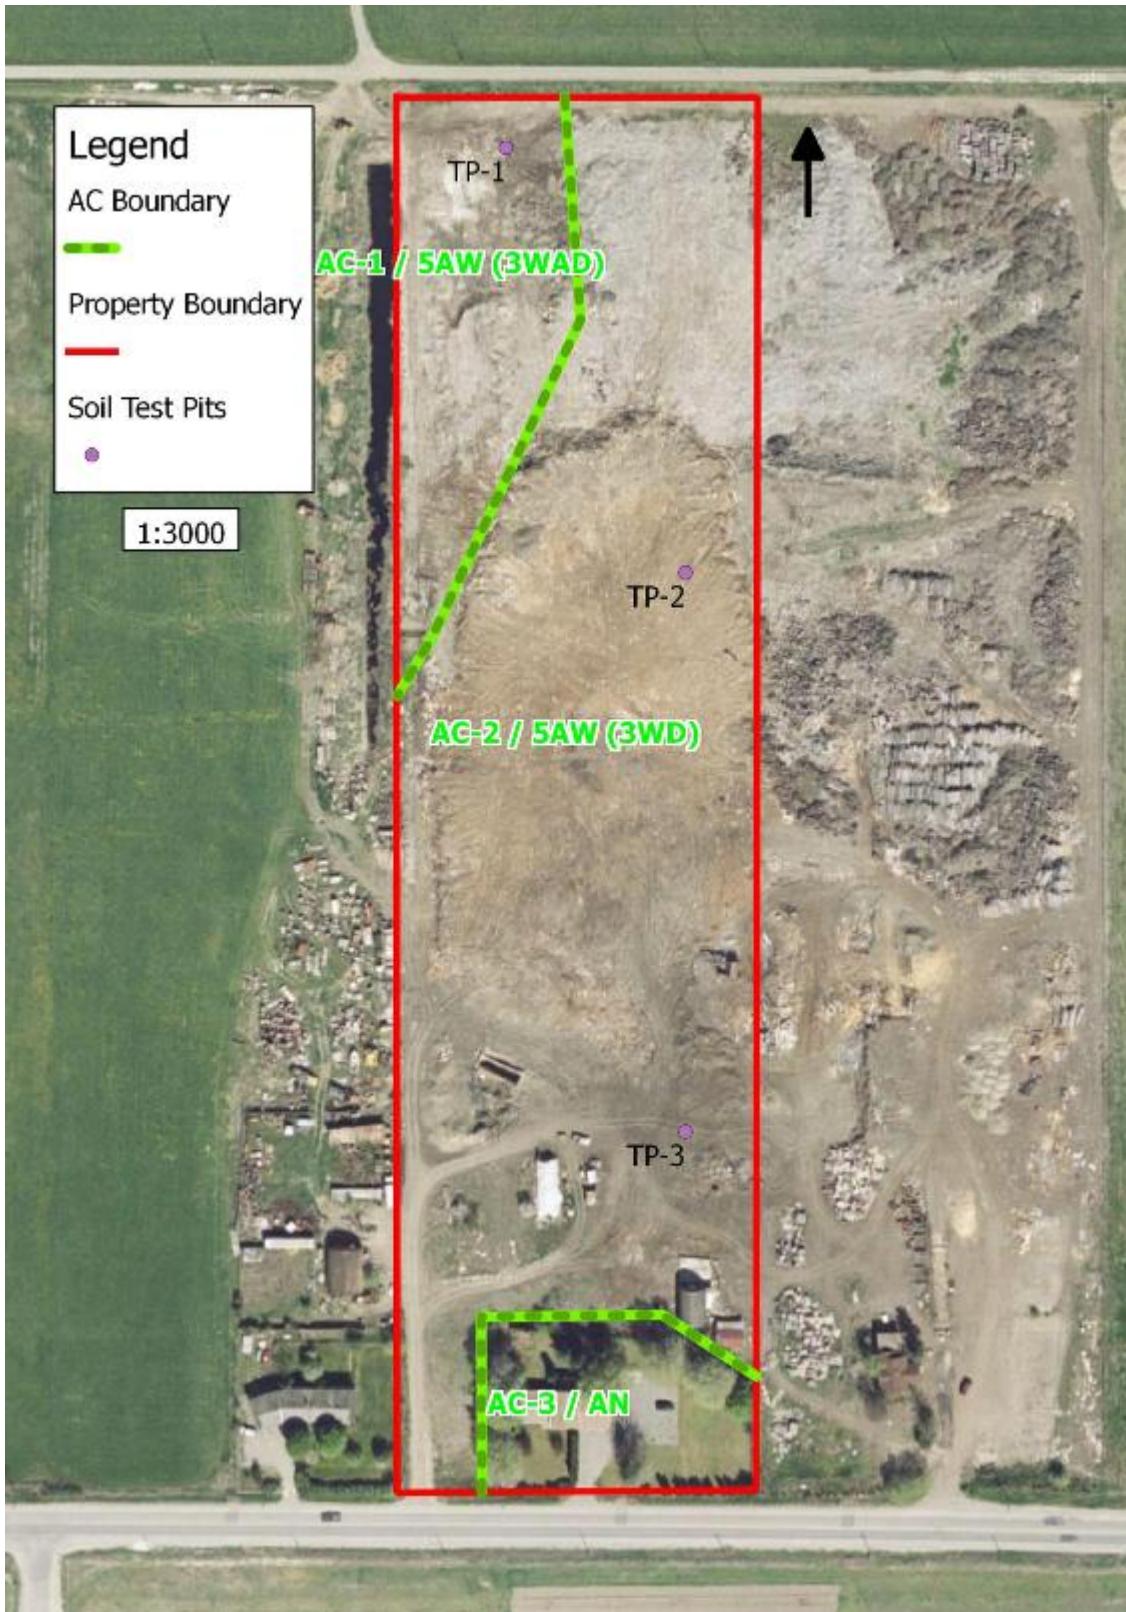
Figure 9: Agricultural Land Capability Mapping, 982 Old Vernon Rd., Kelowna BC

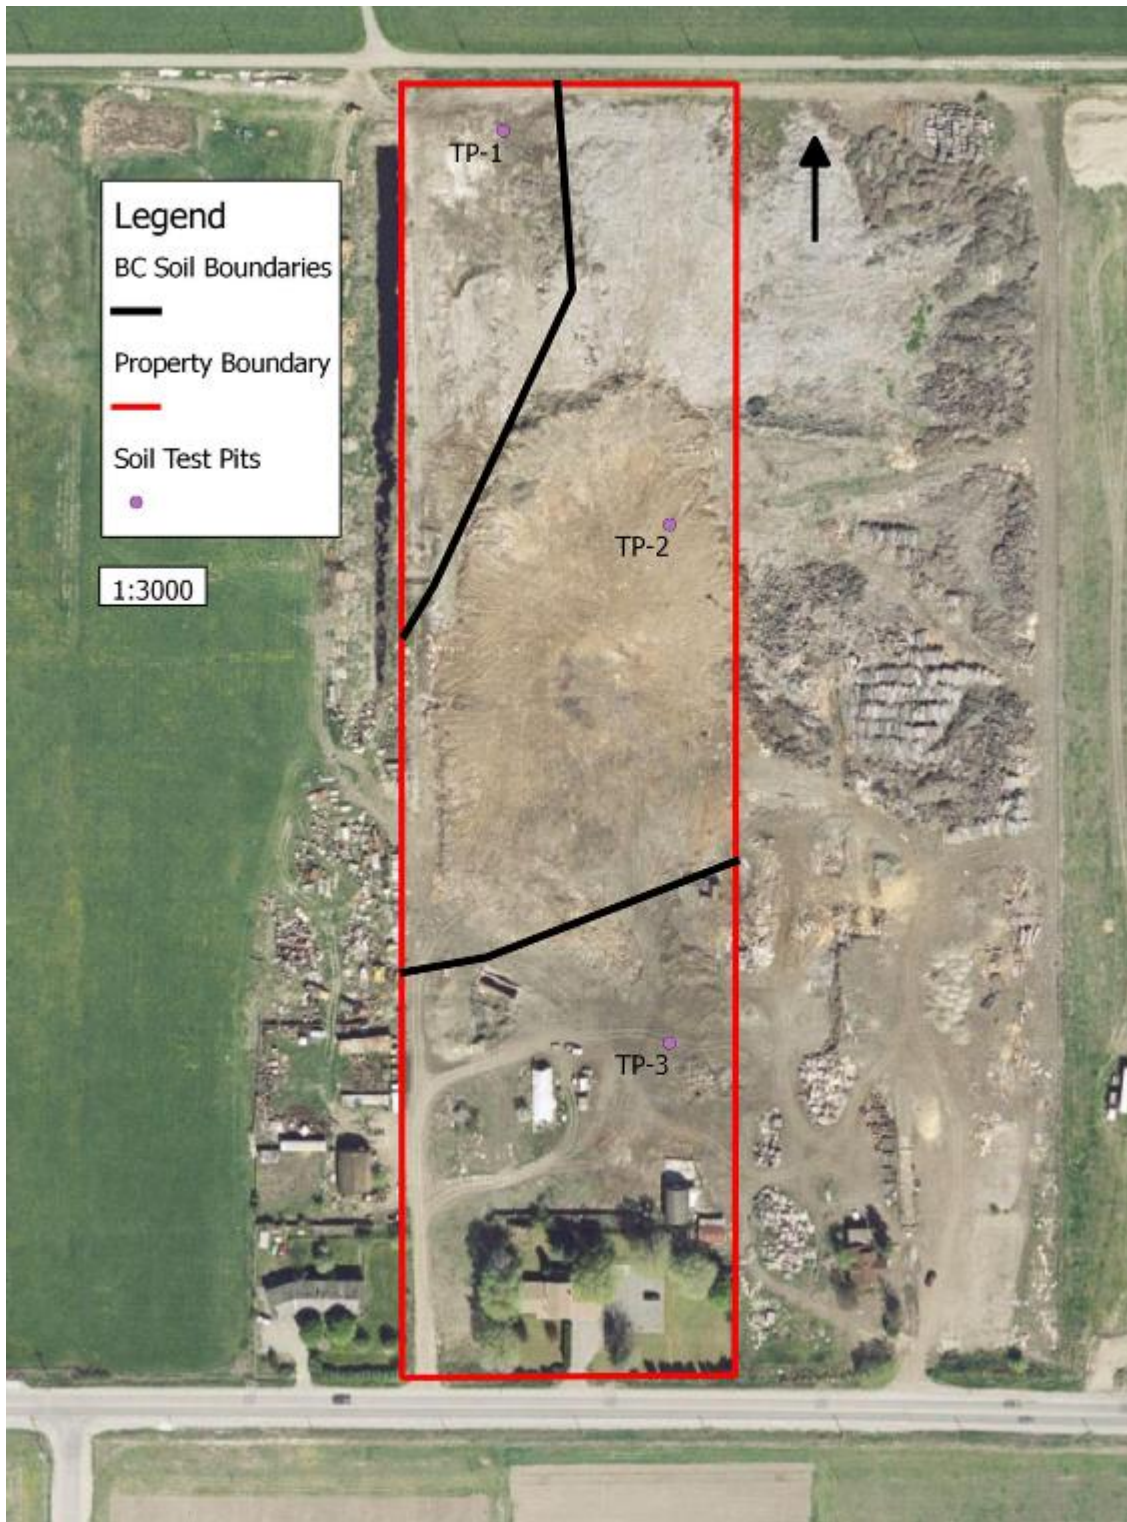
Figure 9: 982 Old Vernon Rd. Kelowna BC – Soil Inspection, Soil test pit location map

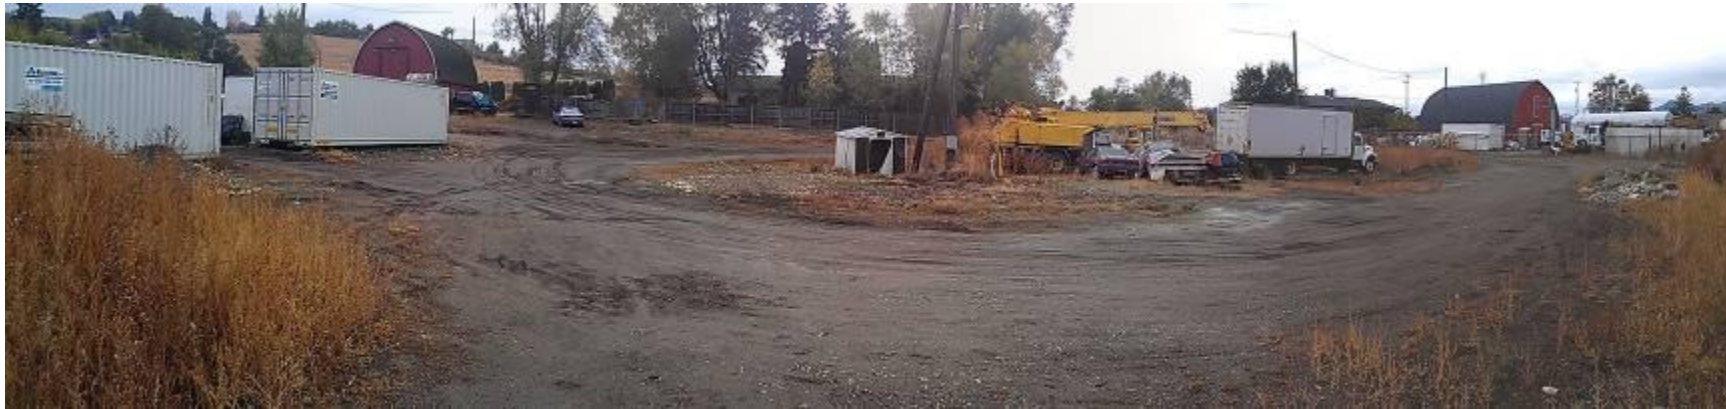
Photo 1: South portion of the site showing remaining footprint of mill work, stored machinery, storage bins and home site in background

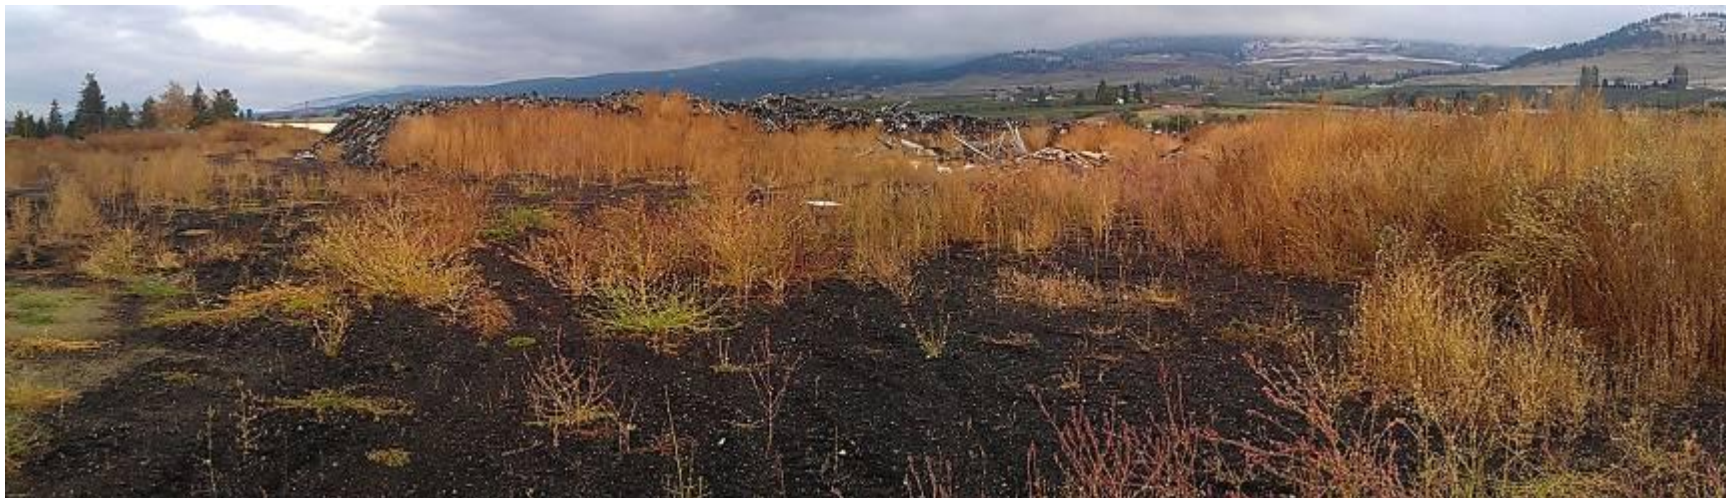
Photo 2: Central portion of the site showing wood waste on the ground, weedy cover and a wood waste pile in background

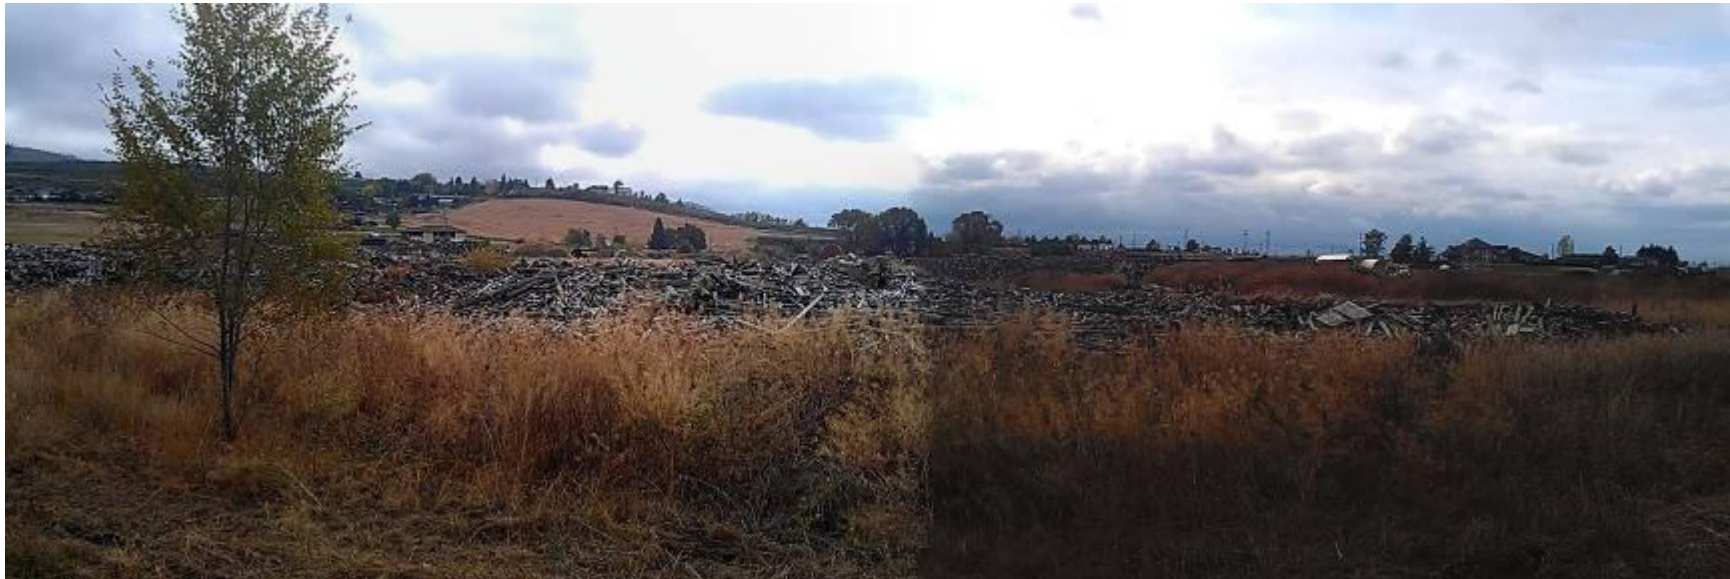
Photo 3: Northern portion of the site showing wood waste on the ground, weedy cover and wood waste piles in background

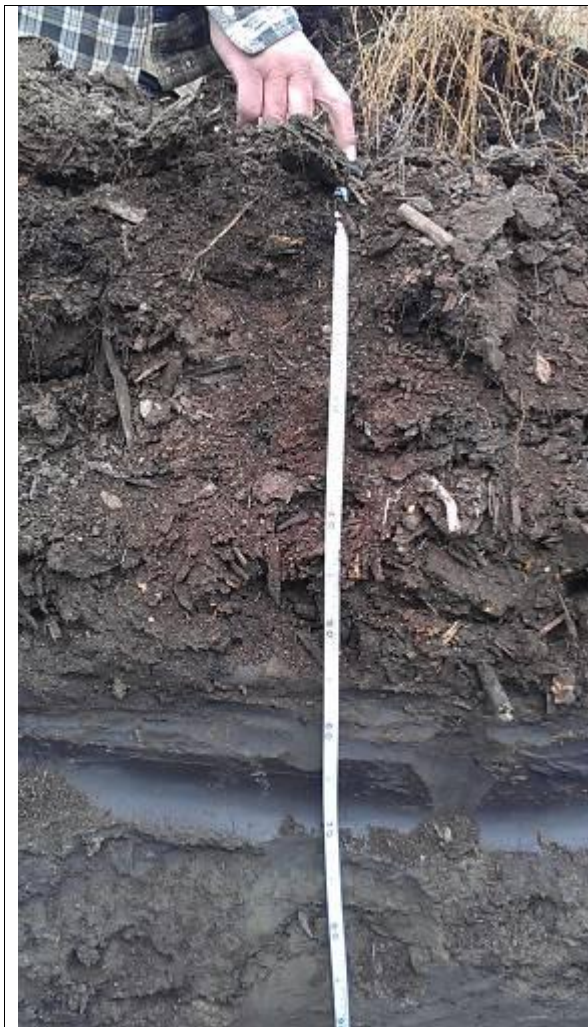
Photo 4: Test Pit 1 – 982 Old Vernon Rd., Kelowna, BC

0cm to 90cm depth

Project 12E043		TP #1	Slope N 1%		24-Oct-12	Overcast 2 C
Depth (cm)	Horizon	Texture	Consistence / Structure	Colour	Mottles	Coarse Fragments
2-0	LFH	-	thatch	-		
0-54	Fill	SL	admixed soil fill / WW	Dk Br	-	10% gravel*
54-70	B	C	firm / massive	DkGr	-	0% gravel
70+	C	HC	v. firm / blocky	Gr	-	0% gravel

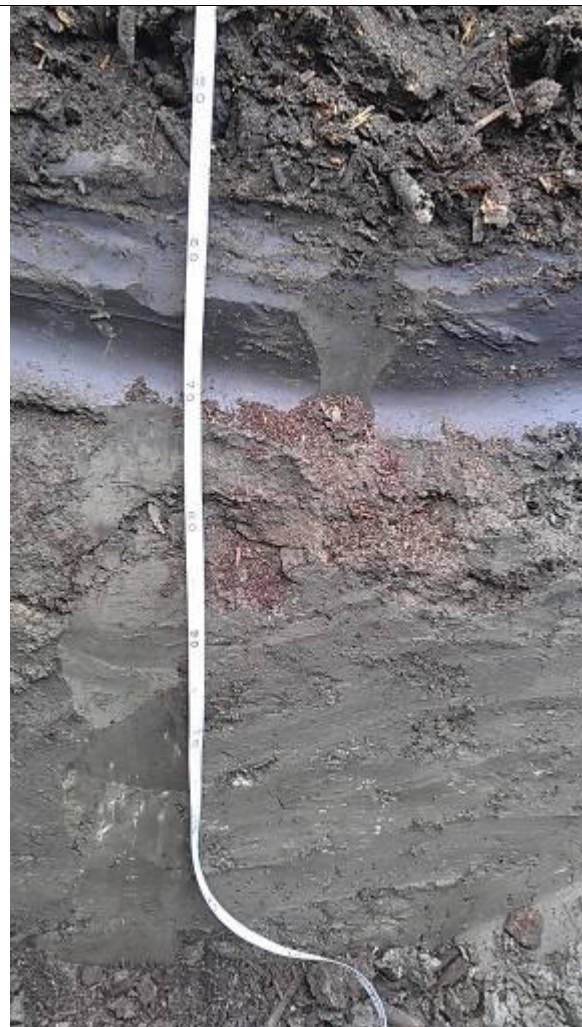
Photo 5: Test Pit 1 – 982 Old Vernon Rd., Kelowna, BC

50cm to 130cm depth

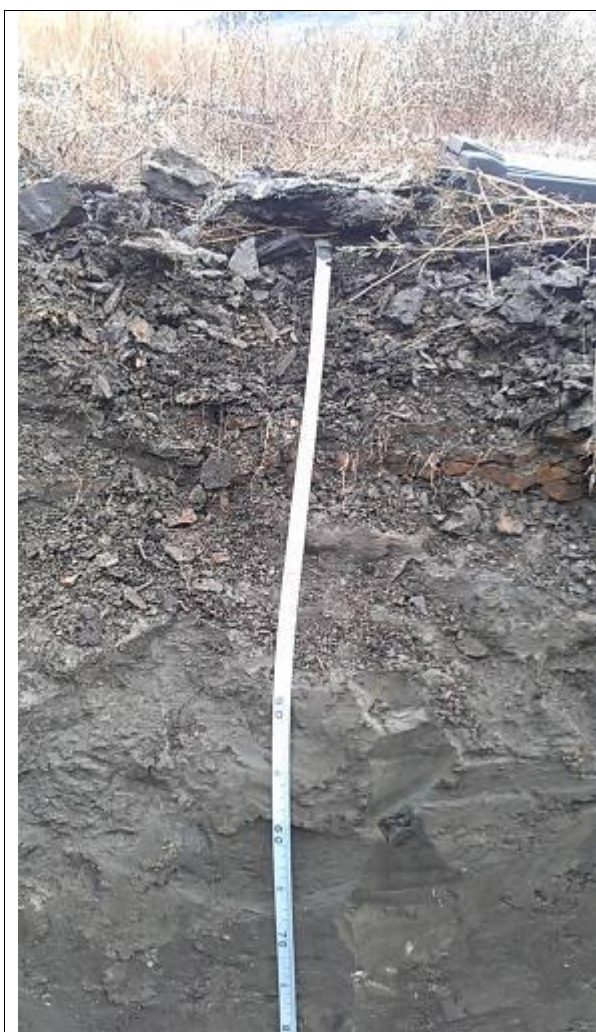
Photo 6: Test Pit 2 – 982 Old Vernon Rd., Kelowna, BC

0cm to 70cm depth

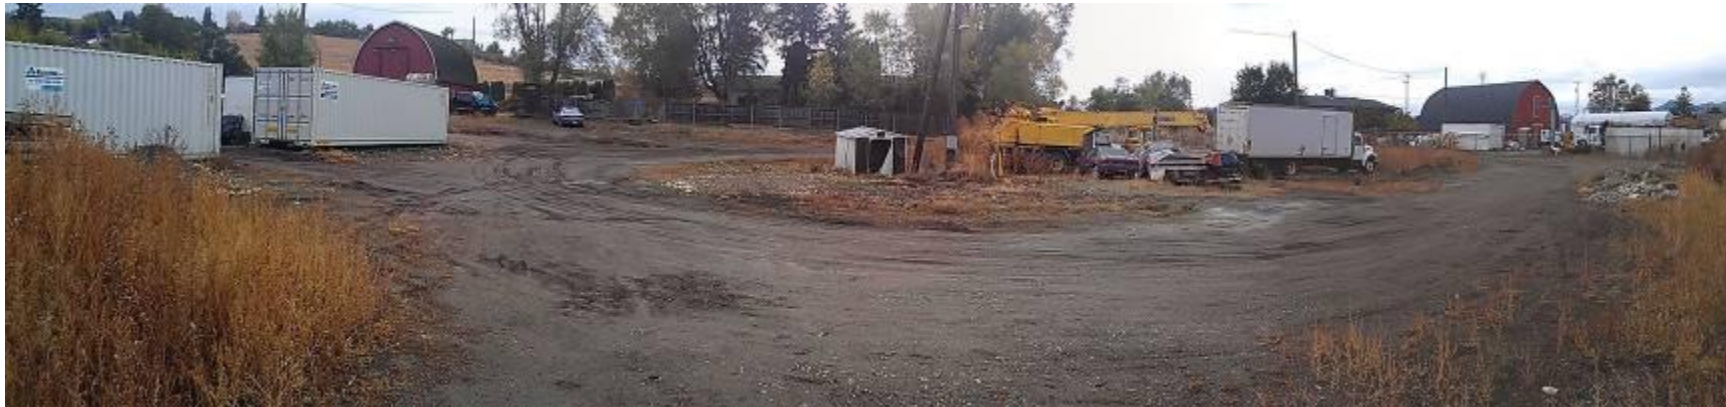
Photo 1: South portion of the site showing remaining footprint of mill work, stored machinery, storage bins and home site in background

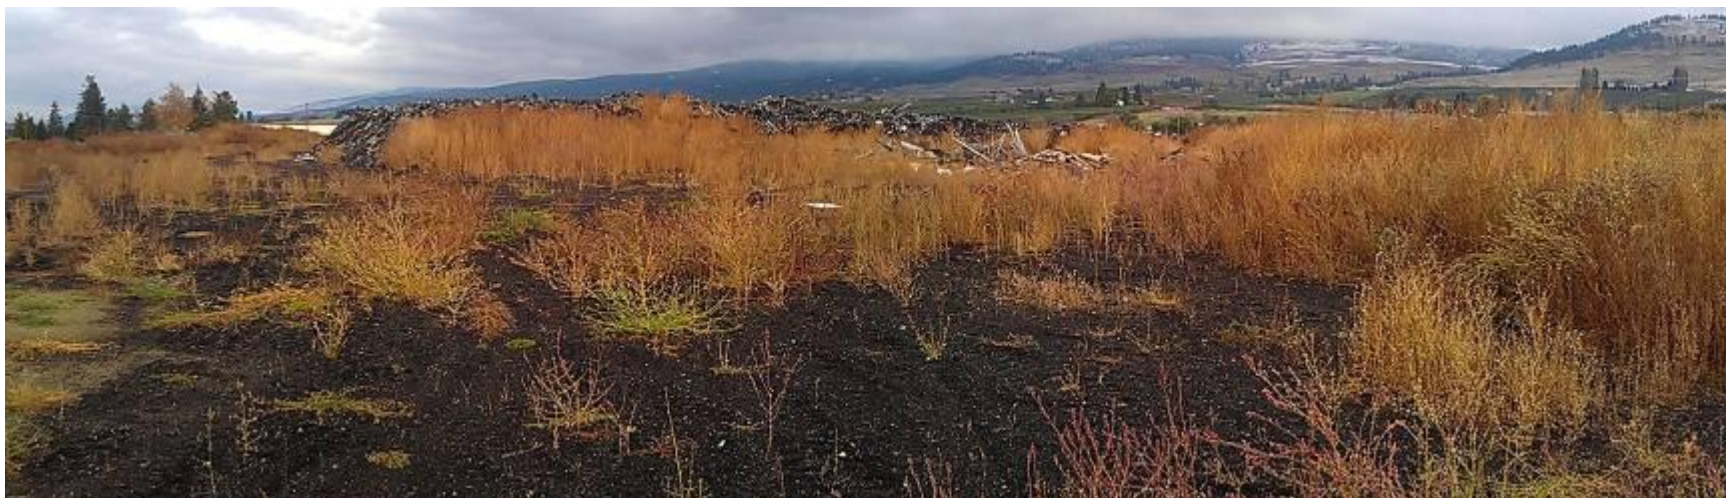
Photo 2: Central portion of the site showing wood waste on the ground, weedy cover and a wood waste pile in background

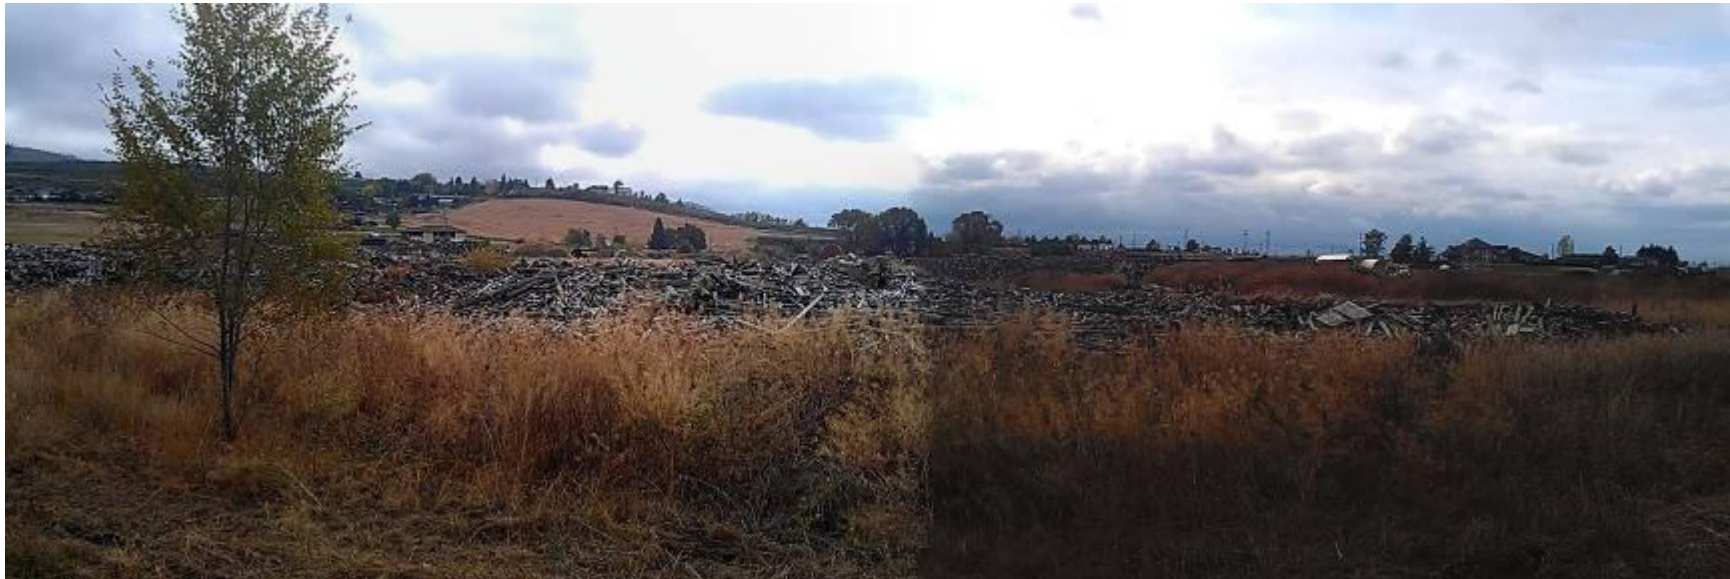
Photo 3: Northern portion of the site showing wood waste on the ground, weedy cover and wood waste piles in background

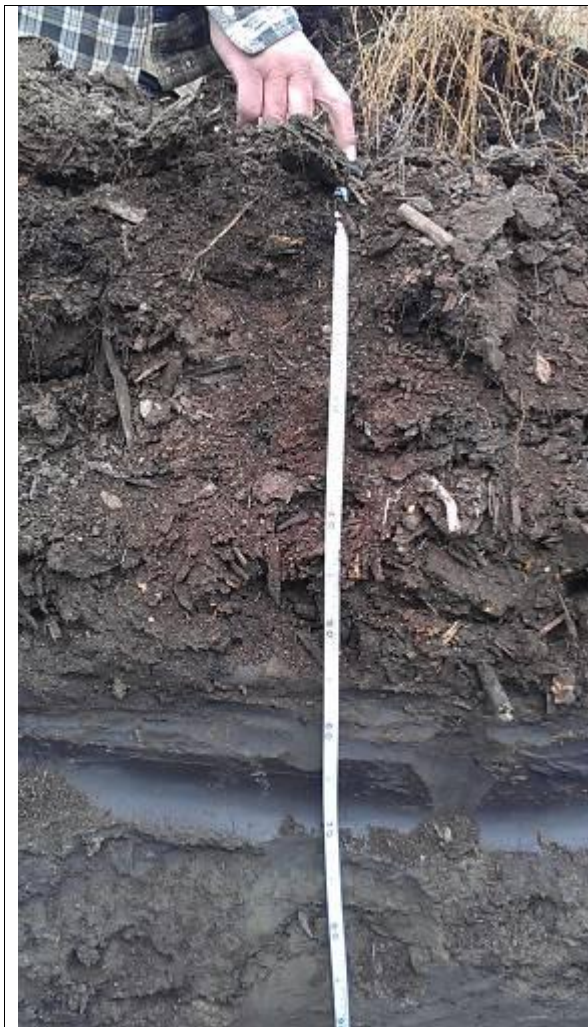
Photo 4: Test Pit 1 – 982 Old Vernon Rd., Kelowna, BC

0cm to 90cm depth

Project 12E043		TP #1	Slope N 1%		24-Oct-12	Overcast 2 C
Depth (cm)	Horizon	Texture	Consistence / Structure	Colour	Mottles	Coarse Fragments
2-0	LFH	-	thatch	-		
0-54	Fill	SL	admixed soil fill / WW	Dk Br	-	10% gravel*
54-70	B	C	firm / massive	DkGr	-	0% gravel
70+	C	HC	v. firm / blocky	Gr	-	0% gravel

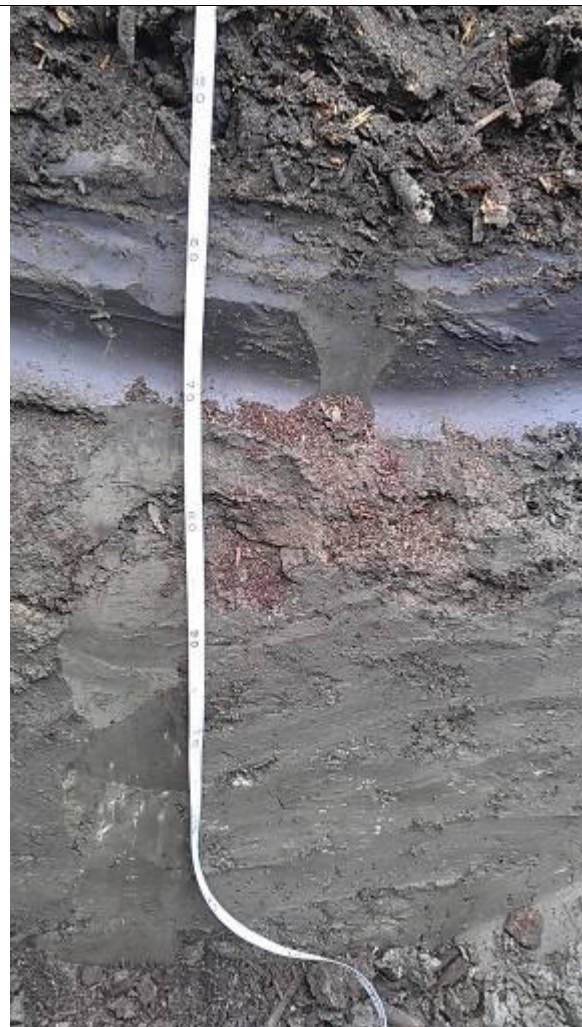
Photo 5: Test Pit 1 – 982 Old Vernon Rd., Kelowna, BC

50cm to 130cm depth

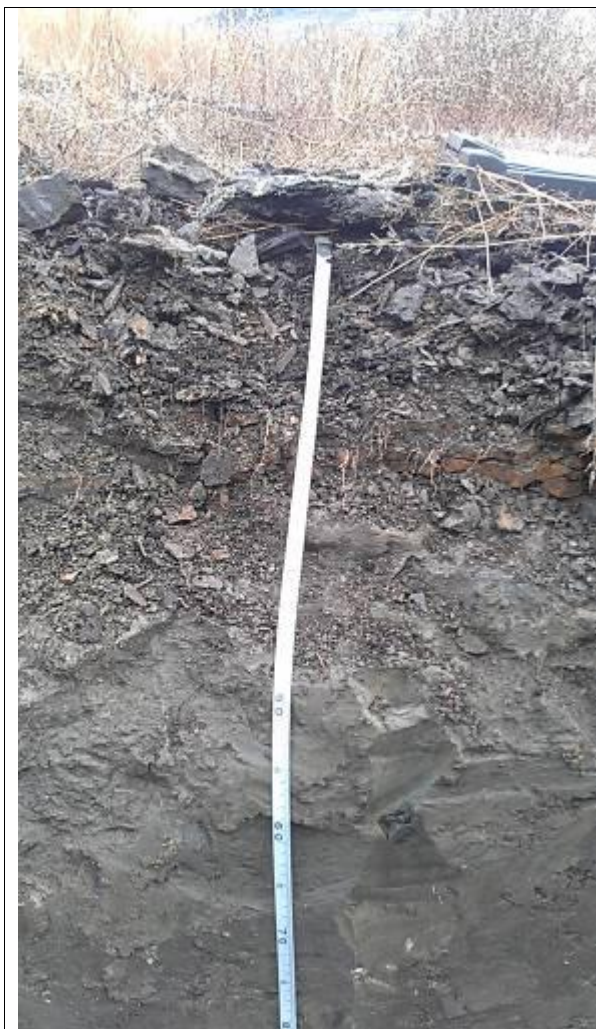
Photo 6: Test Pit 2 – 982 Old Vernon Rd., Kelowna, BC

0cm to 70cm depth

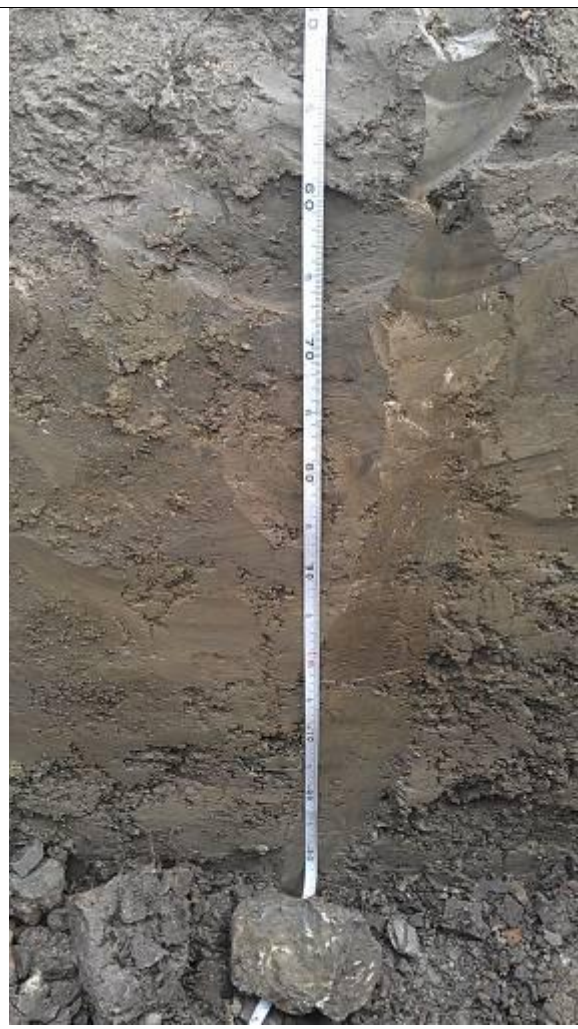
Photo 7: Test Pit 2 – 982 Old Vernon Rd., Kelowna, BC

50cm to 130cm depth
