City of Kelowna

Public Hearing

AGENDA

Tuesday, May 30, 2017
6:00 pm
Council Chamber
City Hall, 1435 Water Street

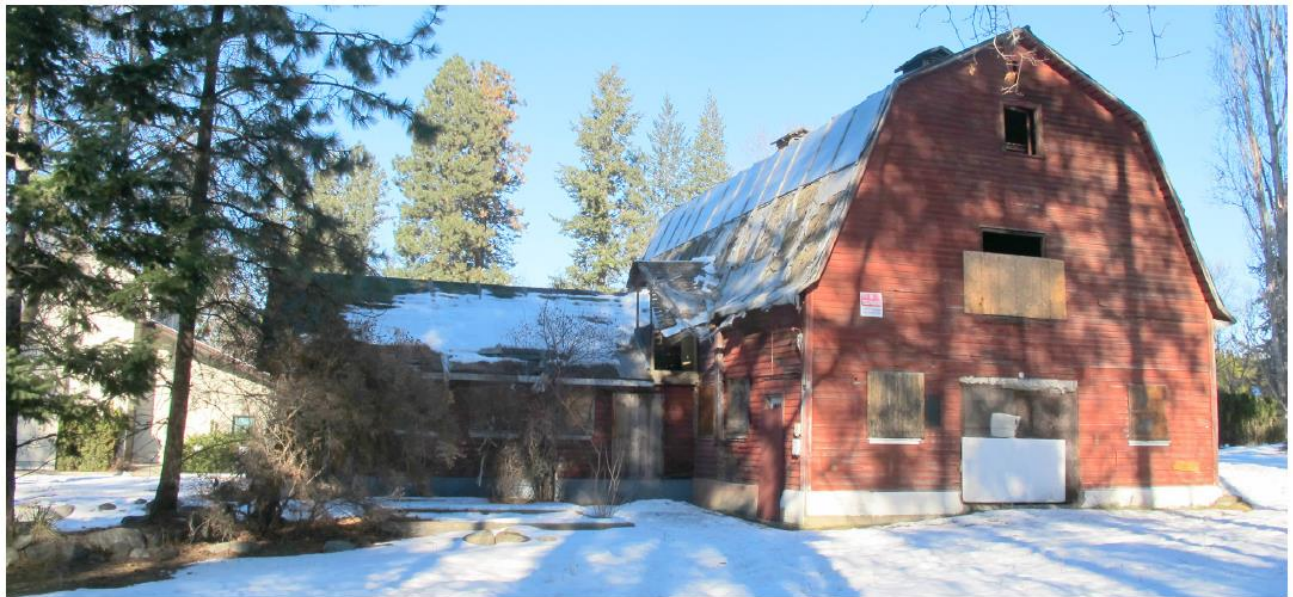
Archival photo showing south elevation of Surtees Barn with cross of church in the background (top; date unknown); photo showing existing condition of Surtees Barn, as viewed from southwest, with St. Andrew's Church in the background.

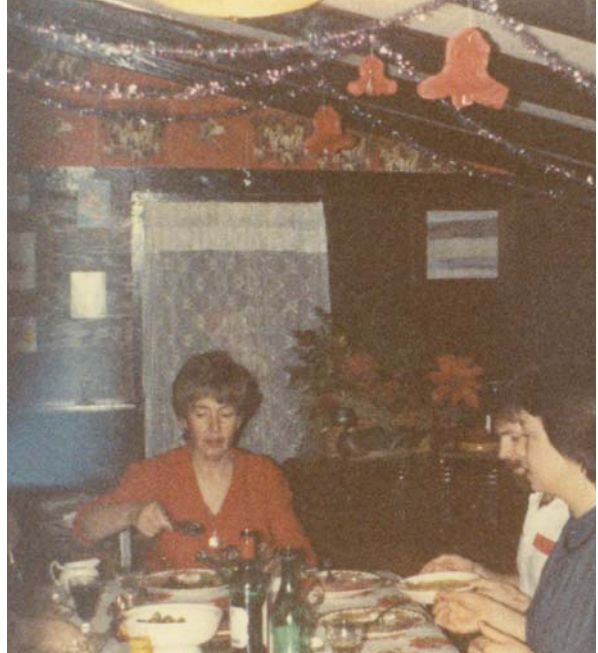
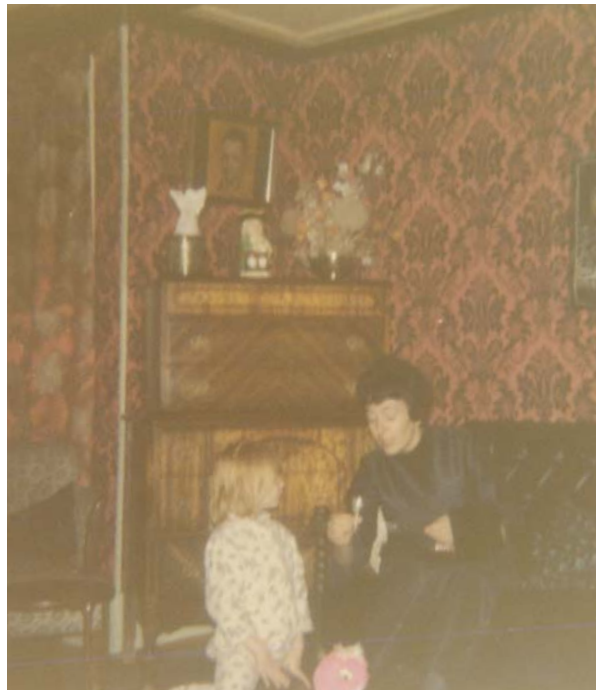
Photos showing interior spaces of Surtees House: dining room at early extension, showing expressed roof rafters (top); living room at north end of the original house, showing north bay window to the left (bottom). [Ursula Surtees Collection]

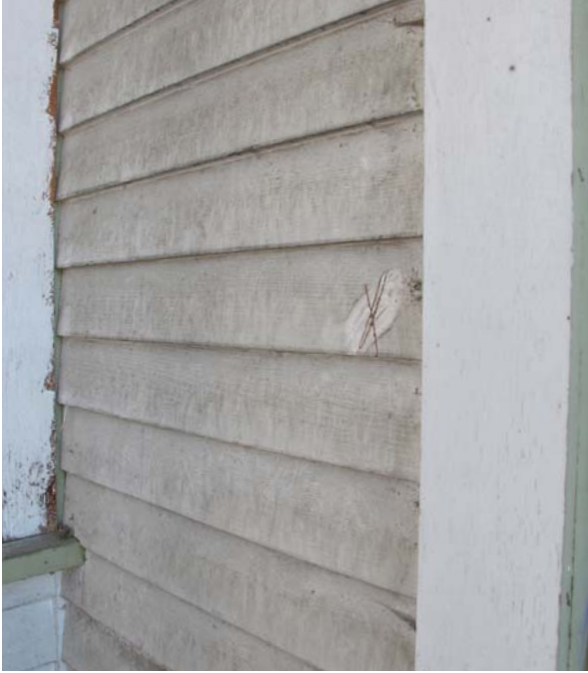
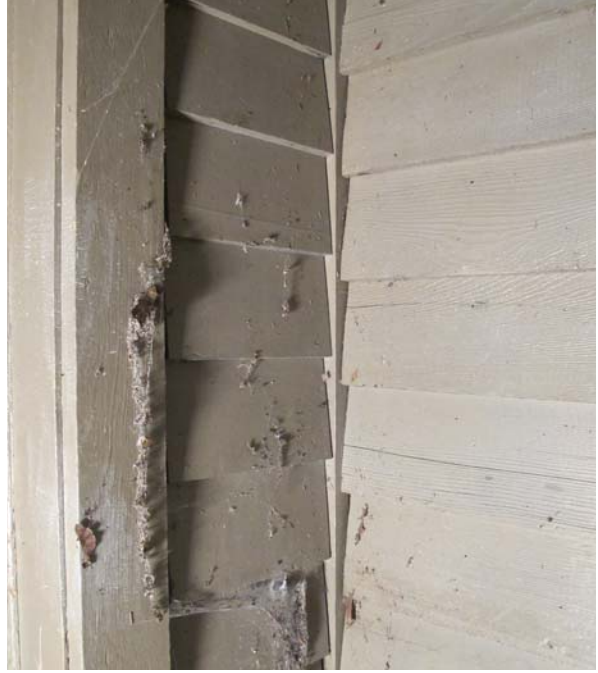
Photo showing existing condition of original exterior wall, with horizontal lapped wood siding and trims at north elevation (top left), and at the interior return walls of the enclosed early addition to the west (top right).

- Cleaning procedures should be undertaken with non-destructive methods. Areas with biological growth should be cleaned using a soft, natural bristle brush, without water, to remove dirt and other material. If a more intense cleaning is required, this can be accomplished with warm water, mild detergent (such as D/2 Biological Solution®) and a soft bristle brush. High-pressure power washing, abrasive cleaning or sandblasting should not be allowed under any circumstances.

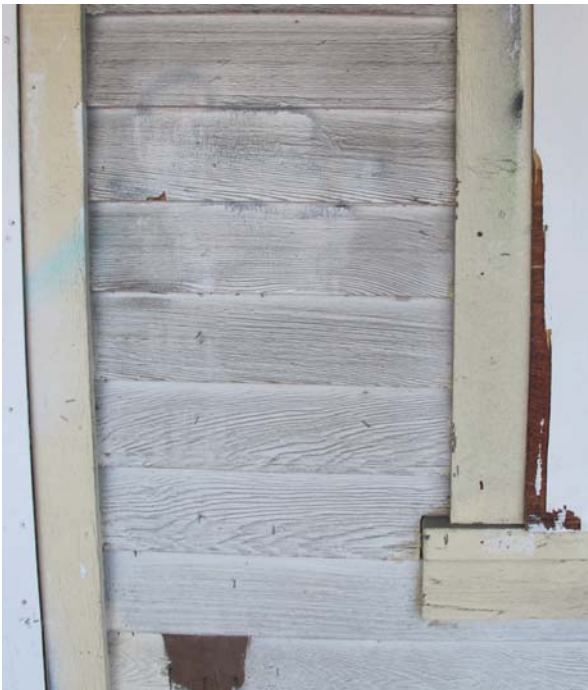
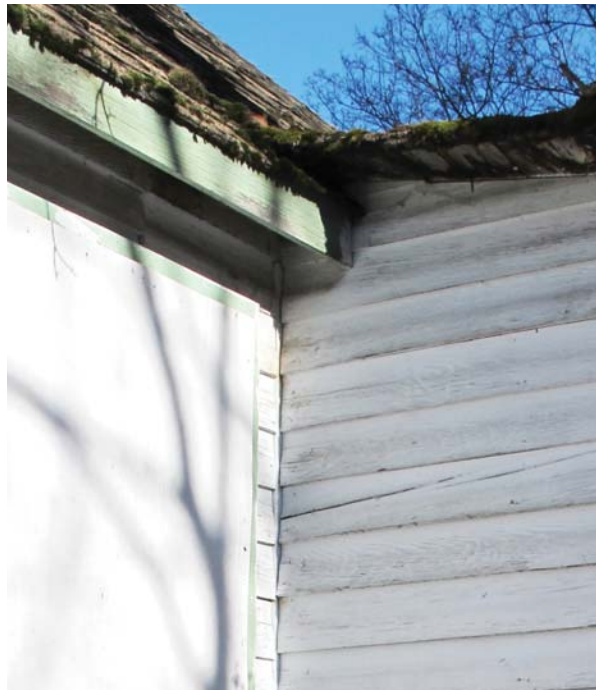
Photos showing original exterior walls with original materials interfaced with later rehabilitation with inappropriate detailing; at historic front facade between door and window opening (bottom left), and at south elevation and return wall of later addition (bottom right).

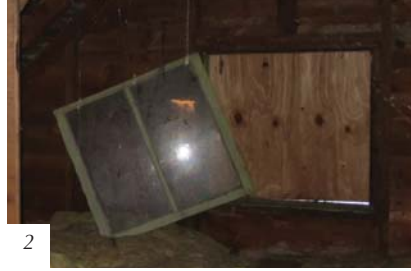
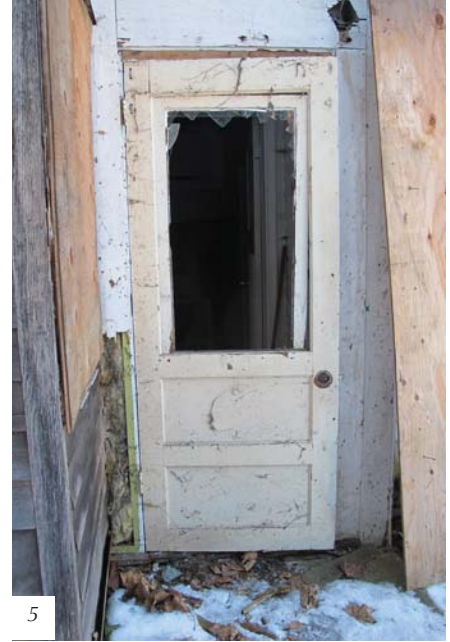
Photos showing existing typical conditions of surviving original wood windows and doors: gable ends at the east/west elevations (1, 2); bay window at north elevation (3); historic front facade at west elevation, showing partial wood door (4); rear exterior door at east elevation (5); main entrance door at west elevation (6).

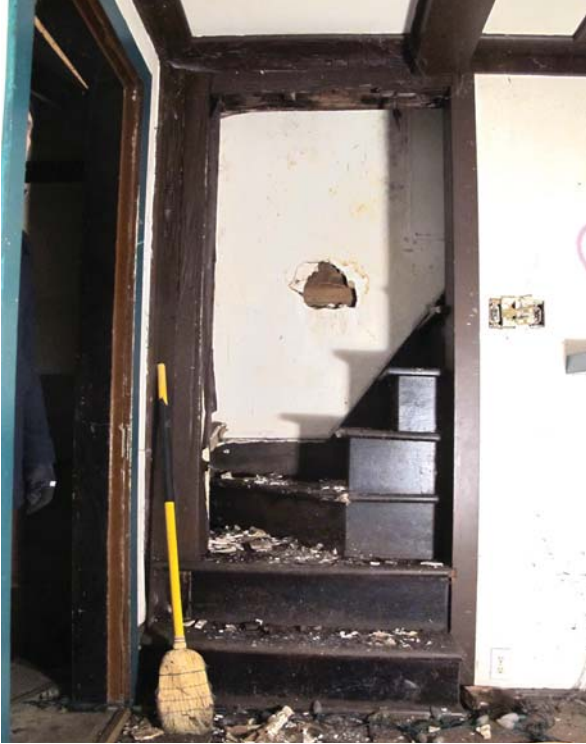
5.8.2 STAIRCASE

The Surtees House features an original, narrow winder staircase that is accessible from the large bedroom to the north, leading up to the attic spaces behind the fireplace. The low-height attic apices may have been used for storage or boarding rooms for servants. The staircase is intact and appears to be in good condition, and may be rehabilitated, as necessary.

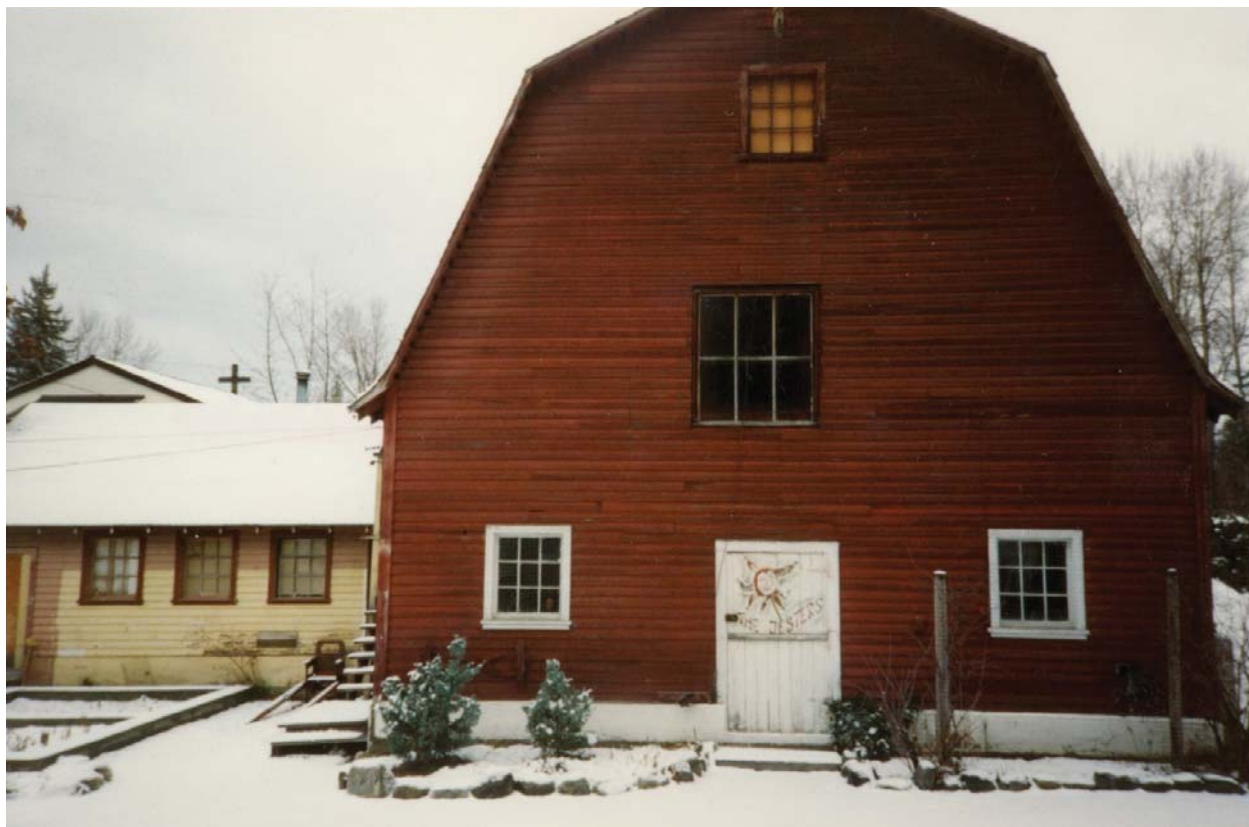
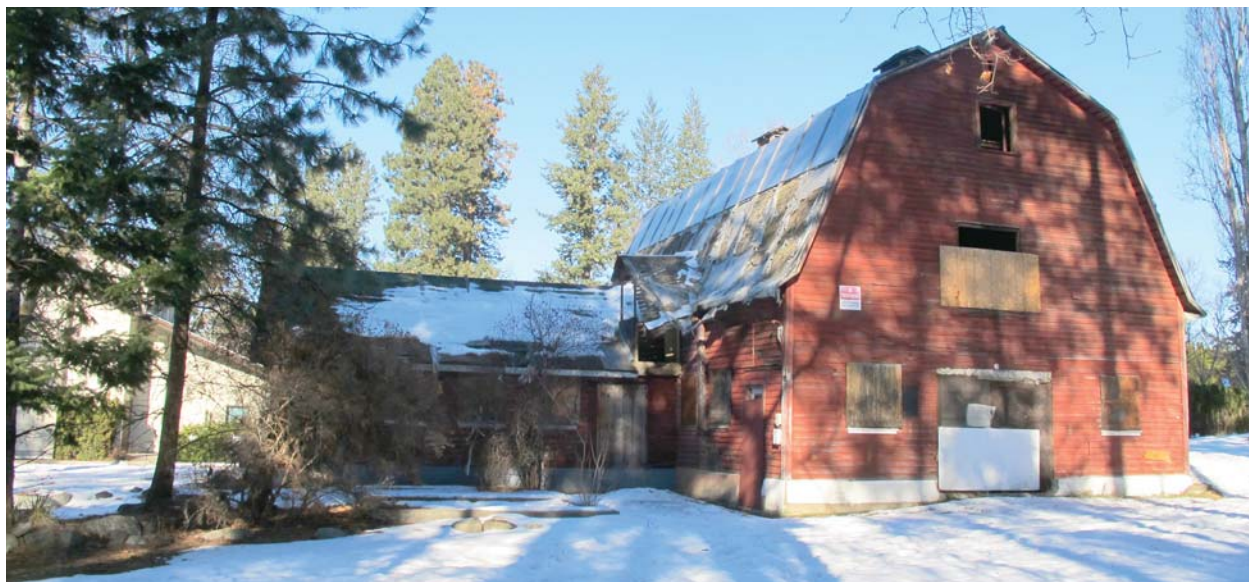
Archival photo showing south elevation of Surtees Barn with cross of church in the background (top; date unknown); photo showing existing condition of Surtees Barn, as viewed from southwest, with St. Andrew's Church in the background.

- Preserve the original location of the building. All rehabilitation work should occur within the property lines.
- Retain the relationship of the Surtees Barn with the Surtees House and the surrounding natural heritage features.
- Protect and retain natural heritage features of the Surtees property. Replace in kind disturbed vegetation with new plantings to match original as required.
- Relocate the historic building within the property lines.

- A relocation plan should be prepared to ensure that the least destructive method of relocation will be used. The original monitor vents should be moved with the barn, if possible.
- The existing structural bracing should be reviewed by a qualified engineer or a professional building relocation company.
- An experienced and qualified contractor should undertake the physical relocation of the historic structure.
- Appropriate foundation materials can be used at the new site, which can include reinforced concrete basement walls and slab.
- Provide utility installations for electricity, communication and other service connections underground. Installations located above ground should be incorporated harmoniously into the design concept for the relocated structure.
- Implement measures for site protection, in particular when the barn sits vacant, and until construction work commences.

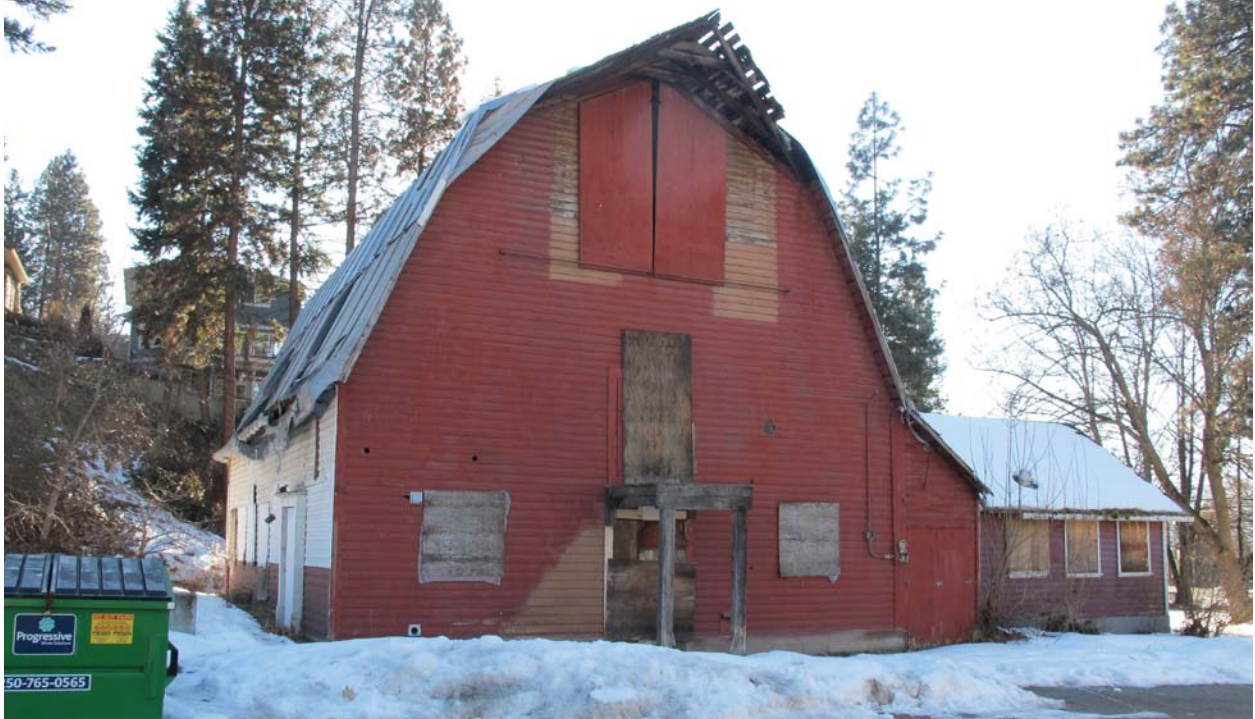
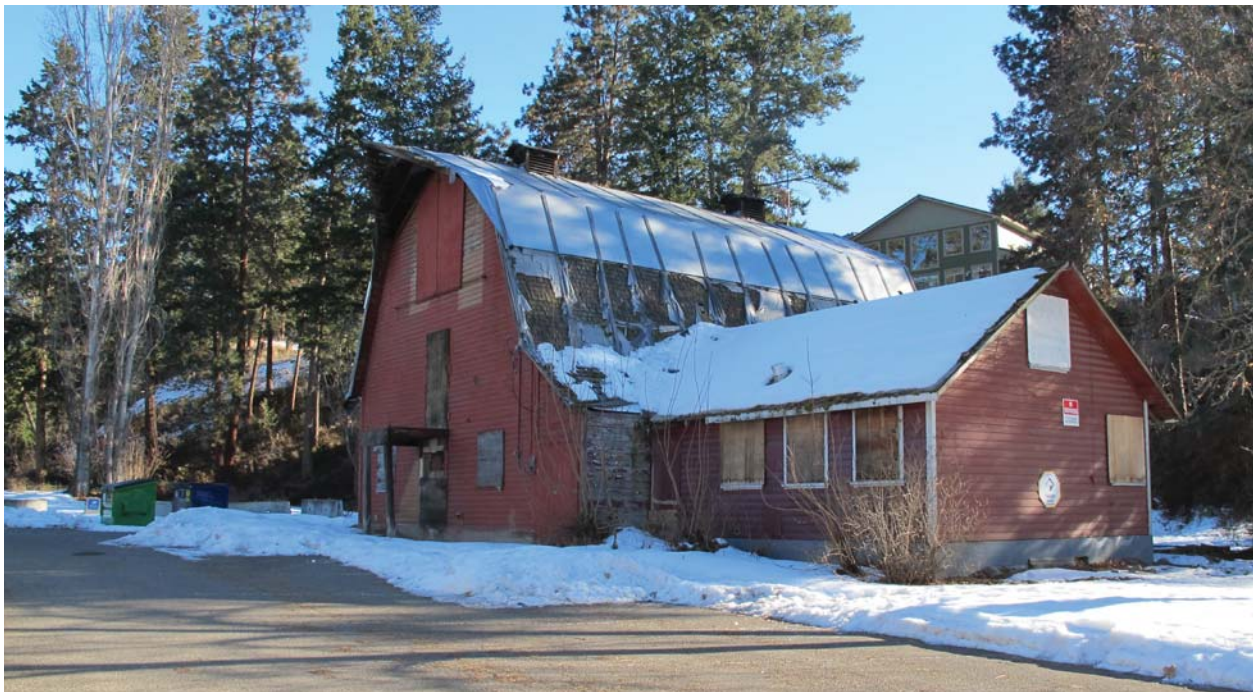
Photos showing north elevation of Surtees Barn, as viewed from northeast (top) and northwest (bottom). Note hill with mature landscape in the background.

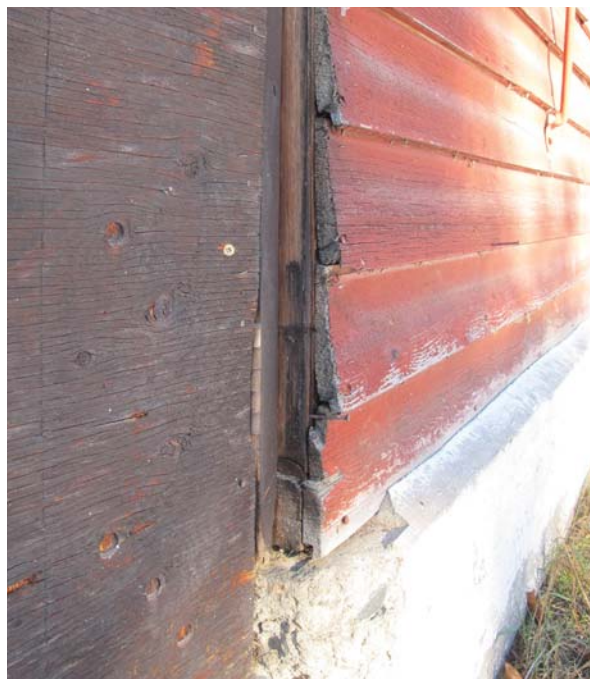
Photos showing typical deteriorated condition of exterior wall cladding above concrete foundation walls. Note profile of original drop siding (top right).

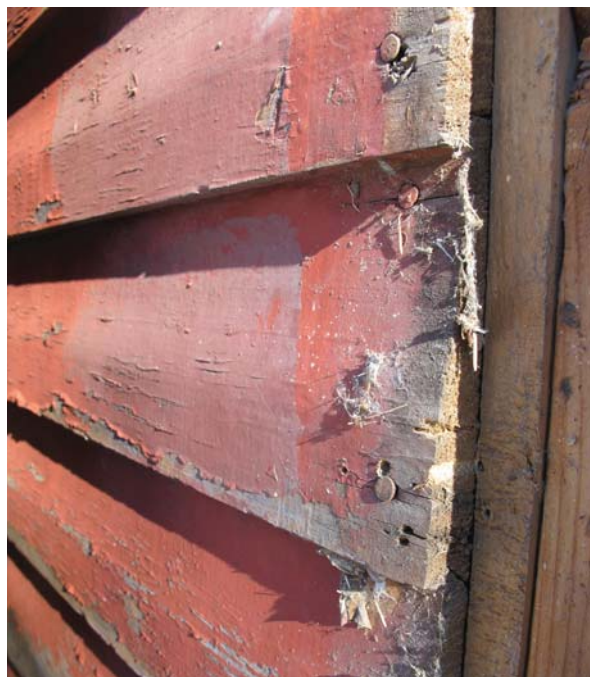
Photos showing typical deteriorated condition of exterior wall cladding, as well as roof soffit and corner board trims.

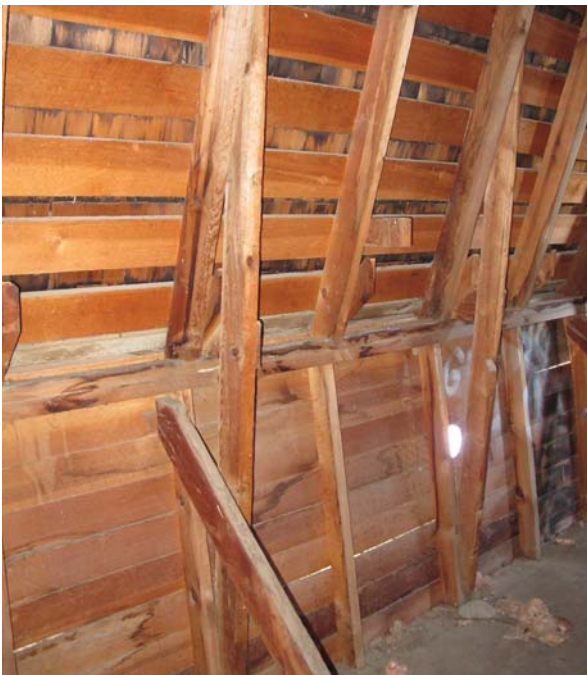
Interior side of the wall-to-roof interface, showing typical existing condition of the original wood materials.

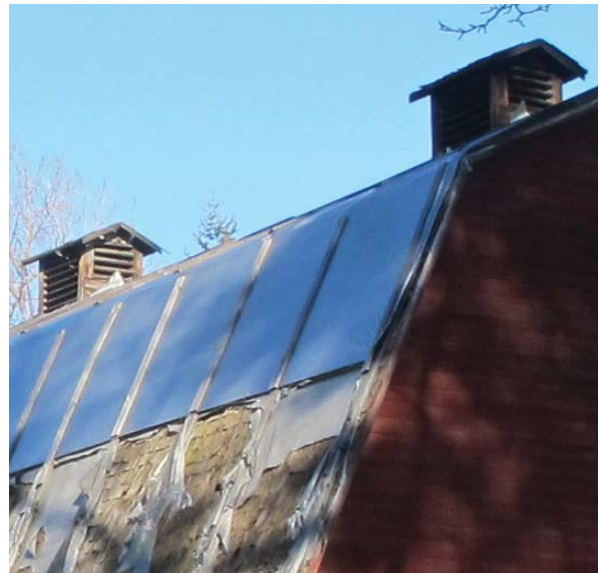
Photo showing typical deteriorated condition of two, existing monitor vents along the roof ridge.

- Preserve the original monitor vents in its original configuration, if possible.
- Original chimneys may require structural stabilization.
- Investigate condition of louvers and siding. If required, they should be repaired and cleaned using gentlest means as possible.
- If the existing monitor vents need to be removed prior to relocation, the existing monitor vents should be carefully documented prior to dismantling. All sound, original materials should be salvaged. Monitor vents should be reinstated above roofline to match original configuration using salvaged original materials as possible, or if necessary, with new materials to match the original. Reconstruction should be discussed with the Heritage Consultant.

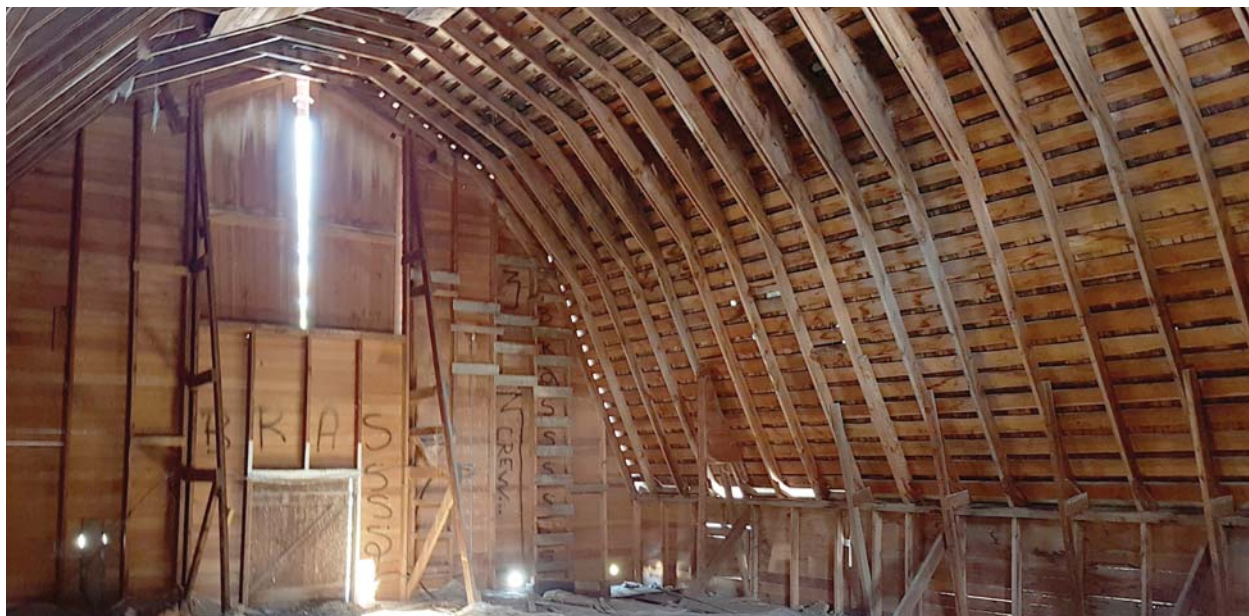
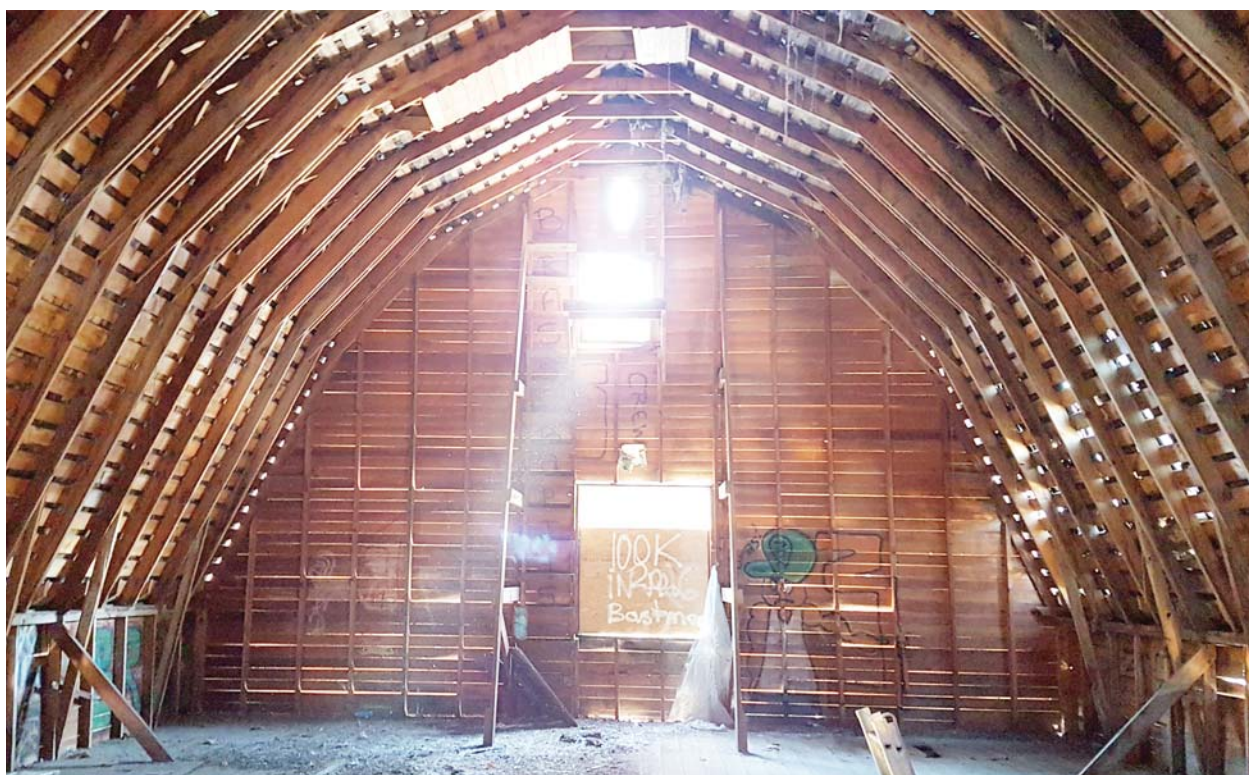
Photos showing exposed gambrel roof structure of the Surtees Barn.
