City of Kelowna

Regular Council Meeting

AGENDA

Tuesday, May 30, 2017
6:00 pm
Council Chamber
City Hall, 1435 Water Street

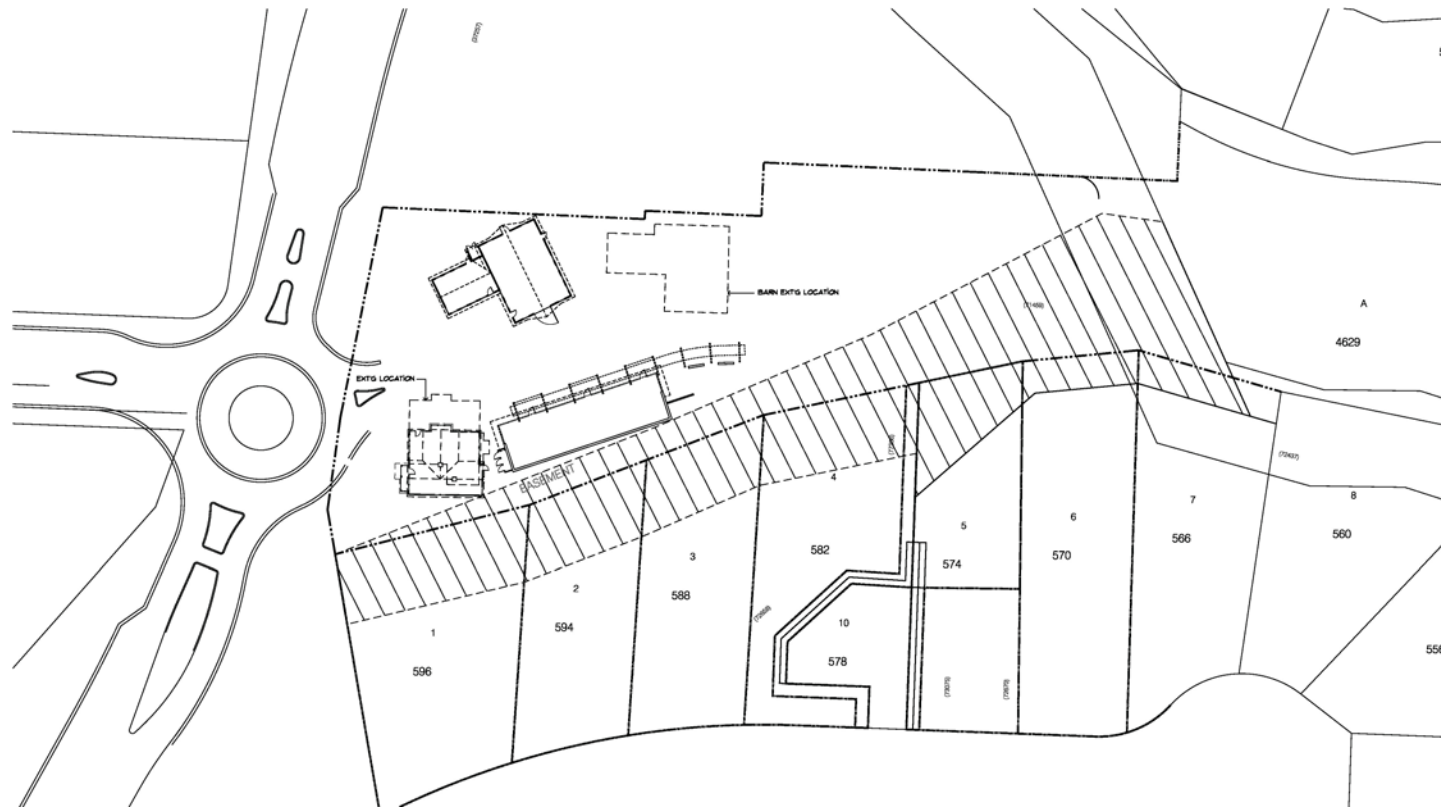
RELOCATION PLAN
SCALE: 1" = 30'

SURTESS HERITAGE PARK
4629 LAKESHORE ROAD KELOWNA
RELOCATION PLAN

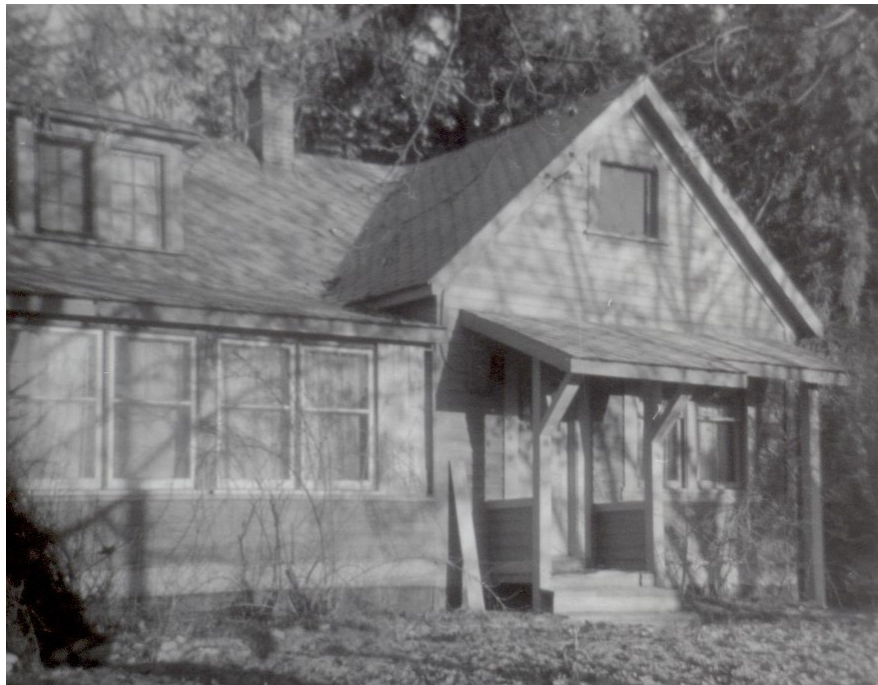
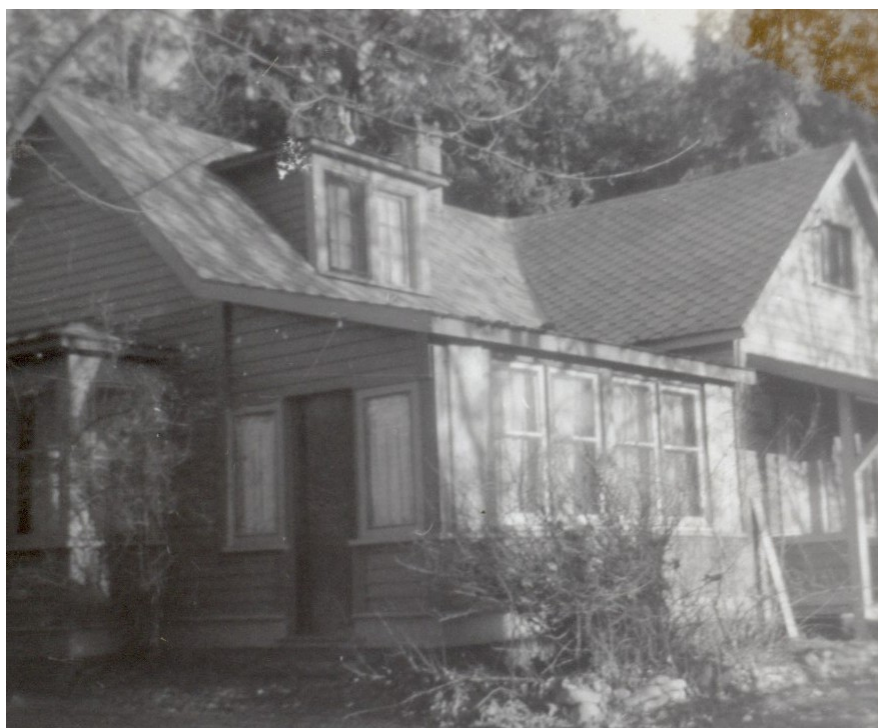
Front facade of the Surtees House (top) and northwest corner of the historic house, partially showing bay window at north elevation (bottom). [Ursula Surtees Collection]

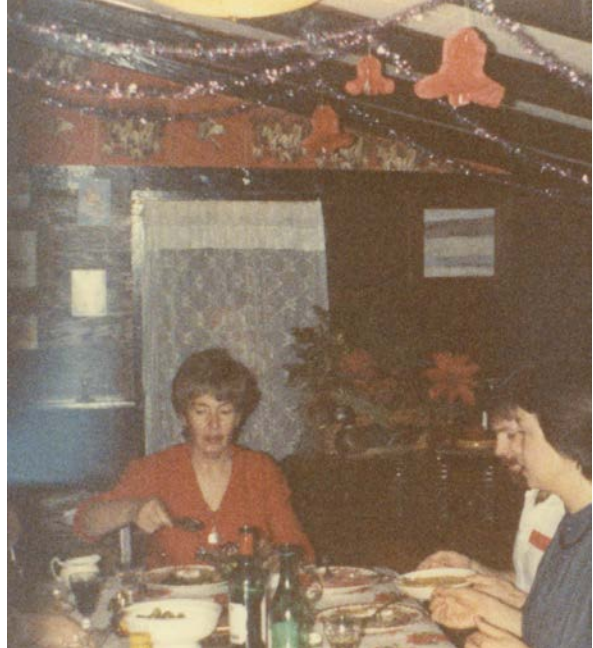
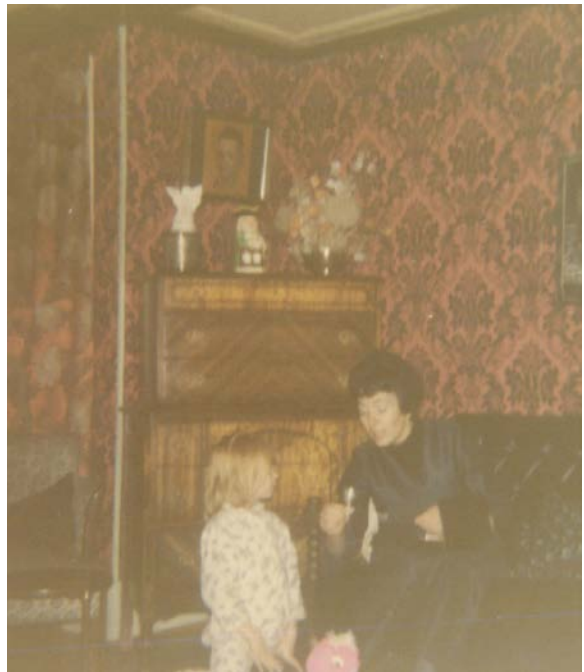
Photos showing interior spaces of Surtees House: dining room at early extension, showing expressed roof rafters (top); living room at north end of the original house, showing north bay window to the left (bottom). [Ursula Surtees Collection]

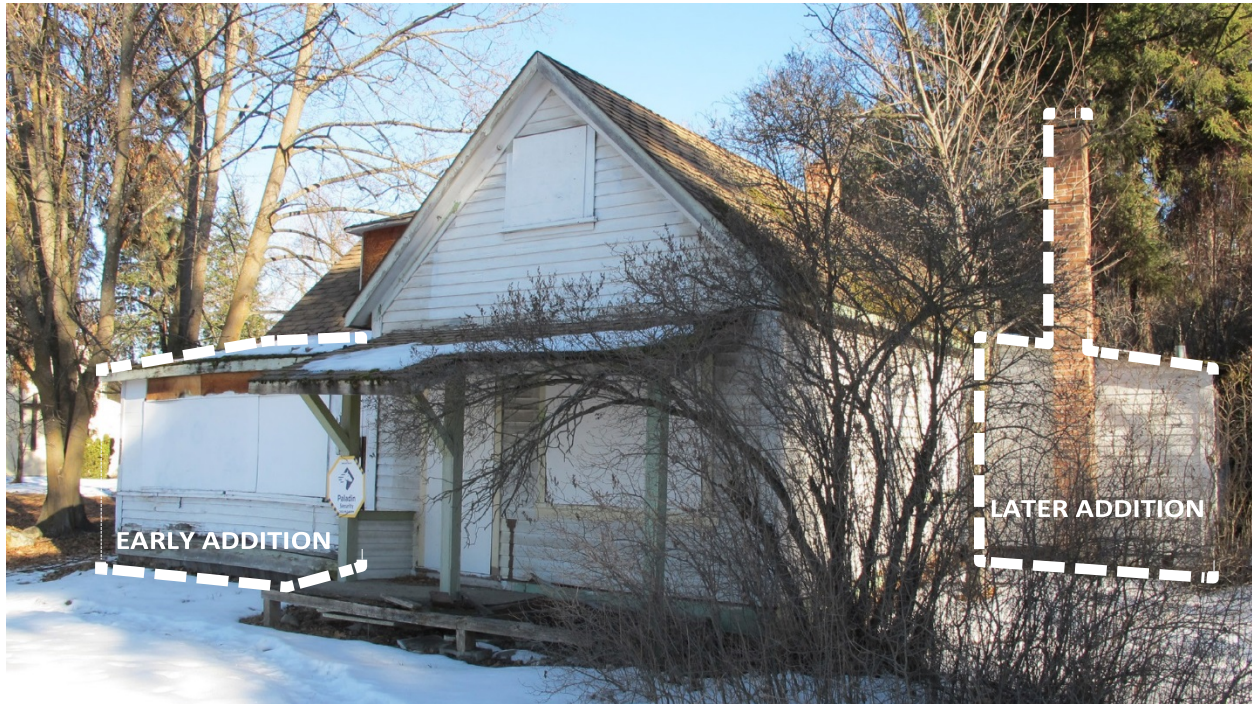
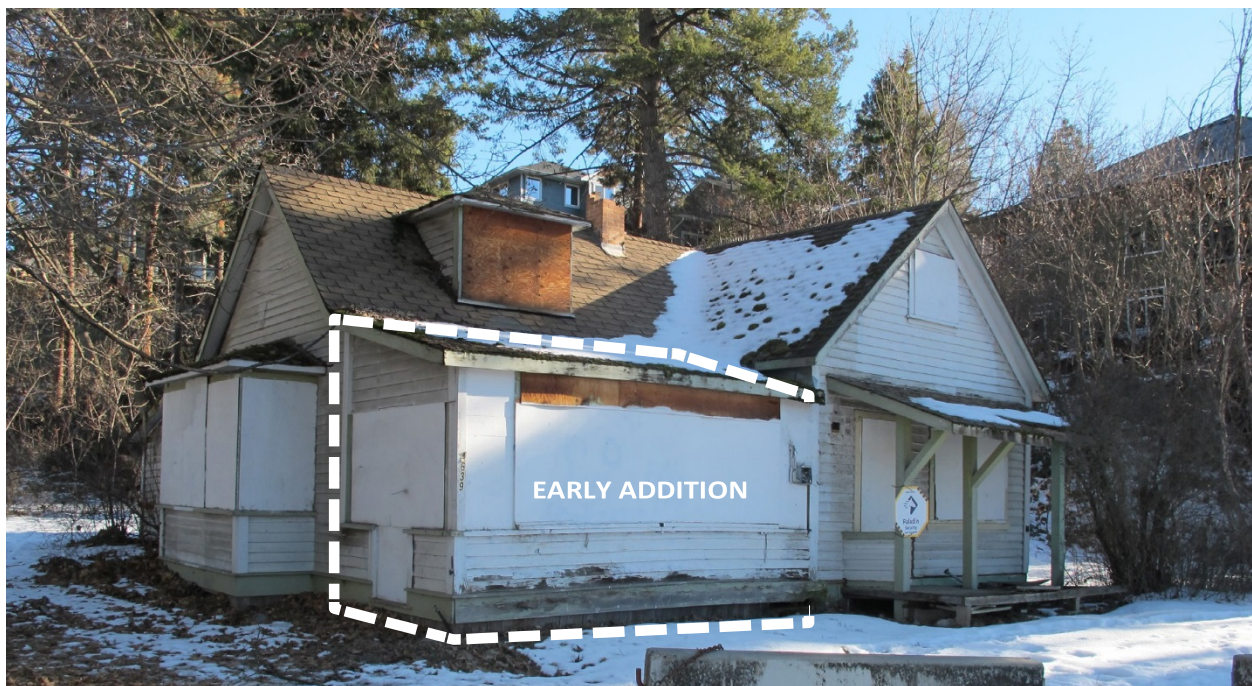
Perspectival views of the Surtees House along Lakeshore Road showing partial west and south elevations (top), and partial west and north elevations (bottom). Note that the .

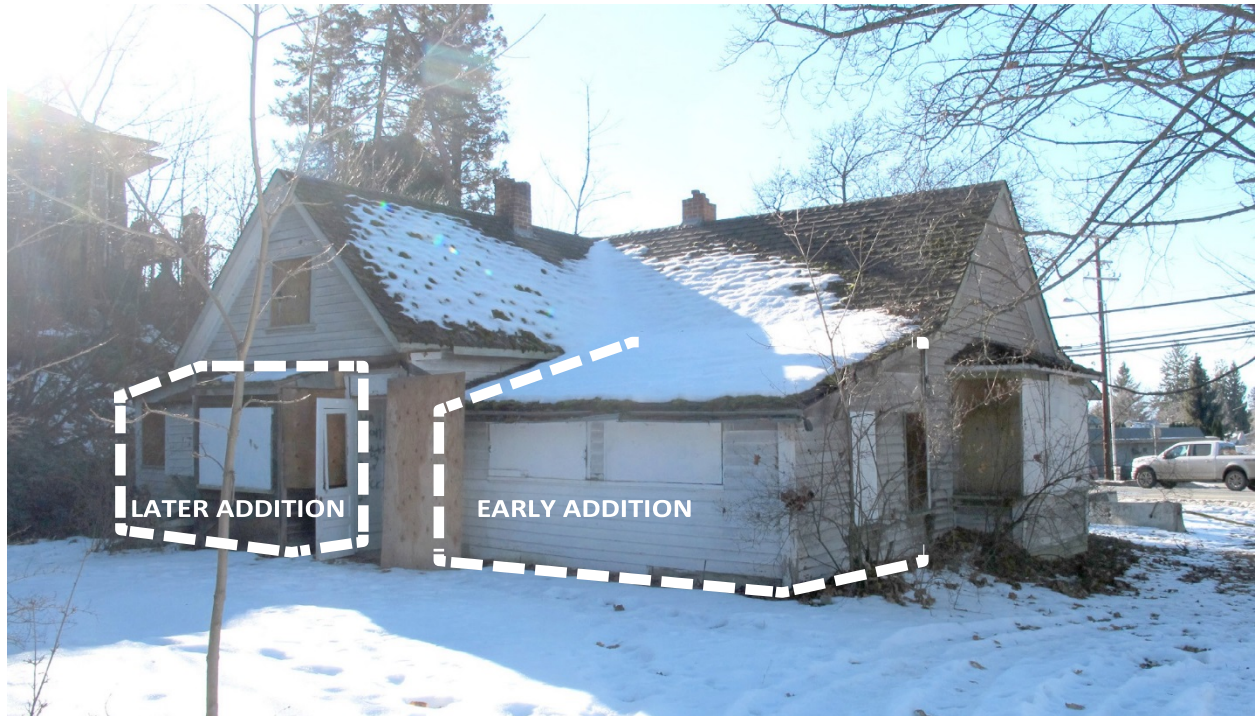
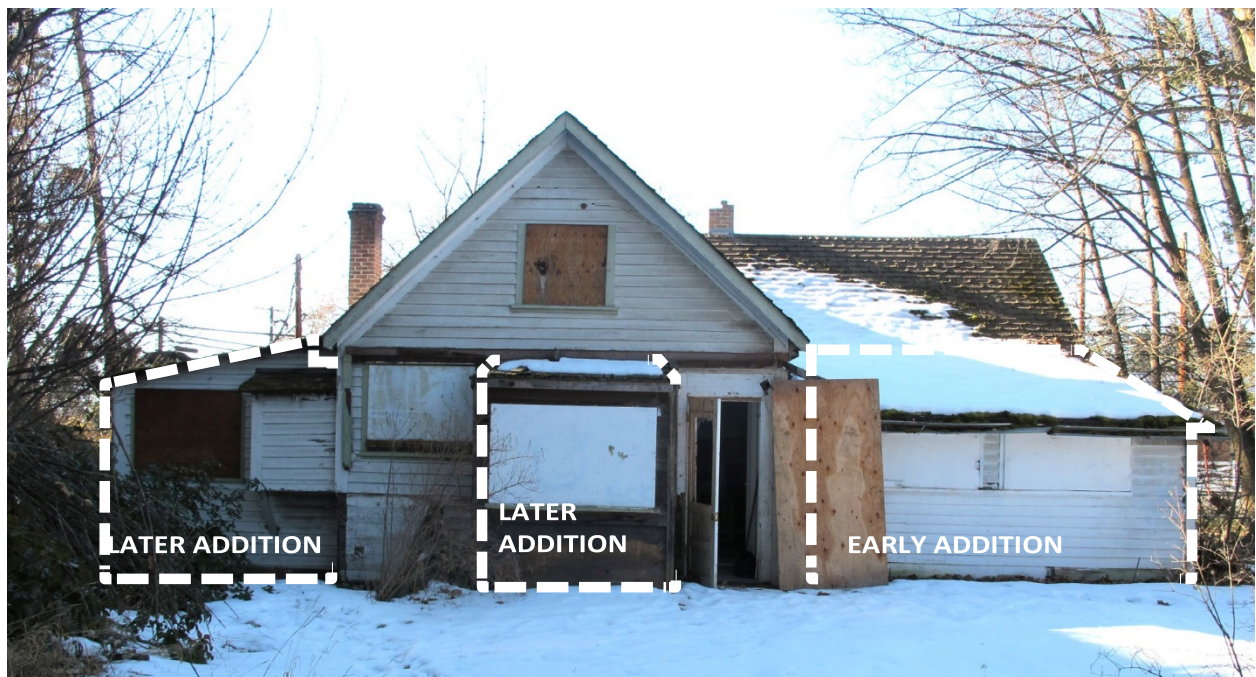
Perspectival view of the Surtees House showing partial east (rear) and north elevations (top); Rear elevation of surtees House to the east (bottom)

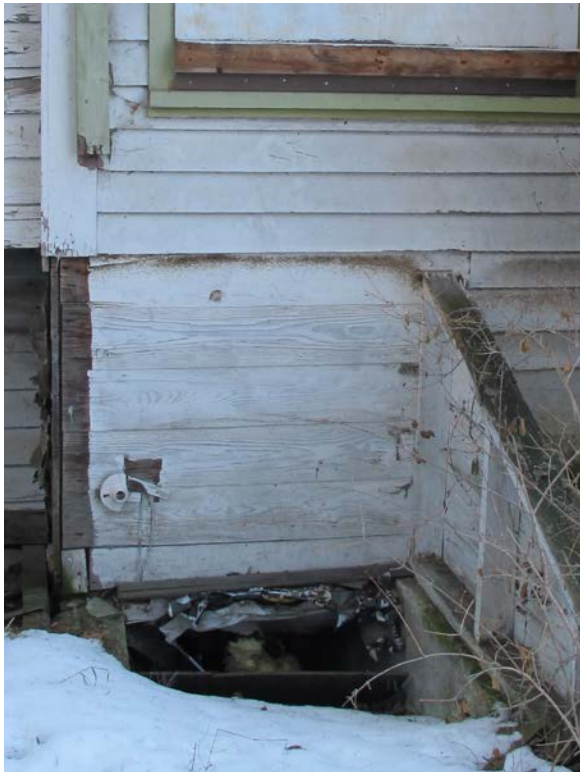
Portion of rear elevation showing opening to unoccupied partial basement, with exposed cast-in-place concrete foundation walls.

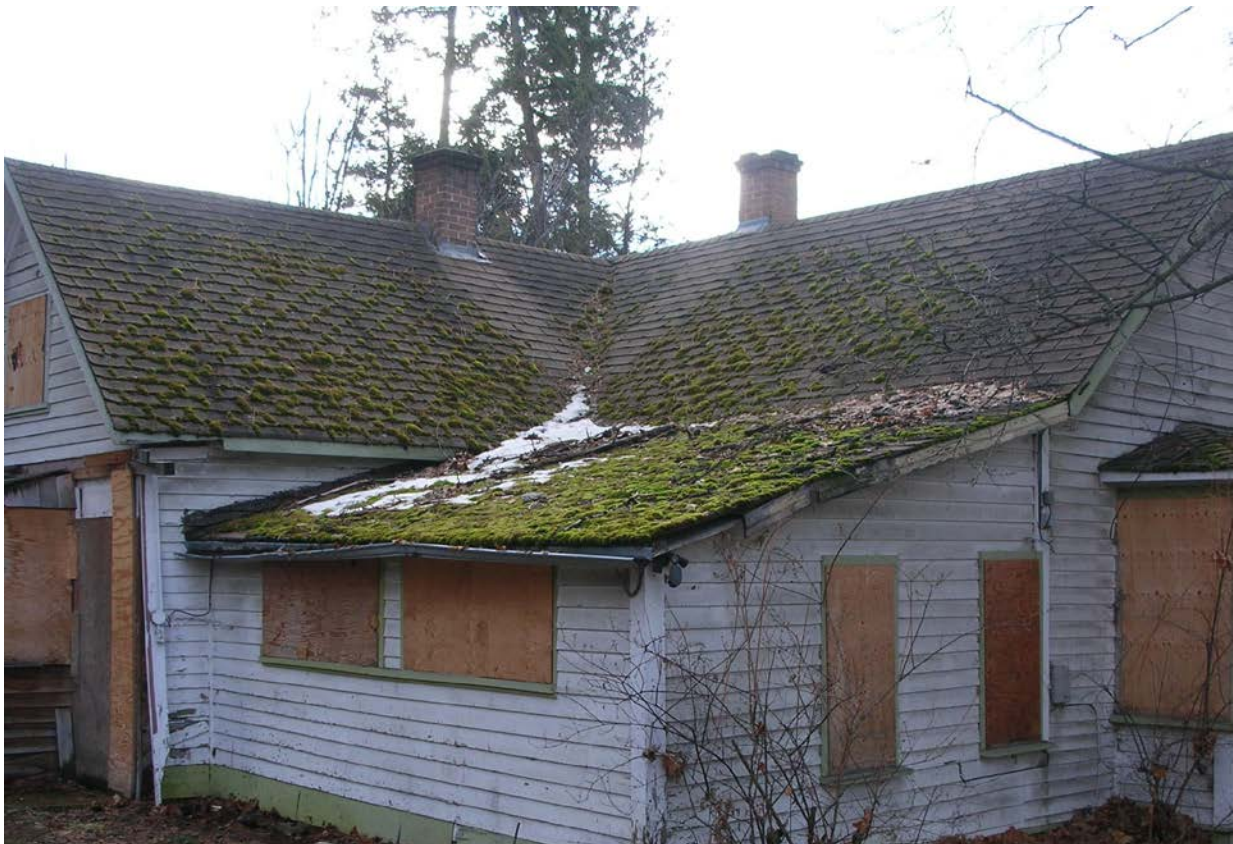
Existing condition of original, primary cross-gabled roof, with shed roof extension of early addition to the northeast portion of the house, as well as two original interior brick masonry chimney stacks along the roof ridges.

Conservation Recommendation: Rehabilitation

- Preserve the roof structure in its current configuration, as expressed by its primary cross-gabled roofstructure.
- If required, roofing membrane and cladding system may be rehabilitated. Cedar shingles are the preferred material, but uroid shingles or Aged Cedar Enviroshingles™ are also acceptable.
- Retain the original bargeboards and fascia boards, as well as the soffit any exposed roof elements.
- Design and install adequate rainwater disposal system and ensure proper drainage from the site is maintained. Wood gutters with galvanized steel downspouts are recommended. Aluminum in appropriate colours is also acceptable. Paint or provide specification of drainage system elements according to colour schedule devised by Heritage Consultant.

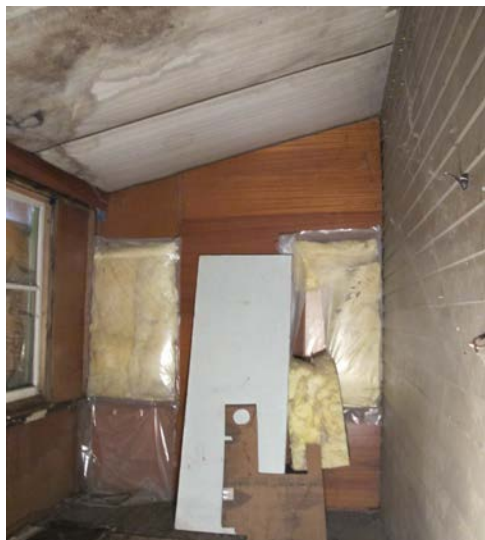
Interior space of the enclosed vestibule (west early addition) showing original exterior horizontal wood lapped siding to the right.

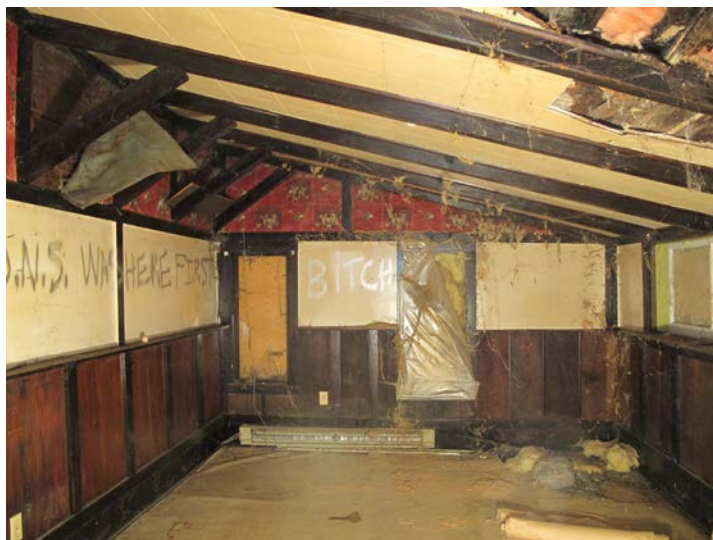
Interior space of the dining room (east early addition) showing exposed shed roof rafters with angle web wood members.

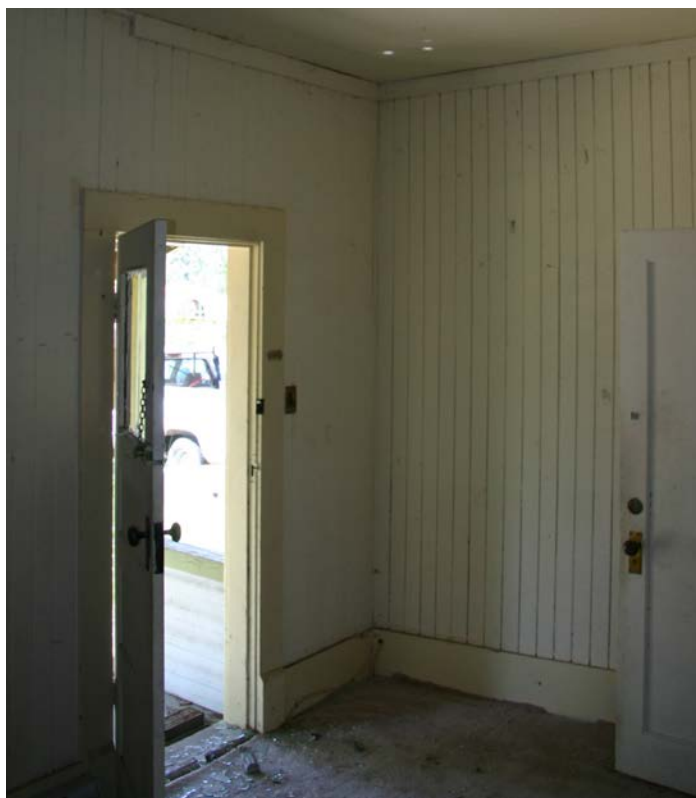
Surviving original v-joint panelling on walls and ceiling of front hall, showing original main entrance door to the left.

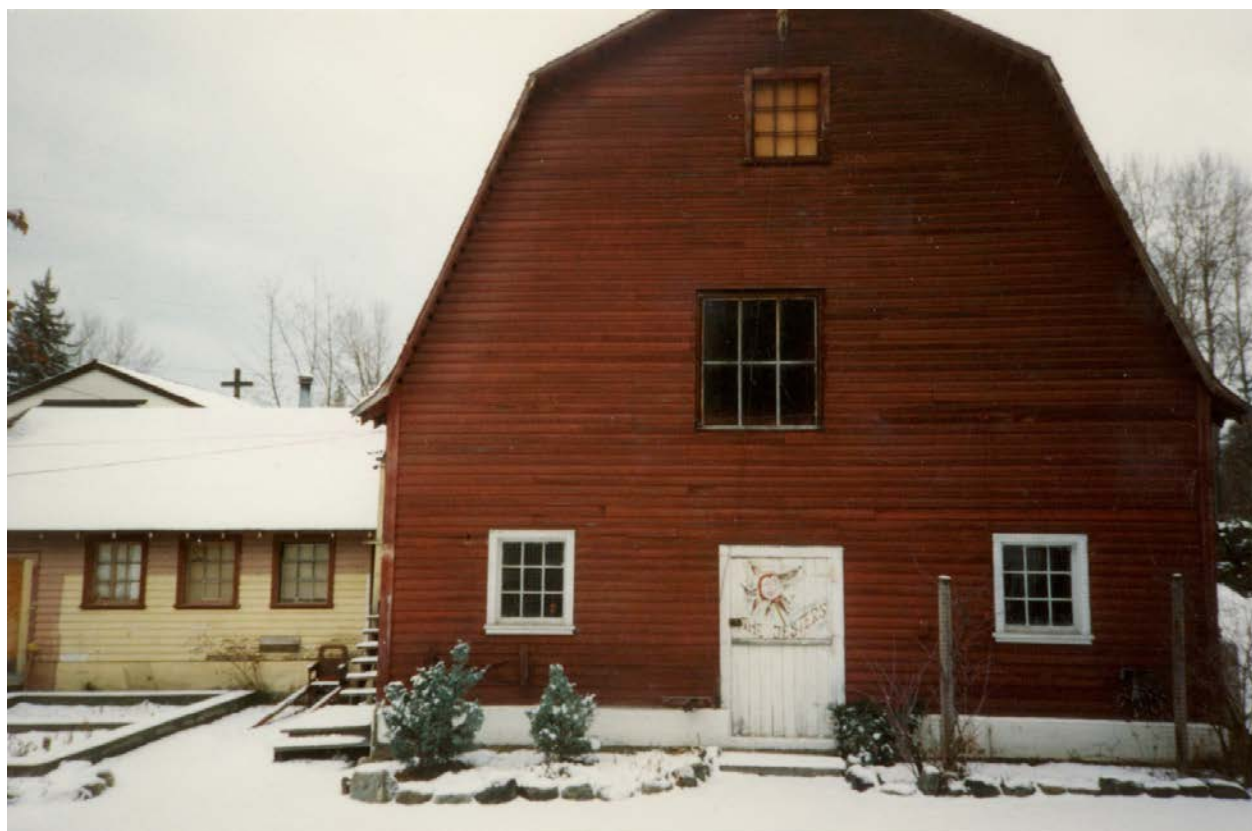
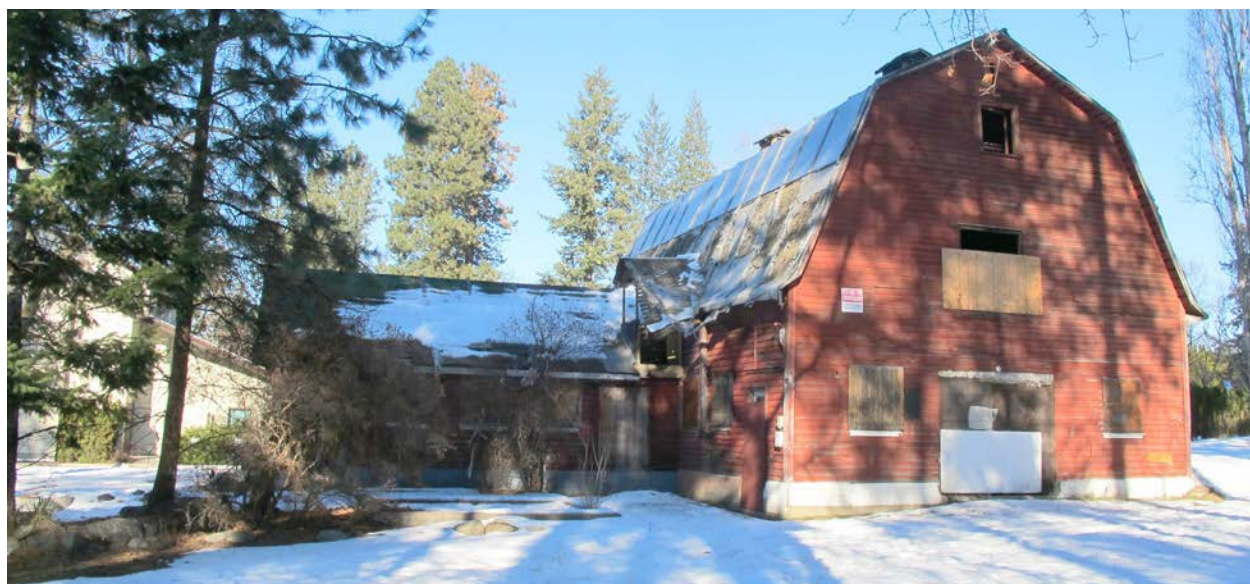
Archival photo showing south elevation of Surtees Barn with cross of church in the background (top; date unknown); photo showing existing condition of Surtees Barn, as viewed from southwest, with St. Andrew's Church in the background.

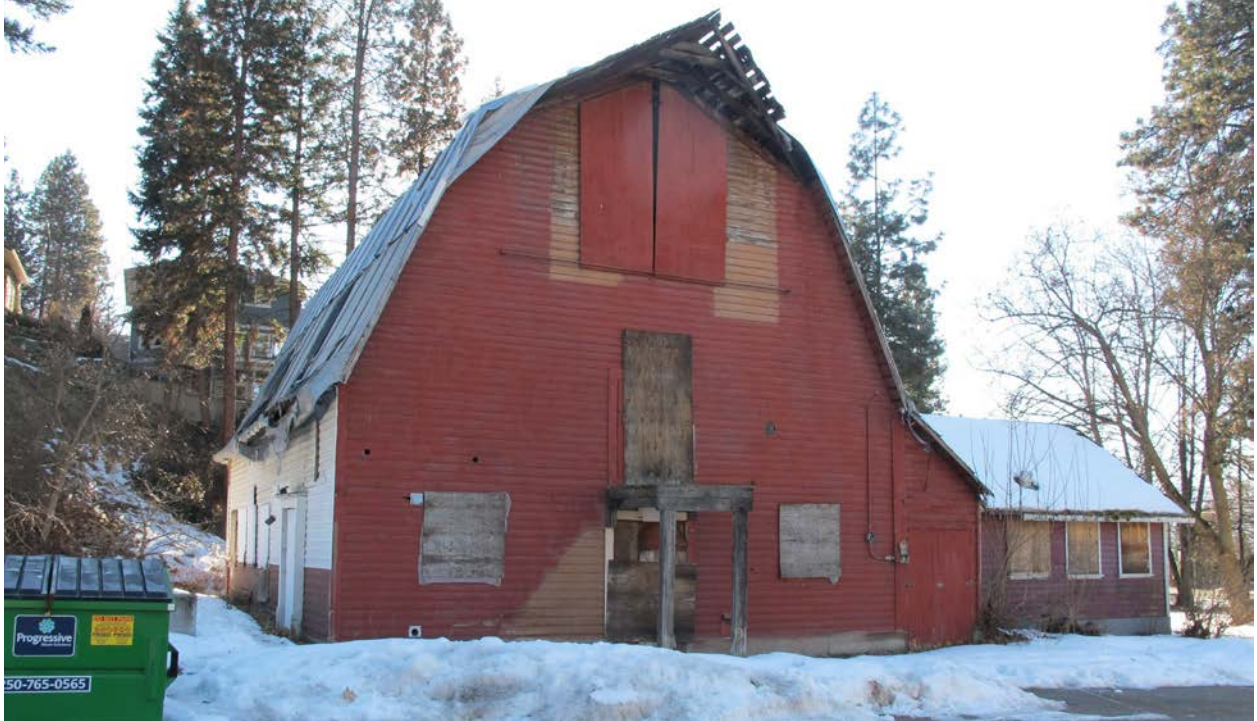
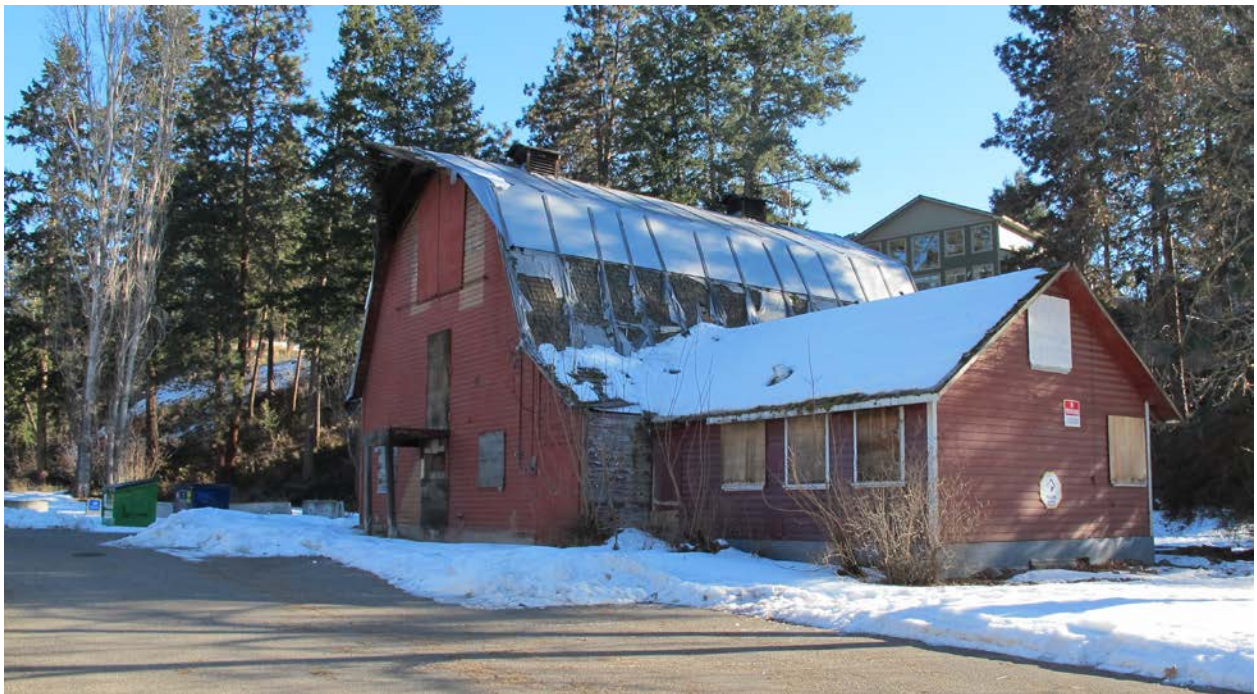
Photos showing north elevation of Surtees Barn, as viewed from northeast (top) and northwest (bottom). Note hill with mature landscape in the background.

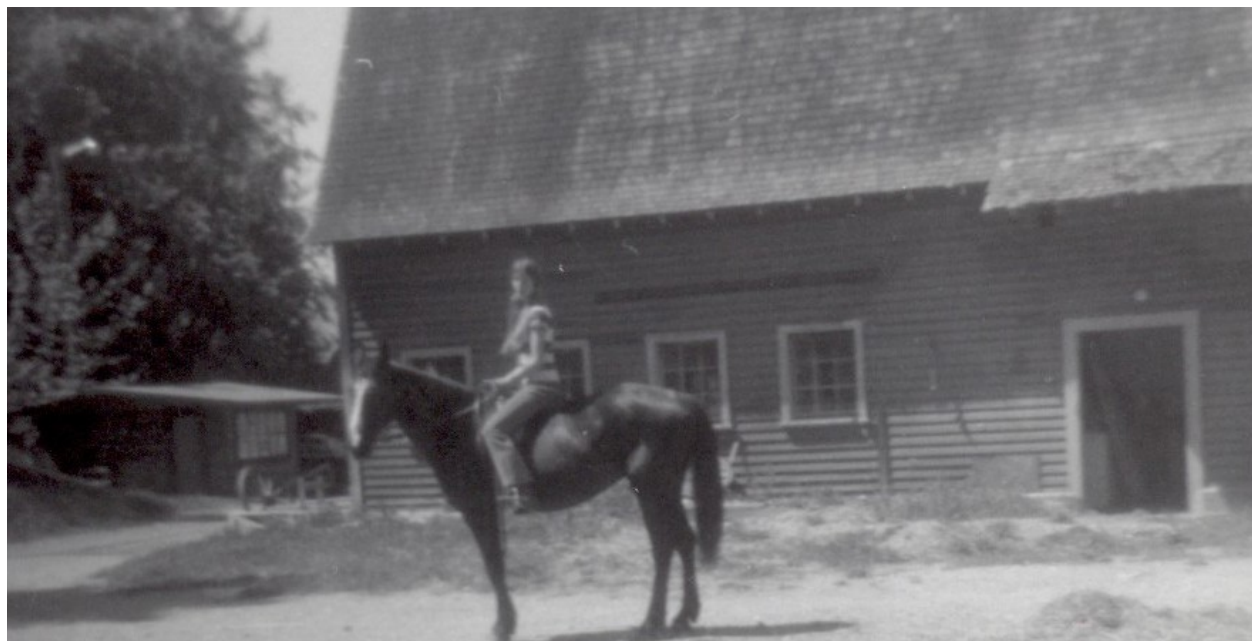
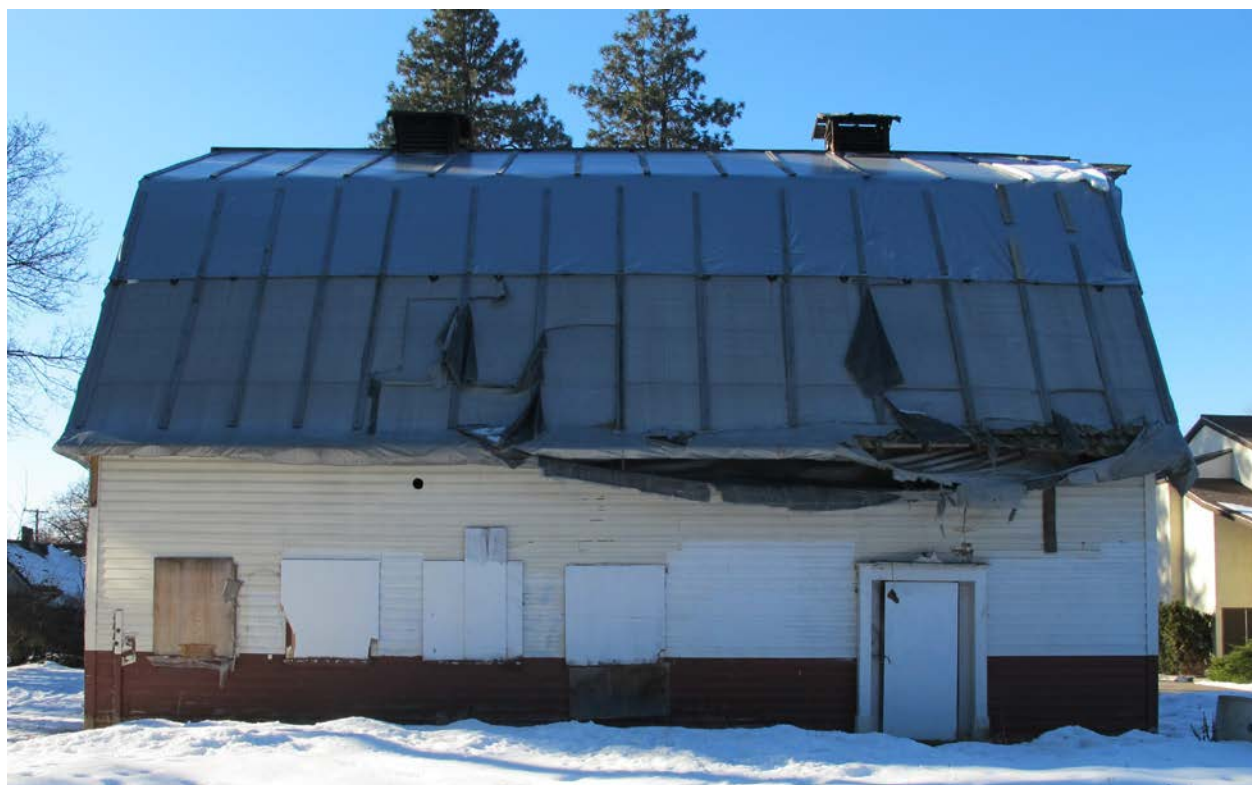
Archival photo showing east elevation of the Surtees Barn (top), with small log house in the background (demolished). Photo showing existing condition of east elevation of the Surtees Barn (bottom); note in the background showing a portion of the Surtees House to the left, and the St. Andrew's Church to the right.

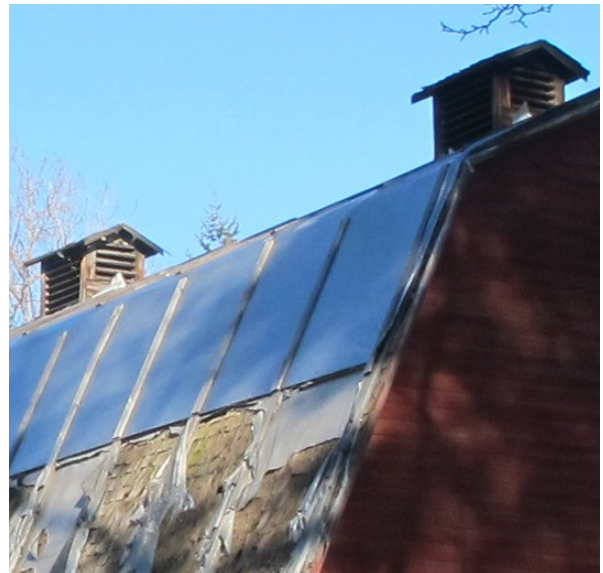
Photo showing typical deteriorated condition of two, existing monitor vents along the roof ridge.

- Preserve the original monitor vents in its original configuration, if possible.
- Original chimneys may require structural stabilization.
- Investigate condition of louvers and siding. If required, they should be repaired and cleaned using gentlest means as possible.
- If the existing monitor vents need to be removed prior to relocation, the existing monitor vents should be carefully documented prior to dismantling. All sound, original materials should be salvaged. Monitor vents should be reinstated above roofline to match original configuration using salvaged original materials as possible, or if necessary, with new materials to match the original. Reconstruction should be discussed with the Heritage Consultant.

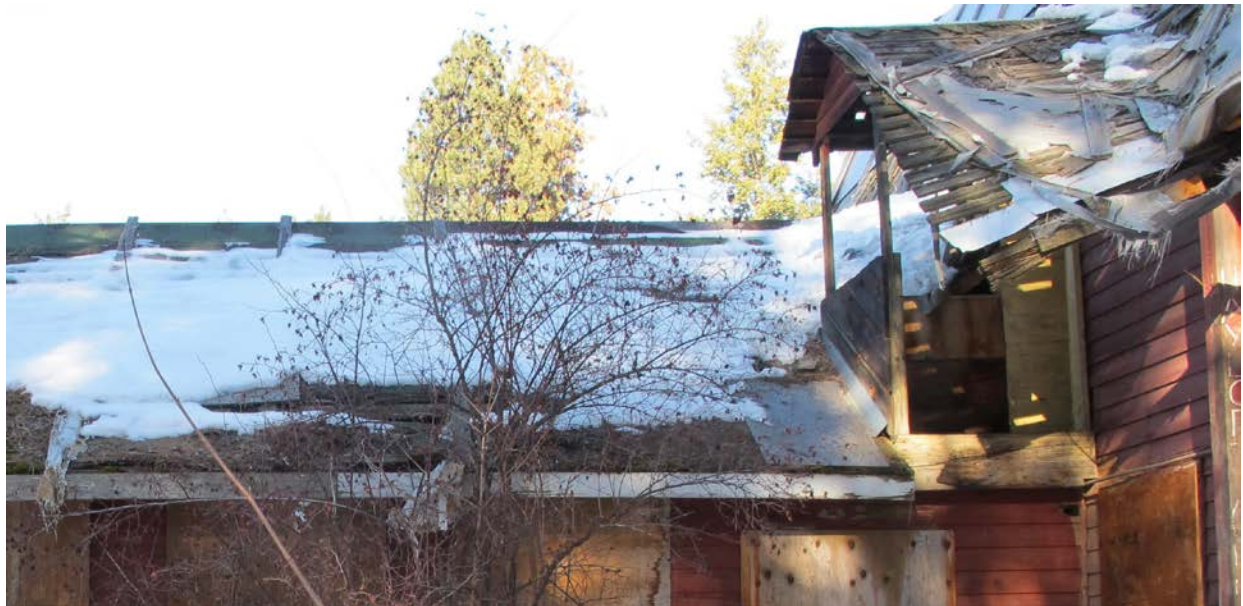
Photos showing side-gabled roof structure of the Surtees Barn extension, from exterior (top) and interior (bottom) side.

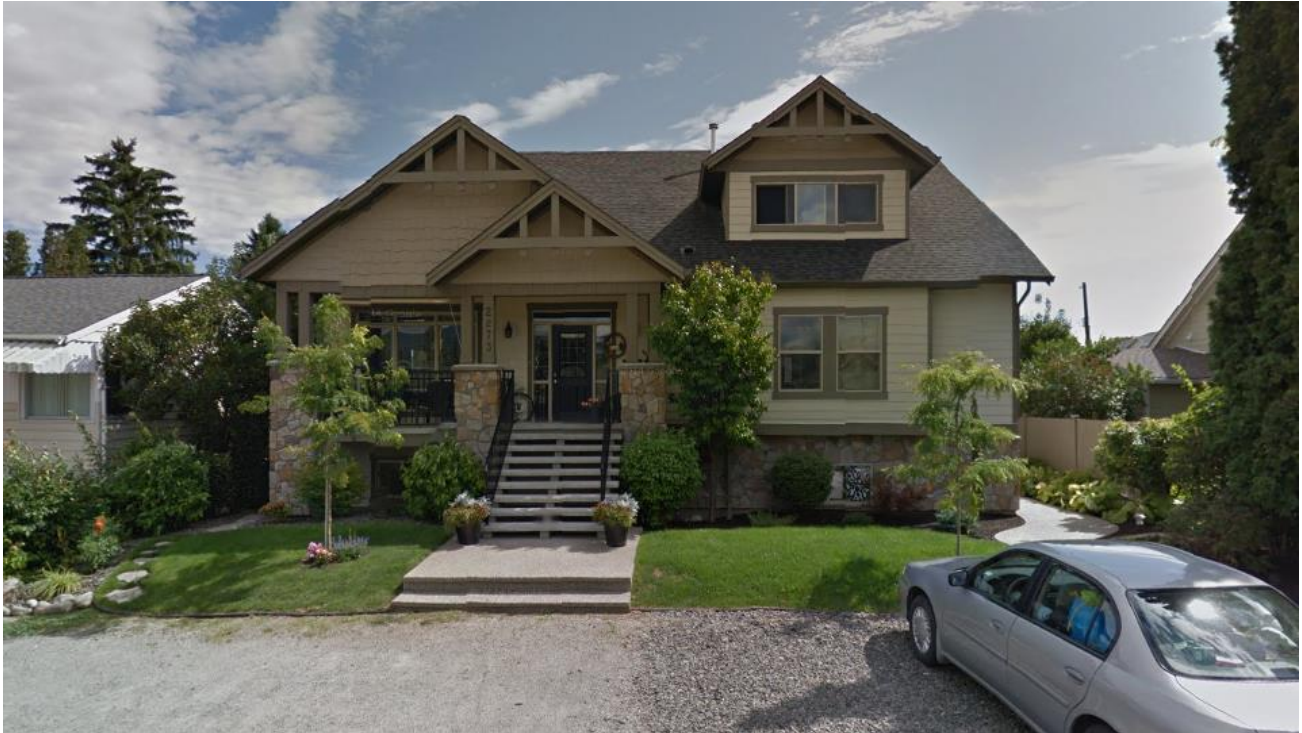
Figure 1: Front Elevation 2273-2275 Aberdeen

The existing duplex and detached accessory building were constructed with a form and character that meets the urban design guidelines in the current Official Community Plan for multiple dwelling housing. The duplex was designed so as to appear as one unit and is asymmetrical in form. The 2.5 storey height minimizes massing, and materials are high quality and durable. The detached accessory building was constructed in the same materials and style of the duplex to create a consistent character.

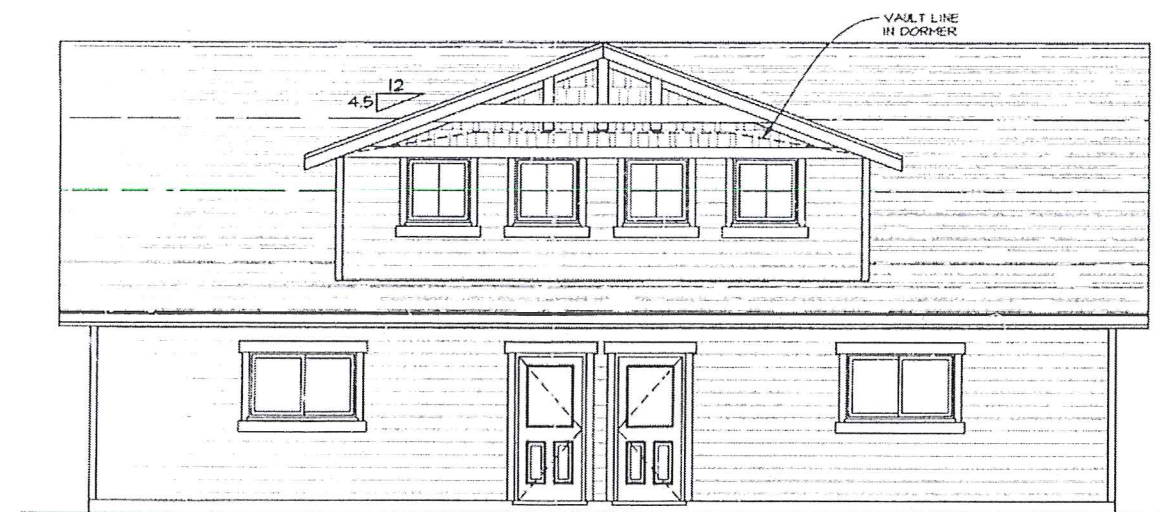
REAR ELEVATION

NOTE:
DROP SLAB TO ALLOW
ADEQUATE CLEARANCE FOR
8'11" O.H. DOOR.
CONFIRM ON SITE.

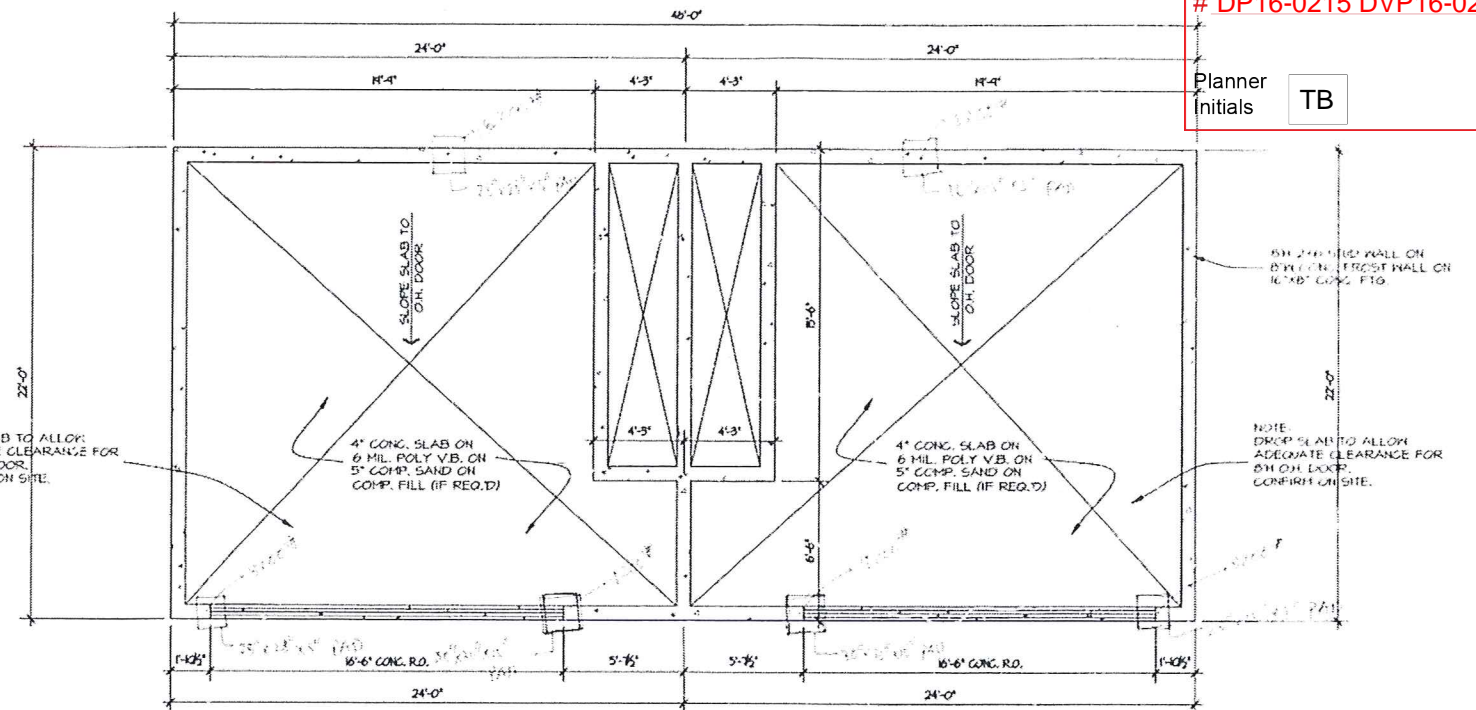
FOUNDATION PLAN

NOTE:
DROP SLAB TO ALLOW
ADEQUATE CLEARANCE FOR
8'11" O.H. DOOR.
CONFIRM ON SITE.

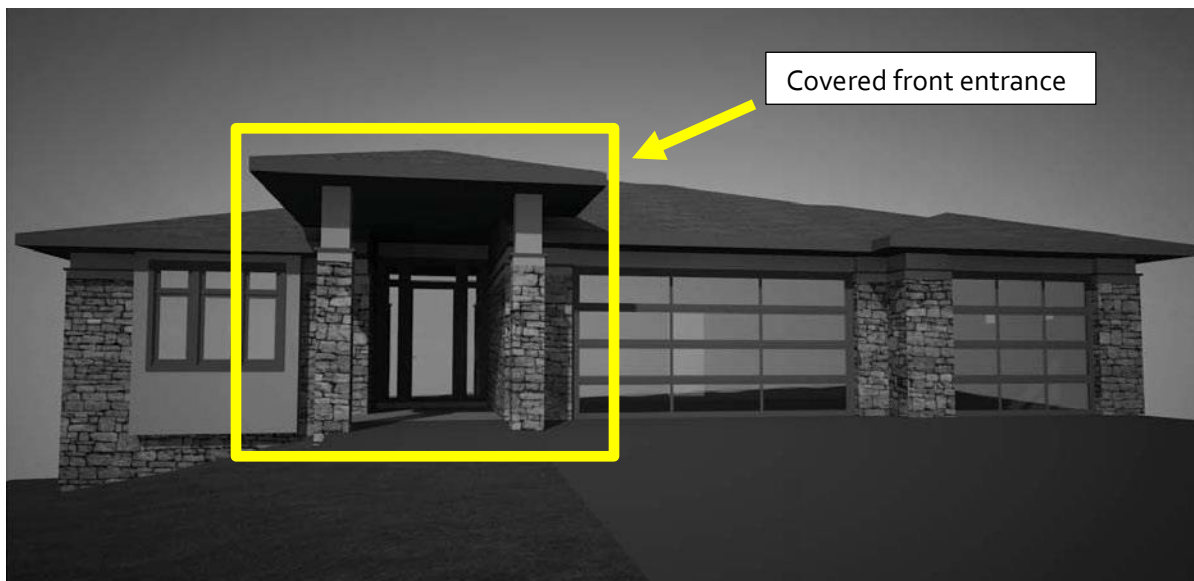
Figure 1. Rendering of front elevation from DP16-0271 application. The covered entrance is indicated by the yellow box.

A Farm Protection Development Permit DP16-0271 for the construction a new single family dwelling was issued by the Community Planning Department on November 30, 2016. Plans submitted with the application that formed Schedules of the Development Permit indicated a front yard setback of 12.19 m to the building foundation and 9.35 m to the covered entrance projection in the front yard.
