365 Rutland Rd - St. Aidan's Church

ST. AIDAN'S CHURCH

HERITAGE IMPACT STATEMENT

DECEMBER 2013

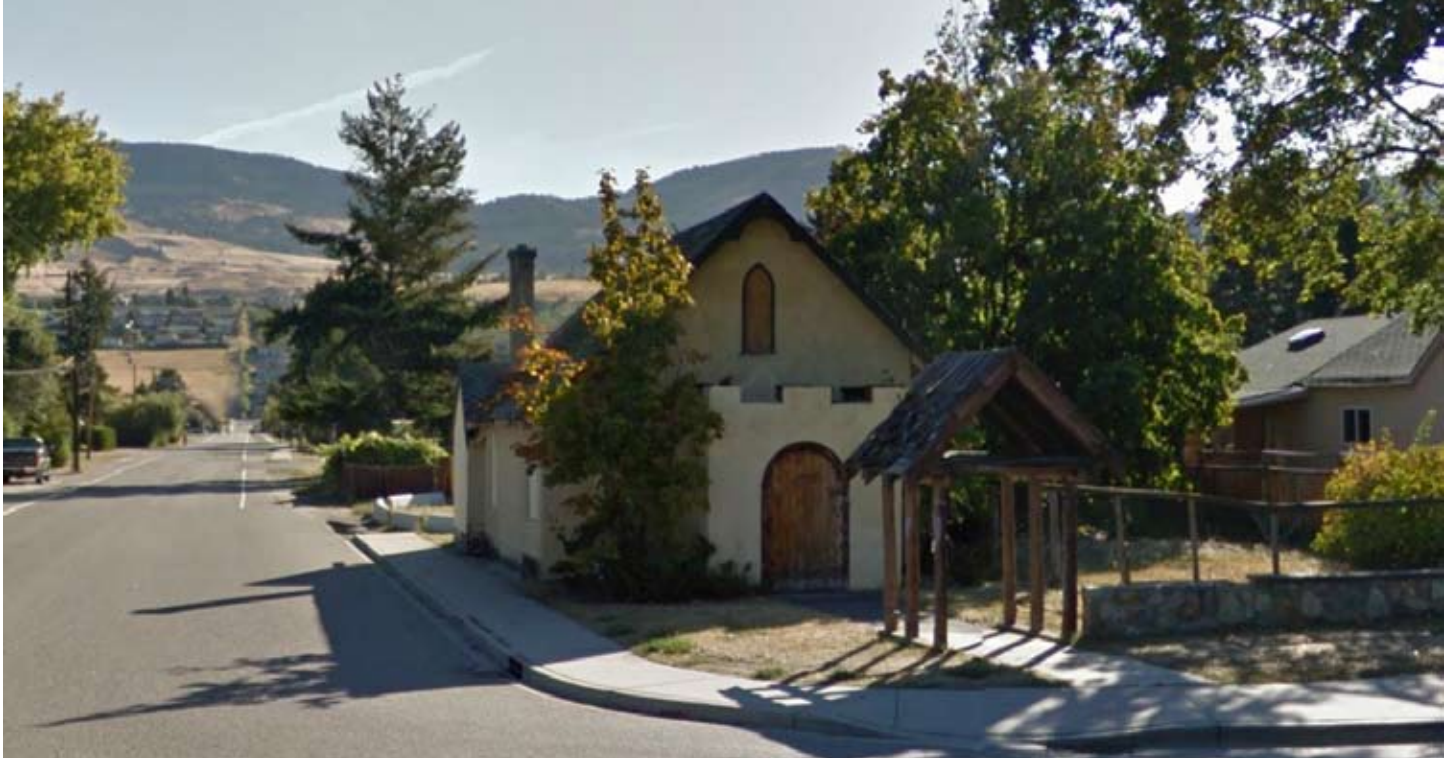
St. Aidan's Church looking east, 2013 (Google Earth)

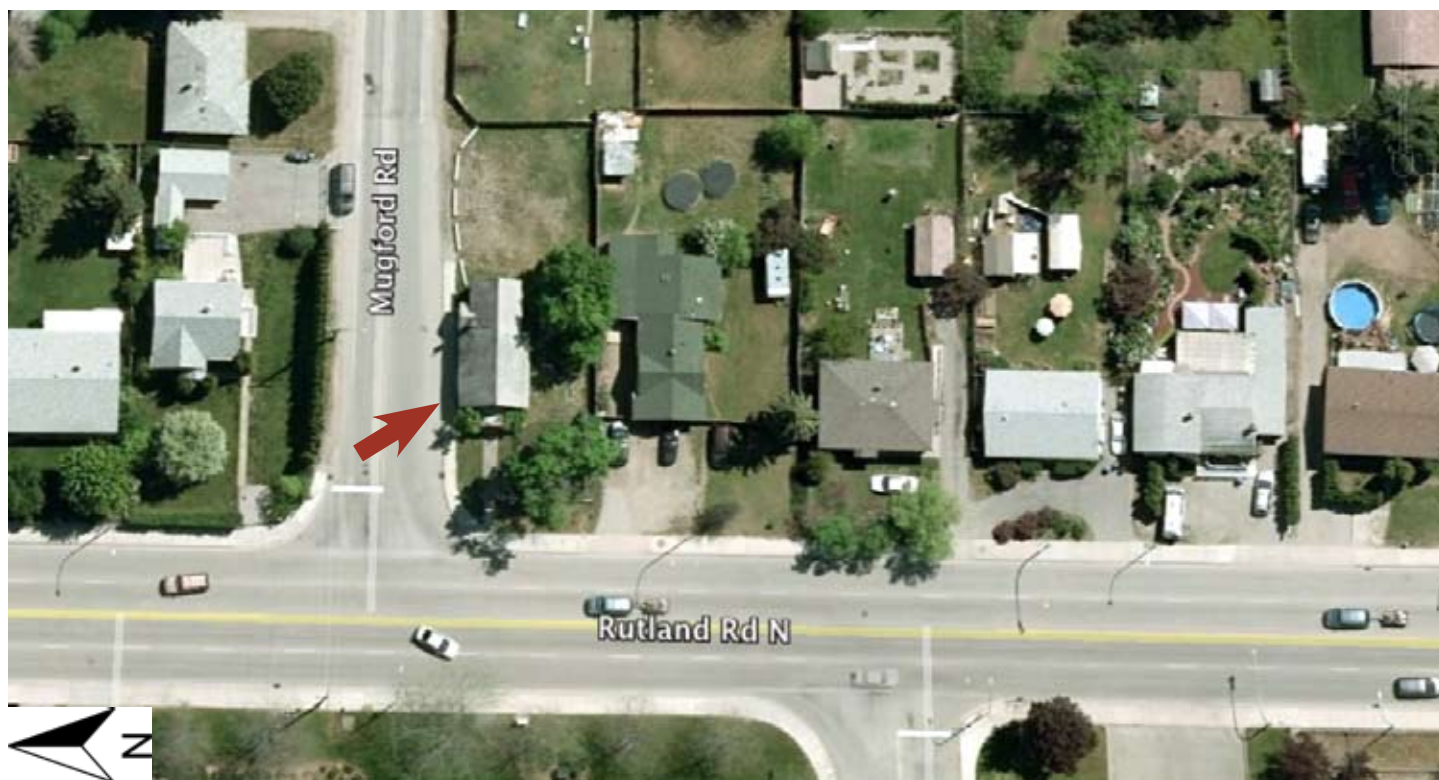
Prominent corner location of St. Aidan's Church in Rutland, 2013 (Google Earth)

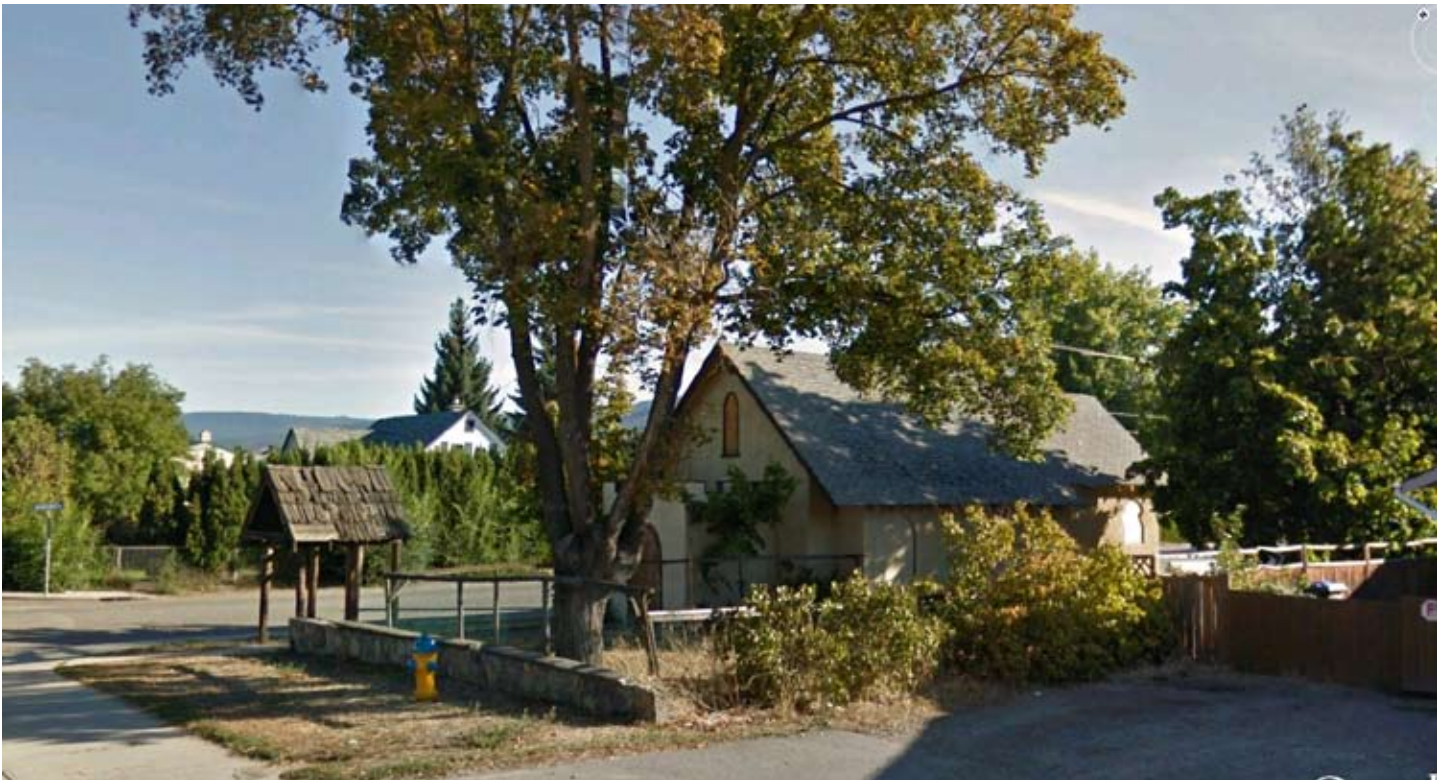
Southwest view of St. Aidan's Church with lych gate and rock wall, 2013 (Google Earth)

Historic landscape features that are still extant including the wooden lych gate and a rock wall on the west perimeter will be dismantled and relocated as part of the proposed rehabilitation of the historic site.

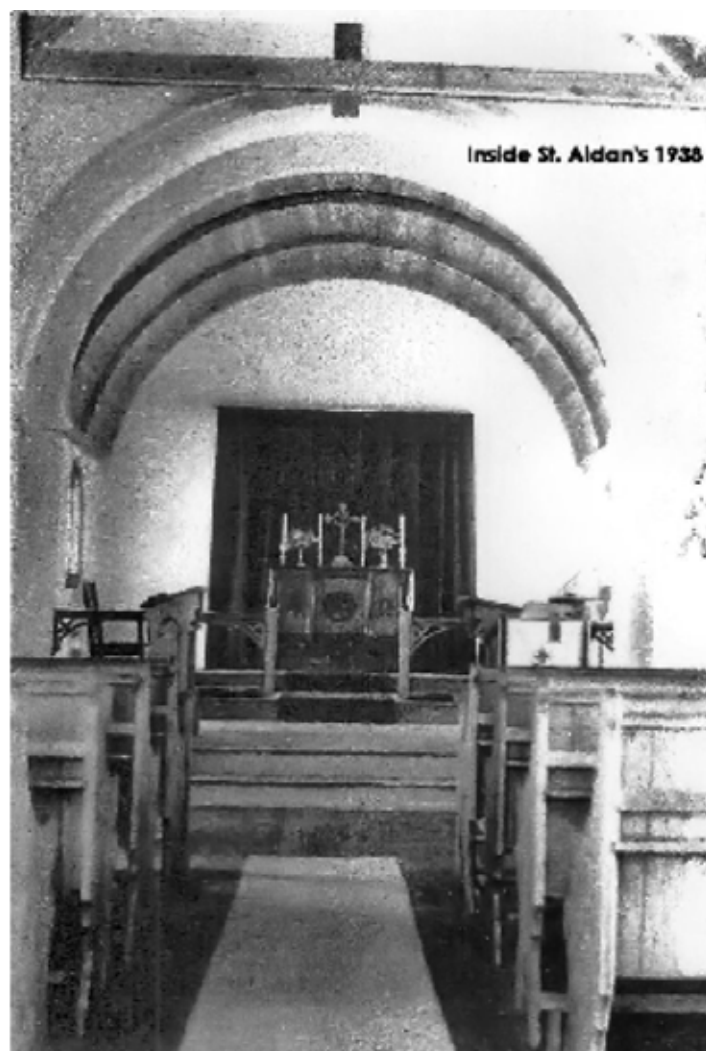
Interior view with Norman arch , 1938 (courtesy: City of Kelowna)

- The Norman arch will be retained.
- Information if other interior features (fir floors, baseboards, lath-and-plaster walls, barrel-vaulted ceiling) will be retained is not available.

- The permanent retention of the Norman arch as a character-defining element is beneficial.
- It is assumed that other listed interior features, in particular the barrel-vaulted ceiling, will be retained and restored where possible.
- Structural/seismic and services (MEP) upgrades may have potentially low to high visual and permanent impacts on the interior finishes. Any alterations will also be difficult to reverse in the future. However, upgrades are required to rehabilitate and re-use the vacant structure, which is strongly desired in order to extend the lifespan of the historic church.

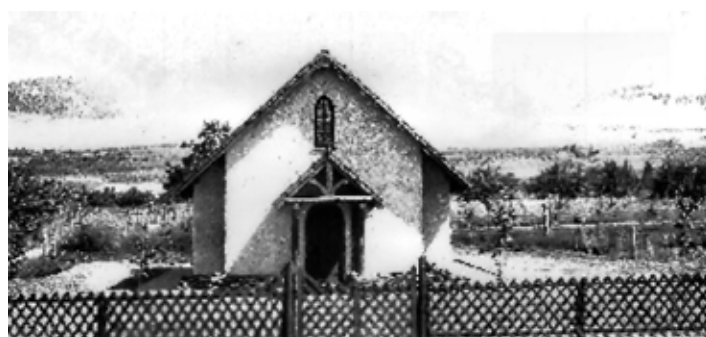
West elevation, 1933 (courtesy: City of Kelowna)

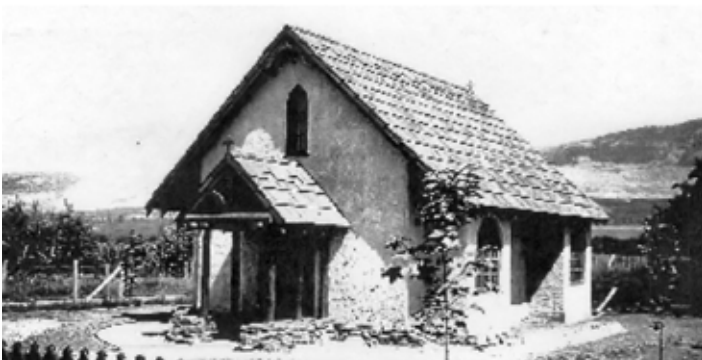
Southwest elevations, 1933 (courtesy: City of Kelowna)

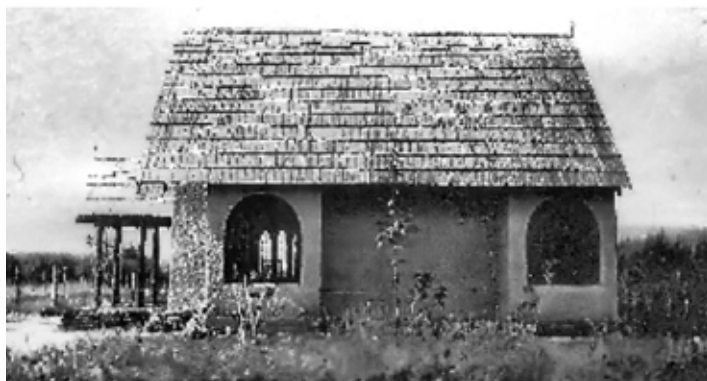
South elevation with original wooden porch, 1933 (courtesy: City of Kelowna)

In 1958, the original wooden entrance porch attached to the west façade was relocated to the front of the lot and repurposed as a lych gate while an enclosed front vestibule was constructed. In 1990, the historic church was deconsecrated and purchased by the City of Kelowna. The structure is not occupied and exterior openings are boarded up. The historic church is situated in the right of way and cannot be preserved in its original location.

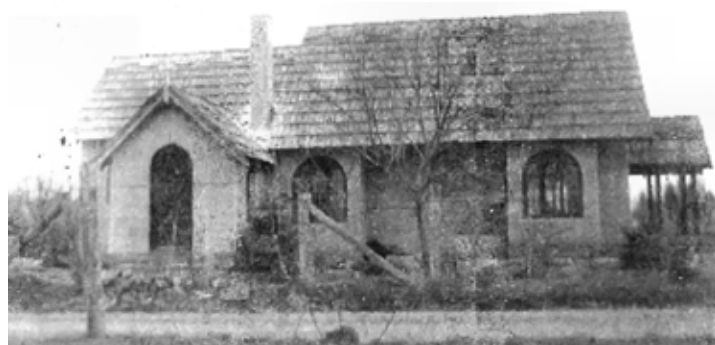
North elevation with chimney and vestry, 1938 (courtesy: City of Kelowna)

- The internal stucco-clad chimney will be retained as a character-defining element.

- The chimney should be relocated with the structure if possible and not deconstructed and rebuilt.
- The chimney can be decommissioned if desired while the exterior stack rising above the roof should be preserved and repaired as required.
- Structural restraints of the chimney may be required and should be designed to minimise the visual impact when viewed from the street.

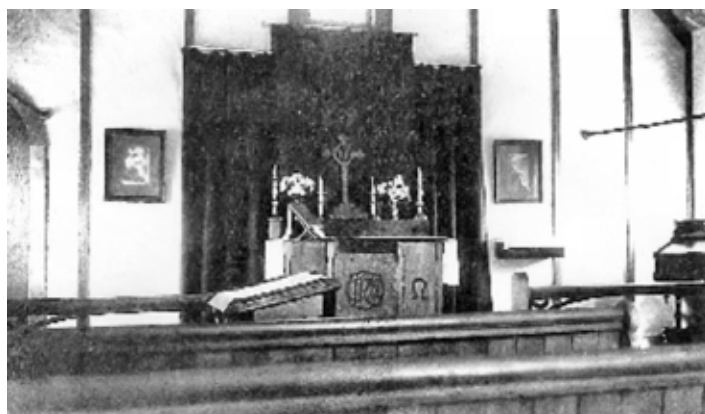
View of altar, 1933 (courtesy: City of Kelowna)

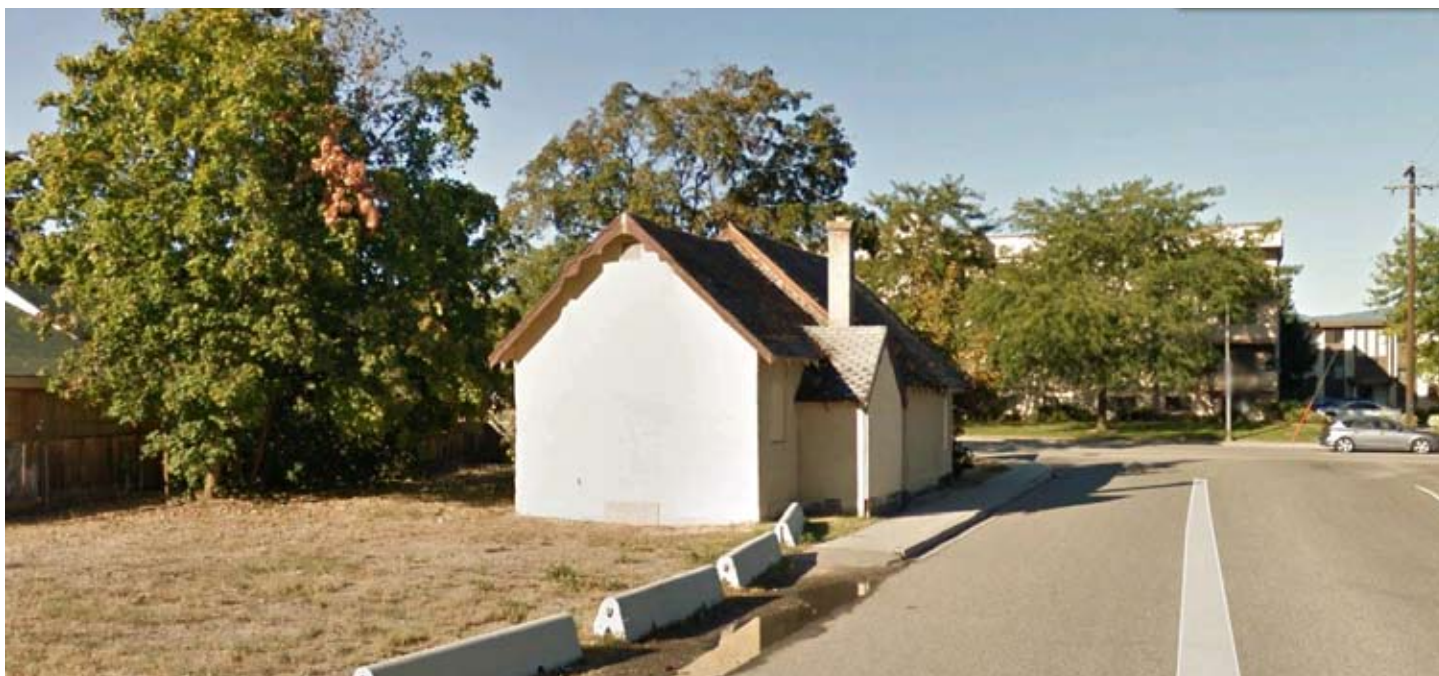
View of northeast elevations, 2013 (Google Earth)
