Geotechnical Investigation 2045 Loseth Road

January 24, 2019
File No. 018-253

Westrek Geotechnical Services Ltd. (Westrek) investigated several slope instabilities developing adjacent to the pump station along Loseth Road, near the corner with Sunrise Road, in Kelowna, BC. The purpose of the investigation was to assess slope stability, estimate the probability of a landslide and potential runout, and recommend methods to stabilize the slope.

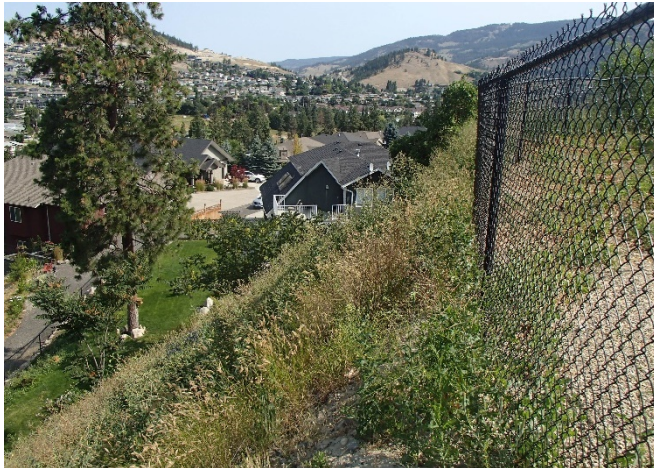
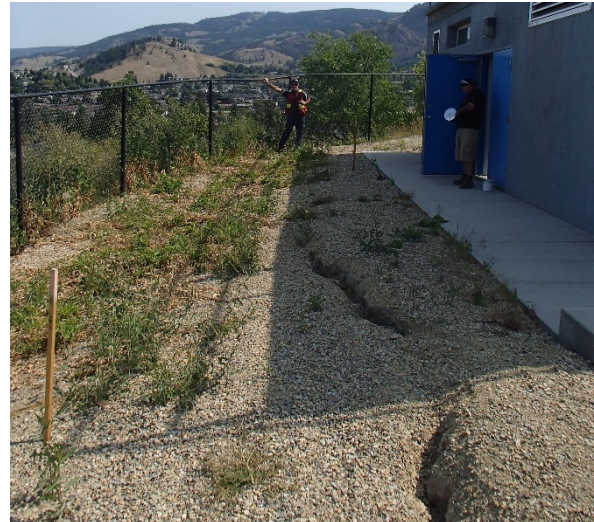
Loseth Road climbs across the hill to the southwest while the hillslope has a northwesterly aspect. A pre-existing gully bisects the site and was completely filled in both at the pump station site and the upslope residential development. The pump station is constructed of reinforced concrete, built into a filled platform on the northwest side of the road. The asphalt paved access and the roof of the pump station are close to road grade while the filled platform steps 3 m down the slope to where the base of the pump station fully daylights (Photo 2).

Photos 1 & 2: Gravel area and slope behind the pump station.

Tension cracks have formed in the gravel-surfaced platform at the rear of the pump station (Photo 2). The tension cracks are 2 to 3 m from the slope crest and 15 cm wide, with 10 to 15 cm of vertical displacement. The slope movement is also evident by bending of the top pole in the chain-link fence around the pump house compound and displacement between fence posts.

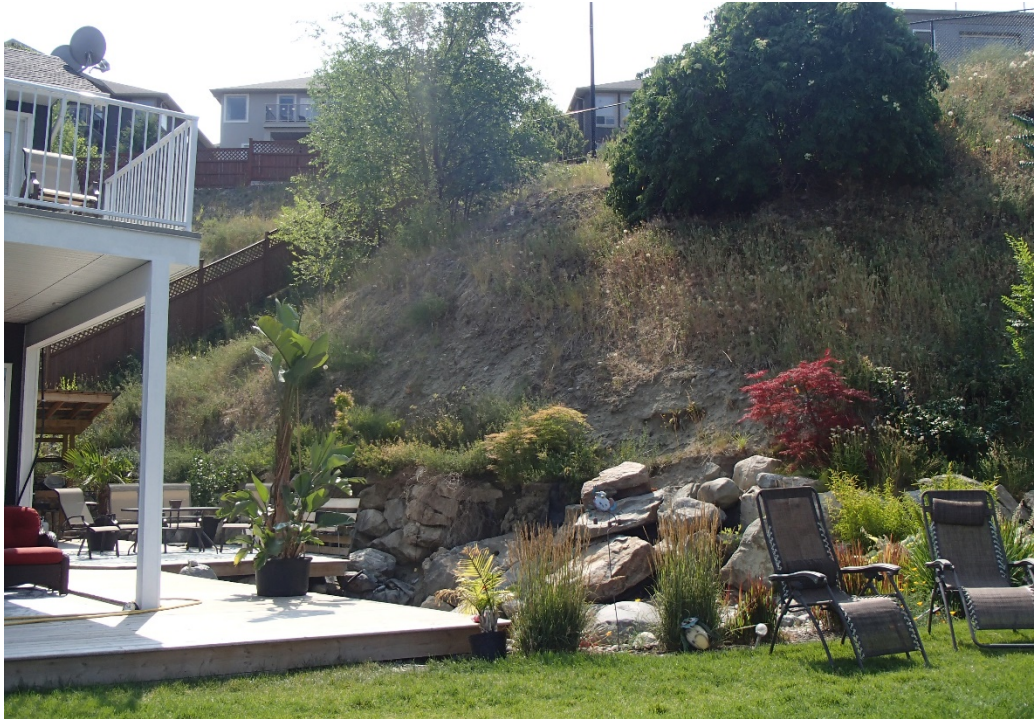
The northerly slope (Figure 3, Cross-section C-C') descends 13 m into the backyard of 2001 Kloppenburg Court with an overall slope of 80 to 90% (39 to 42°). The toe of the slope was excavated in 2015 to install a pond. The lower 5 m was excavated steeper than 50° and supported by a single row of stacked boulders that have since failed (Photos 3 & 4). The City did not issue a building permit for this boulder-stack wall, and the wall thickness indicates that it was not engineered.

Photo 3: The toe of the slope at 2001 Kloppenburg Court.

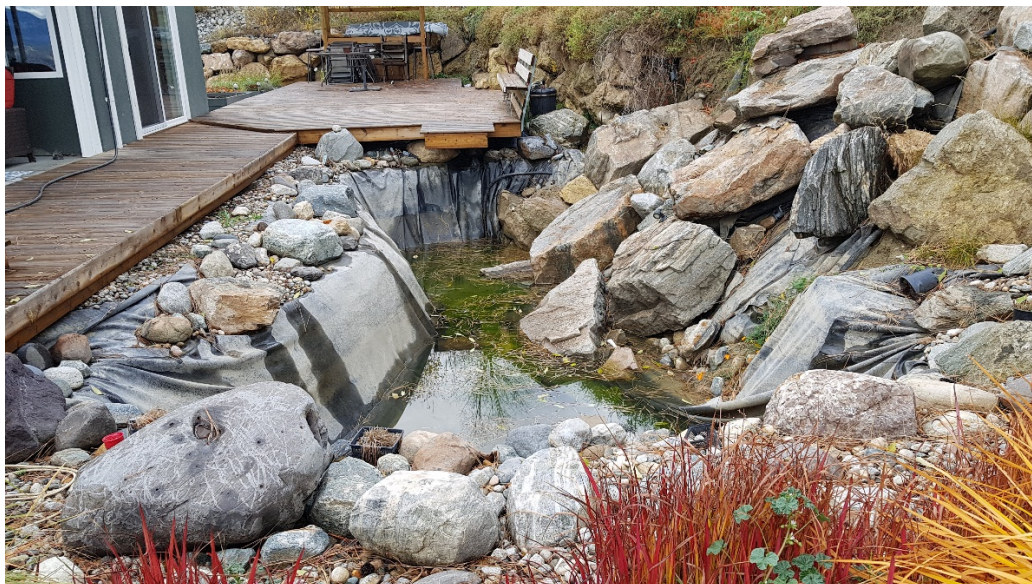
Photo 4: Setback of the house from the slope and failure of the boulder-stack wall.

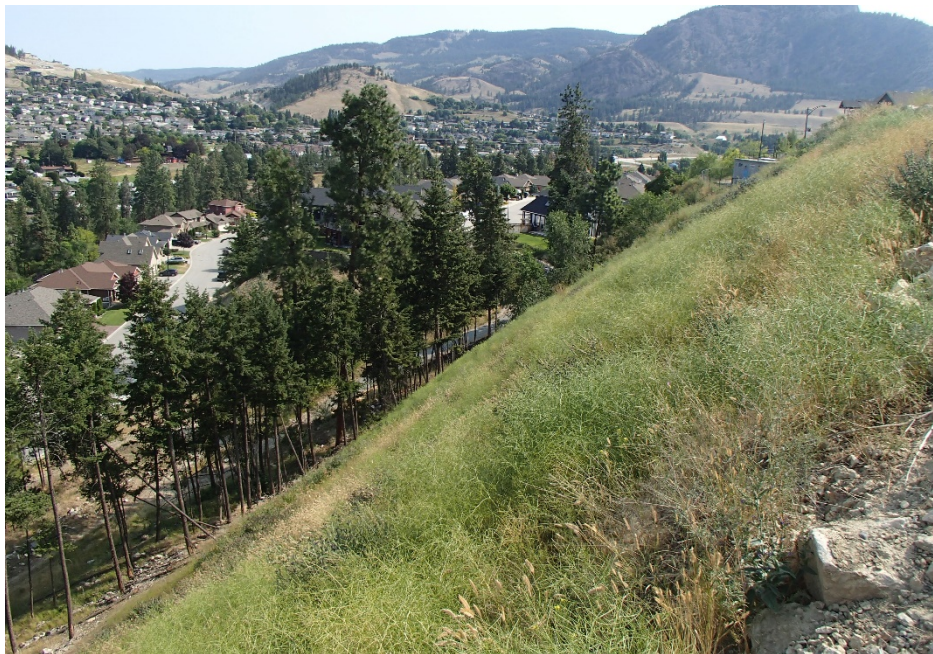
Here, the ground area has been obviously filled out, creating an over-steepened slope more than 20 m high or 30 m long. The overall slope angle is 80 to 85% (39 to 40°) but the lower 20 m slopes at close to 100% (45°) (Figure 4, Cross-section D-D'). Several wide tension cracks are located at various elevations, and the lower half of the slope is bulged, indicating slope movement.

The toe of the slope flattens to between 30 and 50% leading down to Kloppenburg Road. The area is undeveloped at this time and sparsely forested with conifer trees. The trees along the toe of the slope are more densely spaced, with some fill partially burying the base of the trunks.

*Photo 5: Slope at 2045
Loseth Road.*

The slope at the north end of 2045 Loseth Road has several, extensive tension cracks and a large toe bulge, indicating that movement has been occurring for several years. As such, the over-steepened slope, poor soil conditions, and seasonal rise in groundwater levels may fully account for the movement on this slope.

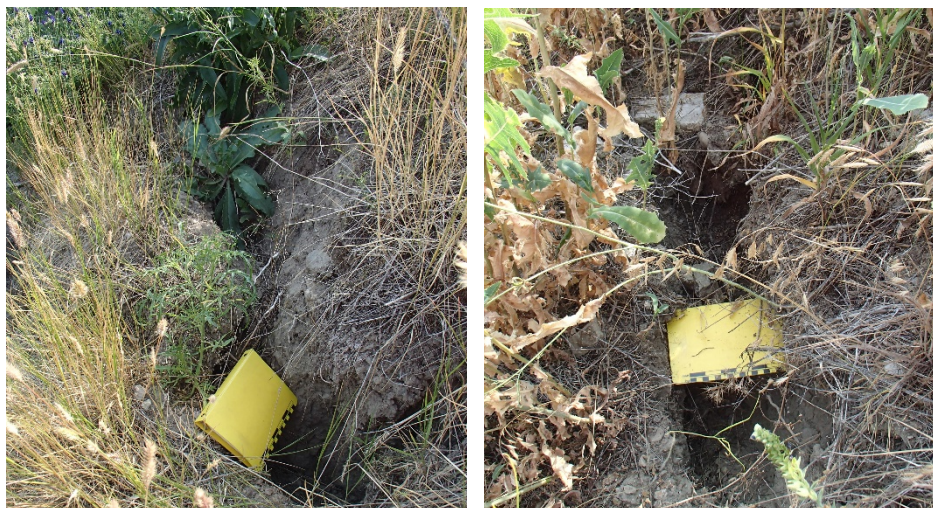
*Photos 6 & 7: Open tension
cracks on slope.*

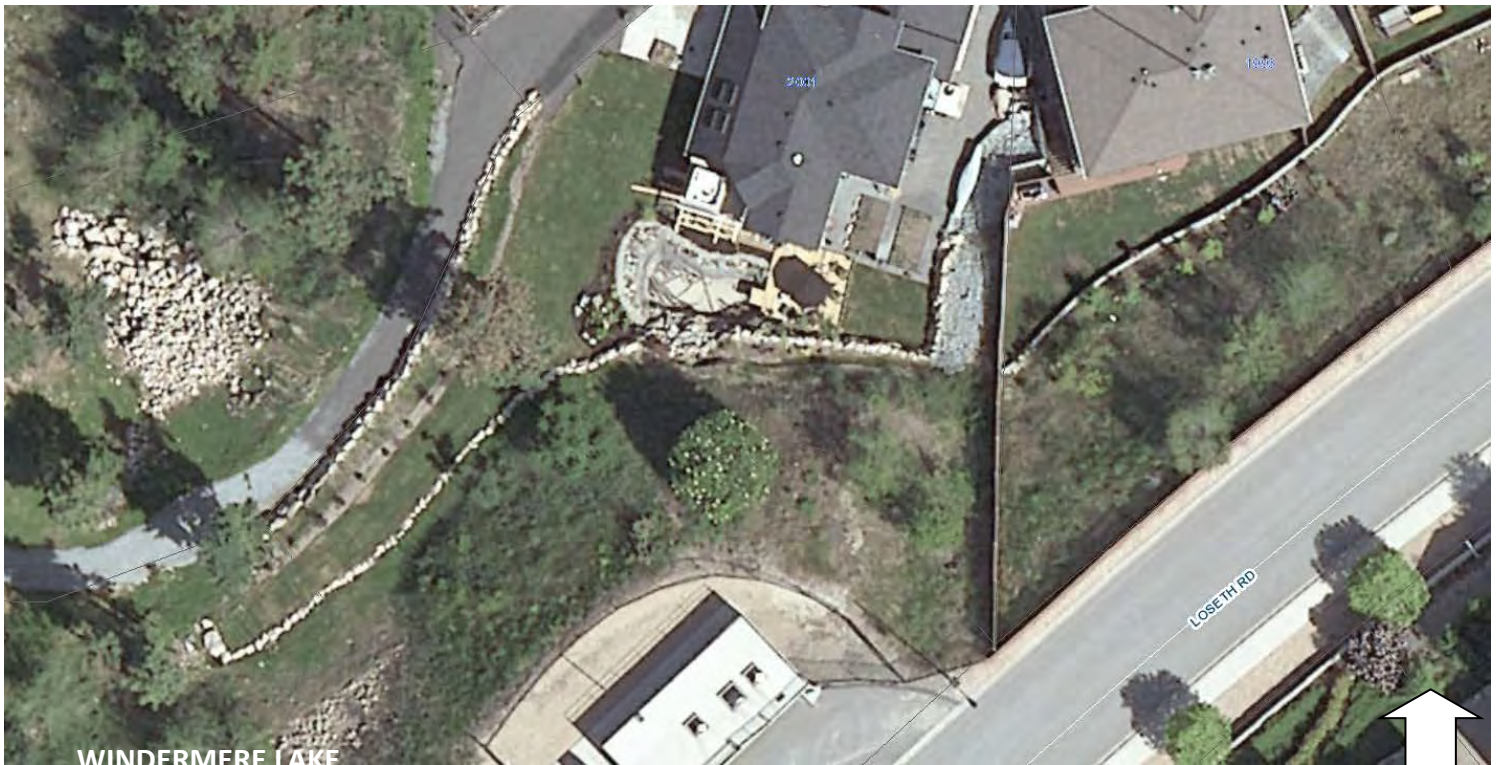
2015 satellite image of slope below the pump station.

- Based on the City of Kelowna aerial photographs, the bench along the toe of the slope between the 2001 Kloppenburg Court residence and the pump station was removed and replaced with a stacked rock wall between 2012 and 2015 (iKelowna Map Viewer) (Figure 5). No additional information regarding this construction was provided to us.
