Initial Report Regarding Soils and Fill Placed at 3850 Swamp Road

Owner: Kevin Schmidt

March 12, 2021

Inspection of Soil Fill
3850 Swamp Road, Kelowna, BC

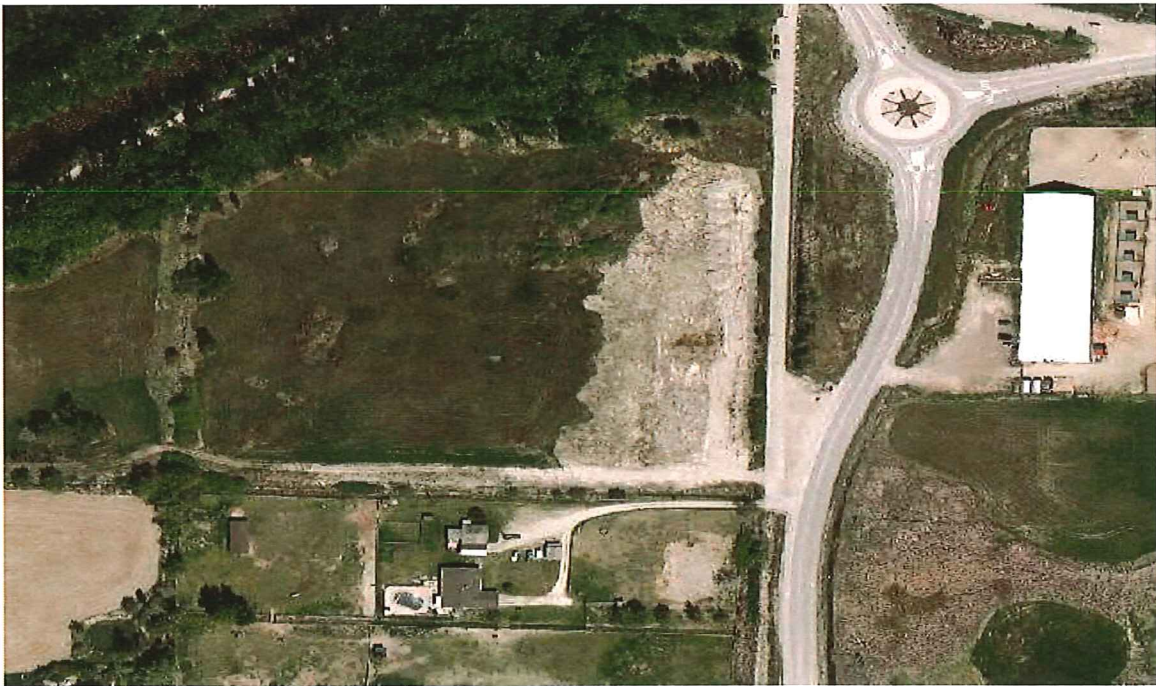
It is worth noting that during this historical review, of the property that the fill currently placed without permission on the property is not the first fill to be placed on the property. Ortho image and Google Earth images reviews have confirmed that fill material from the development of the traffic circle and Swamp road drainage improvements have been placed on the property as early as 2009 and possibly earlier. (Refer to photo 1 below)

Photo 1: City of Kelowna ortho image dated 2012 showing fill placed on site after development of traffic circle and Swamp road drainage improvement.
