Heritage Advisory Committee

AGENDA

SURTEES HOUSE & BARN

4629 LAKESHORE ROAD, KELOWNA, BC

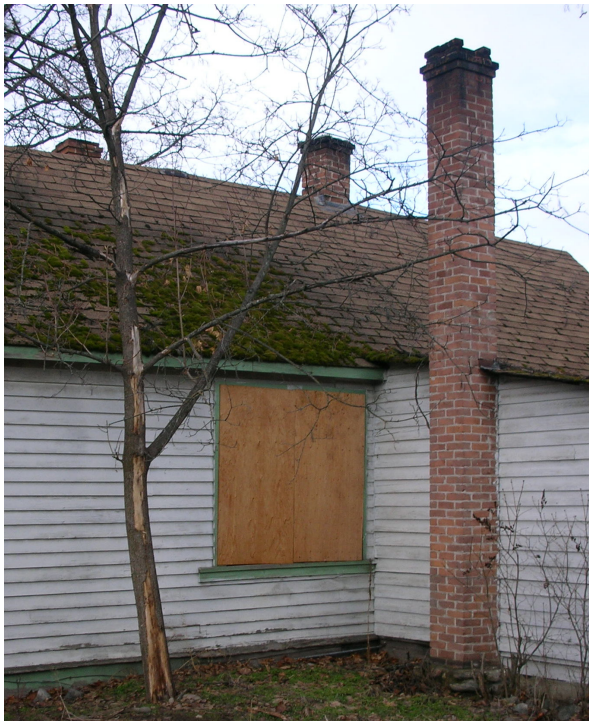
Southwest corner view of the house showing later addition, with exterior brick chimney in the foreground, and two original interior chimney stacks in the background.

- Preserve the roof structure in its current configuration, as expressed by its primary cross-gabled roof structure.
- If required, roofing membrane and cladding system may be rehabilitated. Cedar shingles are the preferred material, but uroid shingles or Aged Cedar Enviroshingles™ are also acceptable.
- Retain the original bargeboards and fascia boards, as well as the soffit any exposed roof elements.
- Design and install adequate rainwater disposal system and ensure proper drainage from the site is maintained. Wood gutters with galvanized steel downspouts are recommended. Aluminum in appropriate colours is also acceptable. Paint or provide specification of drainage system elements according to colour schedule devised by Heritage Consultant.

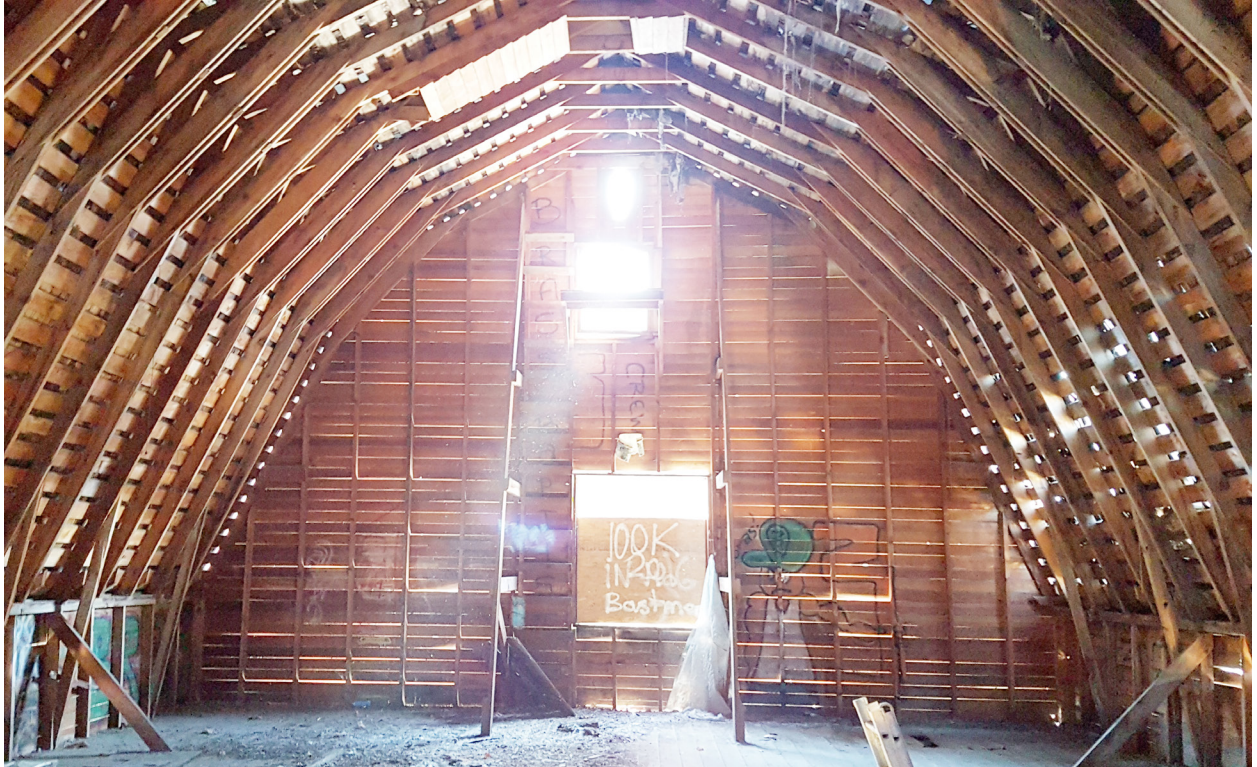
In general, the roof cladding appears to be in poor condition. The temporary roof protection is heavily damaged, which may result to further water penetration and unwanted access to pests.

Photos showing exposed gambrel roof structure of the Surtees Barn.

Conservation Recommendation: Rehabilitation

- Preserve the roof structure in its current configuration, as expressed by its primary cross-gabled roof structure.
- If required, roofing membrane and cladding system may be rehabilitated. Cedar shingles are the preferred material, but Duroid shingles or Aged Cedar Enviroshingles™ are also acceptable.
- Retain the original bargeboards and fascia boards, as well as the soffit any exposed roof elements.
- Design and install adequate rainwater disposal system and ensure proper drainage from the site is maintained. Wood gutters with galvanized steel downspouts are recommended. Aluminum in appropriate colours is also acceptable. Paint or provide specification of drainage system elements according to colour schedule devised by Heritage Consultant.

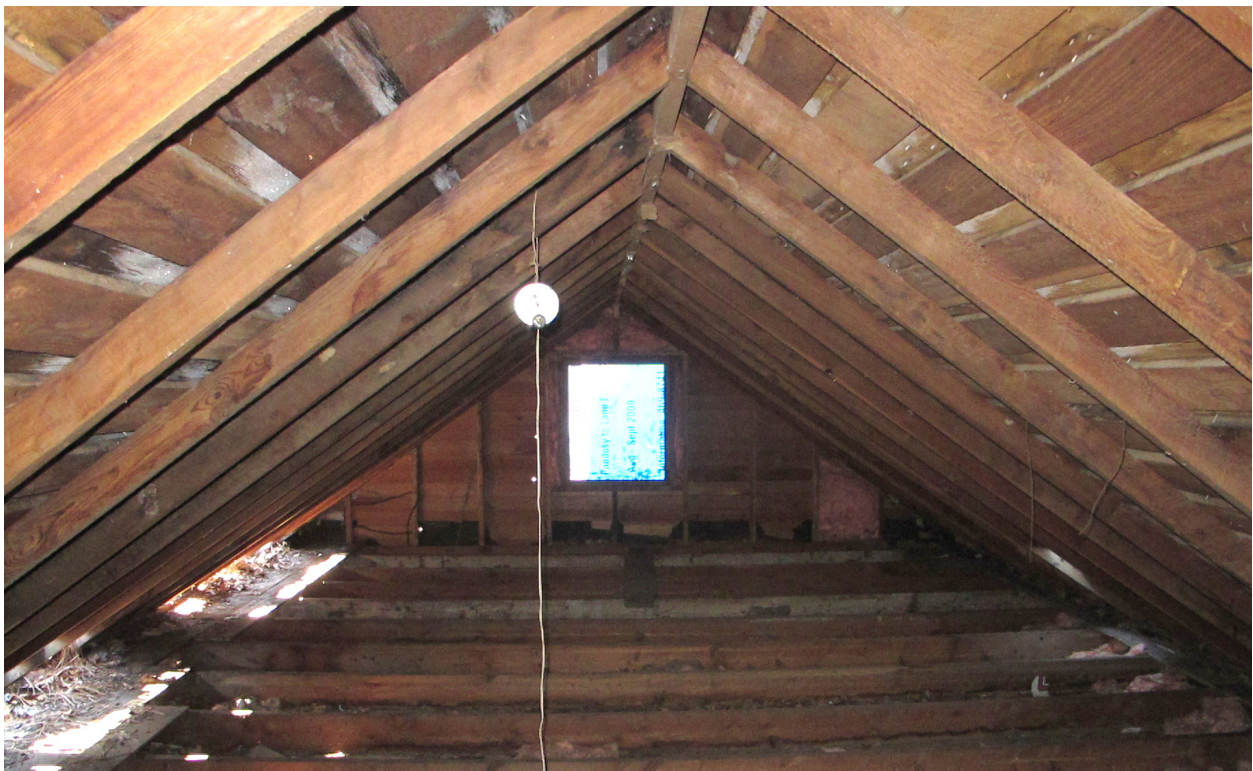
Photos showing side-gabled roof structure of the Surtees Barn extension, from exterior (top) and interior (bottom) side.

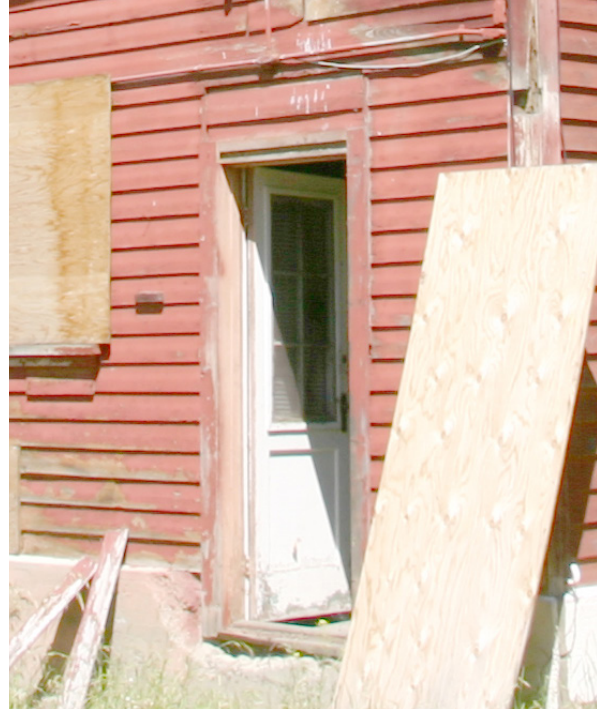
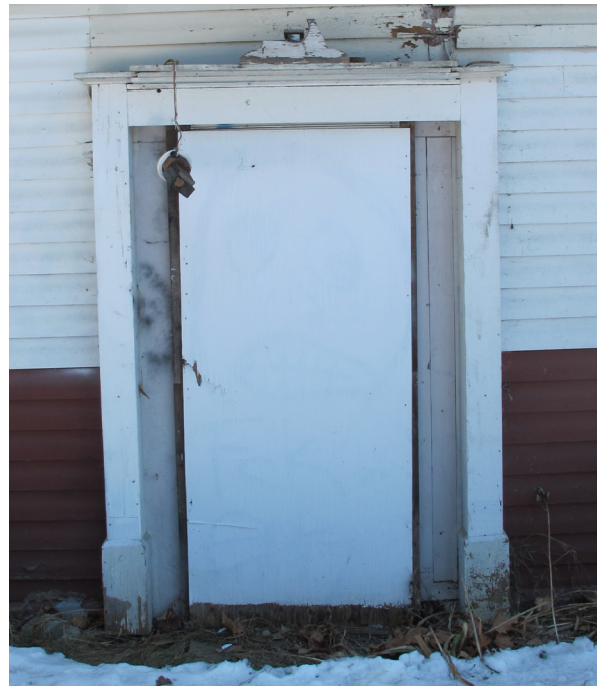
Photos showing original, existing door assembly at west return of south elevation (top), and later door surround trim at east elevation (bottom).

The Surtees Barn features original door openings on all elevations, although it appears that only one later door is extant, which is located at the west wall return of the Surtees Barn. The door is characterized by an inset panelling, with six glass panes in true divided lights. The surviving later door should be preserved, and repaired as necessary. All missing doors should be replaced with new, appropriate wooden doors that are sympathetic to the historic character of the Barn.

- Retain the door openings in their original locations, and preserve and repair all original door.
- New doors should be visually compatible with the historic character of the building.
