# **HERITAGE CONSERVATION (MANAGEMENT) PLAN for the McIver House**

**2269 - 2279 Benvoulin Road, Kelowna, BC**

**Prepared for: The Central Okanagan Heritage Society,  
August 2018**

**Prepared by: Lorri Dauncey, MA, BA, Dip**

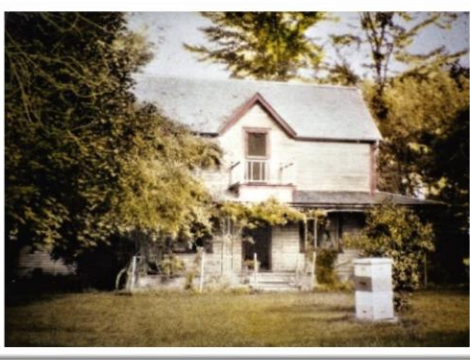
<p>View of the front of the house soon after the Mclver family moved in. Many of the house's original design and elements are visible. Mclver Family Photos &amp; COHS Fonds, c.1930s</p>	<p><b>Original design and elements:</b></p> <p>The approx. 30-year-old house appears to be in fair to good condition. The burgundy trims are faded. The siding colour has faded and appears to be a lighter tone. The roof appears to be in good condition, with the chimney not visible from this side of the house. The second-floor balcony appears to be in fair condition. Both the second-floor door onto the balcony and the front door have simple two panel screen doors. The front verandah is in fair condition with the wood detailing on the posts and beneath the eaves visible. The vertical verandah skirting, as well as the simple steps up to the verandah can be seen.</p>

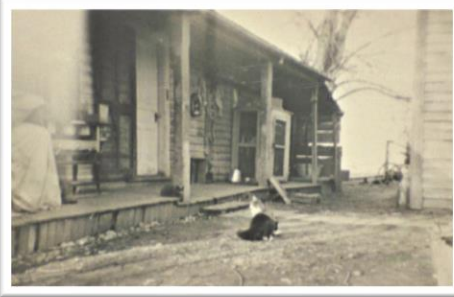
<p>View of the back of the house after the McIver family moved in. The original design of the verandah is visible. McIver Family Photos &amp; COHS Fonds, c.1930s</p>	<p><b>Original design and elements:</b></p> <p>The back verandah of the house looks to be in fair to poor condition. The skirting that encloses the deck has missing boards. The verandah posts are visible, as well as the horizontal boards at the end of the verandah, that have likely been added later to enclose this section of the verandah. The simple step up to the verandah's back door and the open four-panel screen door is visible.</p> <p>The verandah was on three sides of the house when the McIver family moved in. This included the early/ original sleeping porch, which was enclosed with boards in between the posts with screening on the upper half. There would have been a screen door facing the back of the house, next to the side door into the kitchen area of the house.</p>
