Canadian National Railways Station Railway Garden and Plaza Heritage Assessment

1177 Ellis Street, Kelowna BC

February 2023

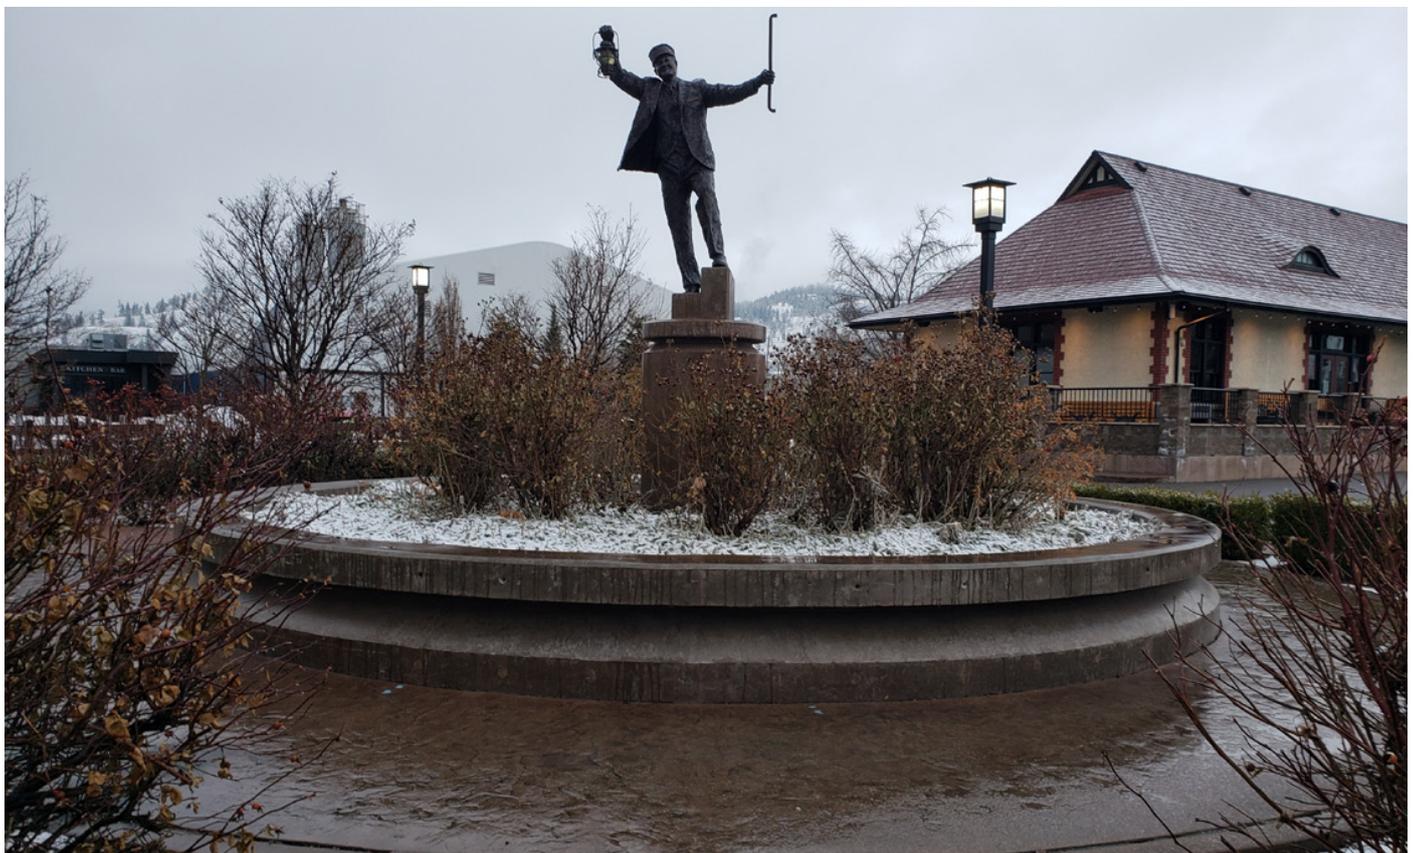
The garden sits at the corner of Clement Avenue and Ellis Street (figure 1) and includes perennial and shrub plantings, feature boulders, a circular raised concrete planter with a sculpture feature of The Conductor (figure 2), four stamped concrete access walkways, and a textured concrete circular path. There are feature boulders within the planting areas and uprights for the sculpture.

Figure 2: View of the garden area from the corner entrance at the intersection of Clement Avenue & Ellis Street

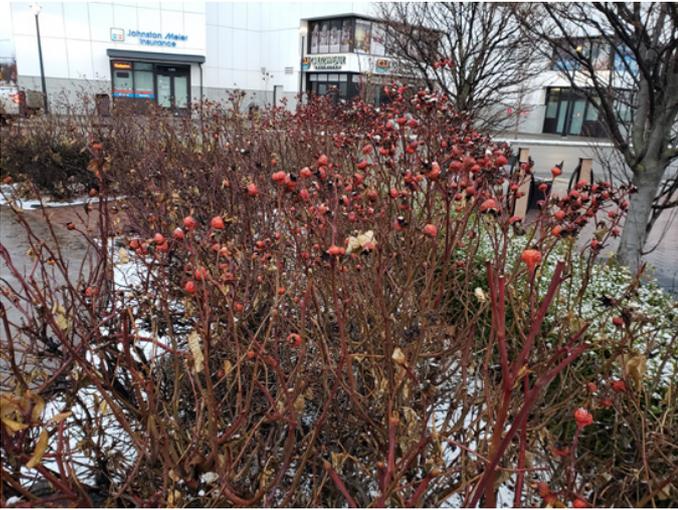
Generally, the garden appears to be in good condition. At the time of the site visit (mid-February, 2023), some foliage was visible on the perennial Lamb's Ear plantings (figure 5), and decorative rose hips were visible on both types of roses (figure 3). The boxwood looked green and healthy (figure 3). Plant density appeared good, with only a few small gaps in the boxwood hedge along the perimeter (figure 4 & 6).

Figure 3: Decorative rose hips visible on rose plantings

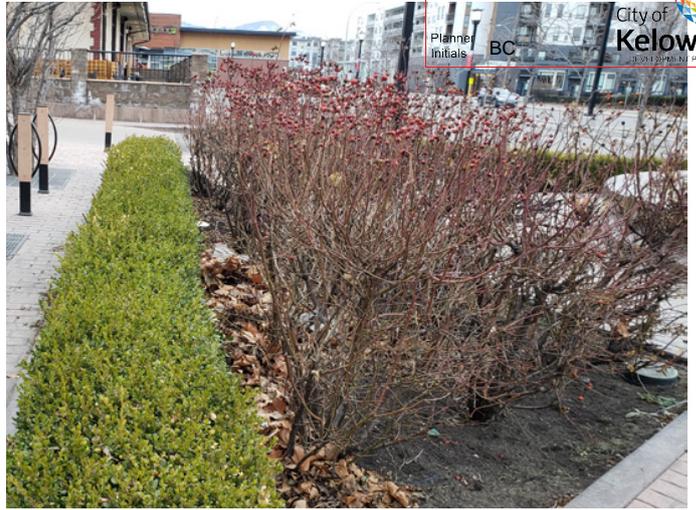
Figure 4: Healthy green boxwood hedge and dense rose plantings

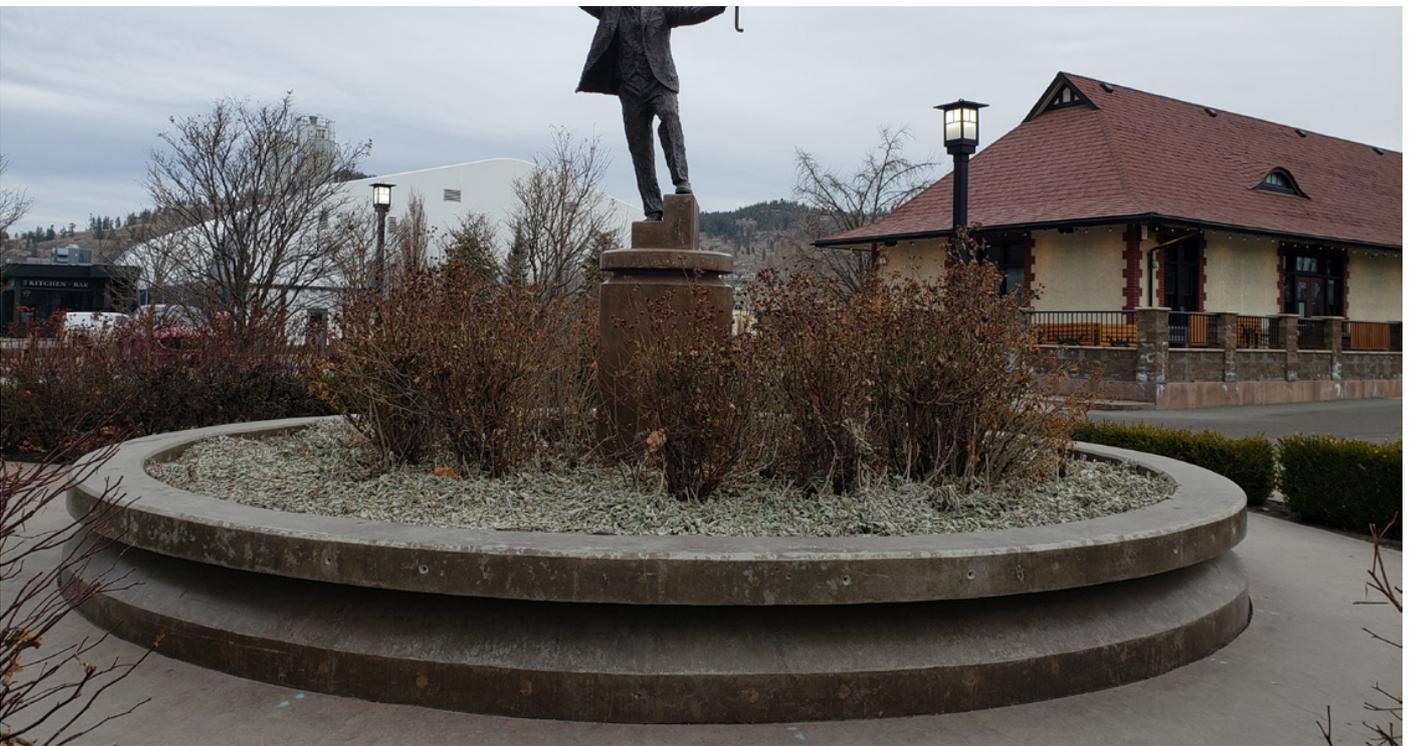
Figure 5: Dense cover of perennial Lamb's Ear plantings at base of roses in raised planter feature

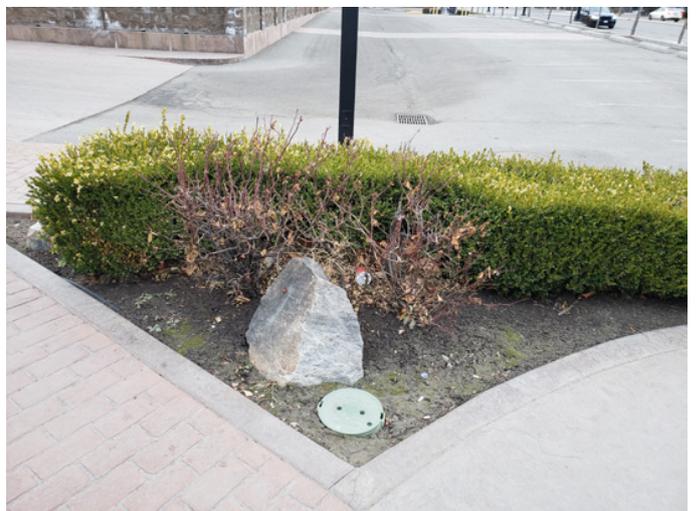
Figure 7: Feature boulder in landscape bed.

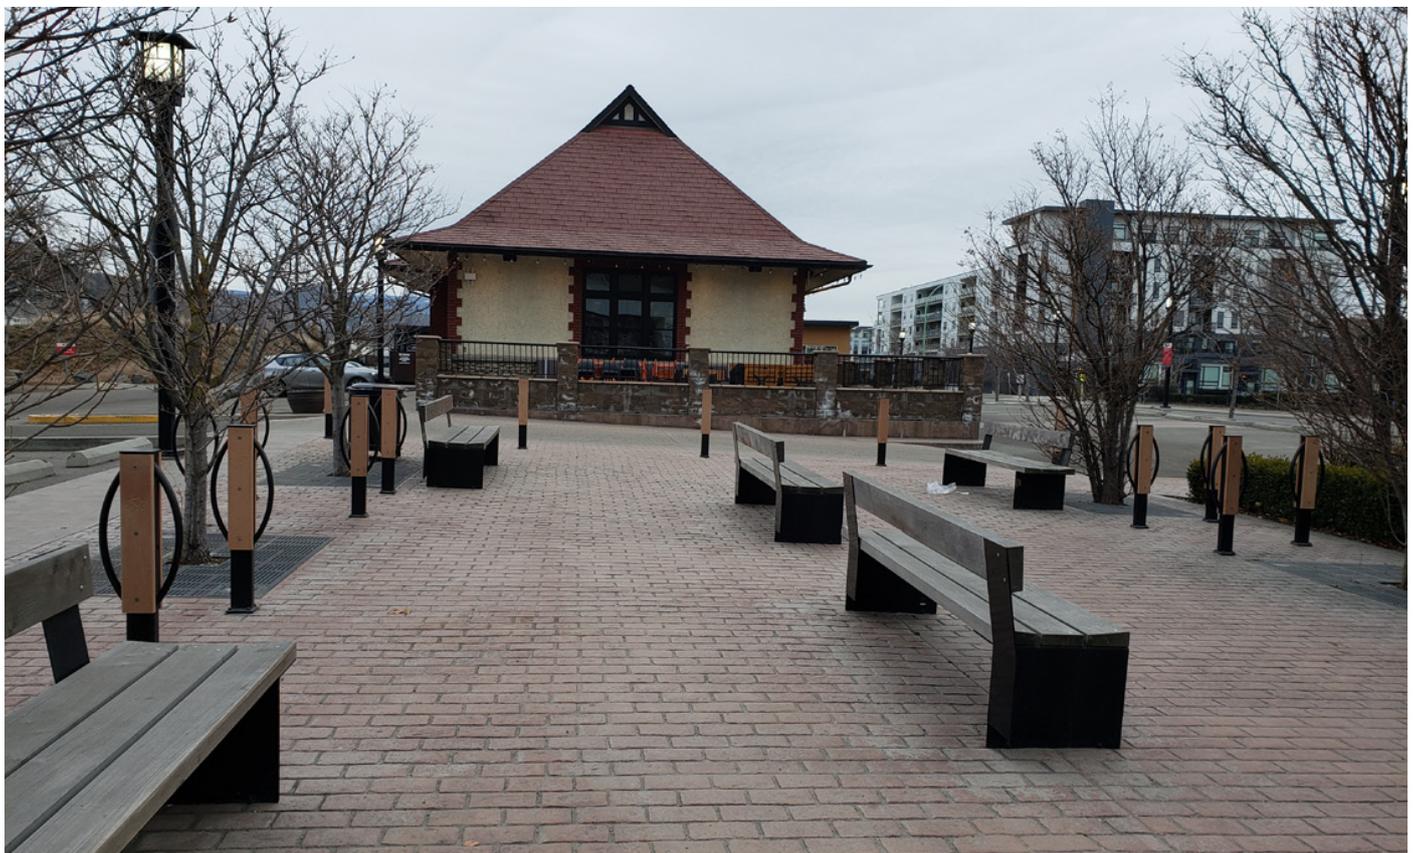
The plaza is sited North of the garden along the West side of the property and connects Ellis Street to the Train Station building (figure 18). It includes a variety of site furnishings, light standards, bicycle racks, benches, bollards, a waste receptacle, and tree plantings with tree grates. The surface is constructed of the same stamped red brick concrete paving as the garden, with a timber boardwalk stamp along the far North end of the plaza, along the parking stalls (figure 19).

Figure 19: View of the plaza area from Ellis Street

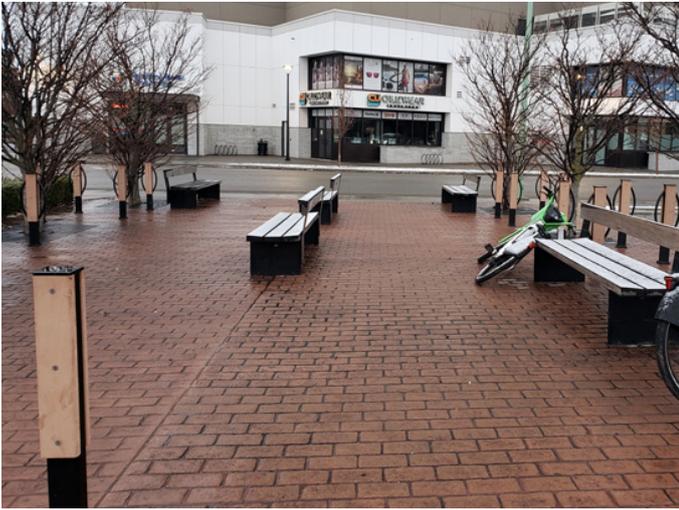
The stamped red brick concrete paving was in good condition, with some fade in colour over the years due to weather and sun exposure, similar to that of the garden area. There still appeared to be positive drainage across the plaza, with no visible low spots (figure 26). There was some additional wear of the surface near the Northeast most tree planting, where the surface was darkened (figure 27). Minor cracks were visible in a few places, but do not pose structural or public safety hazards (figure 28).

Figure 25: Positive drainage on plaza surface with no visible low points

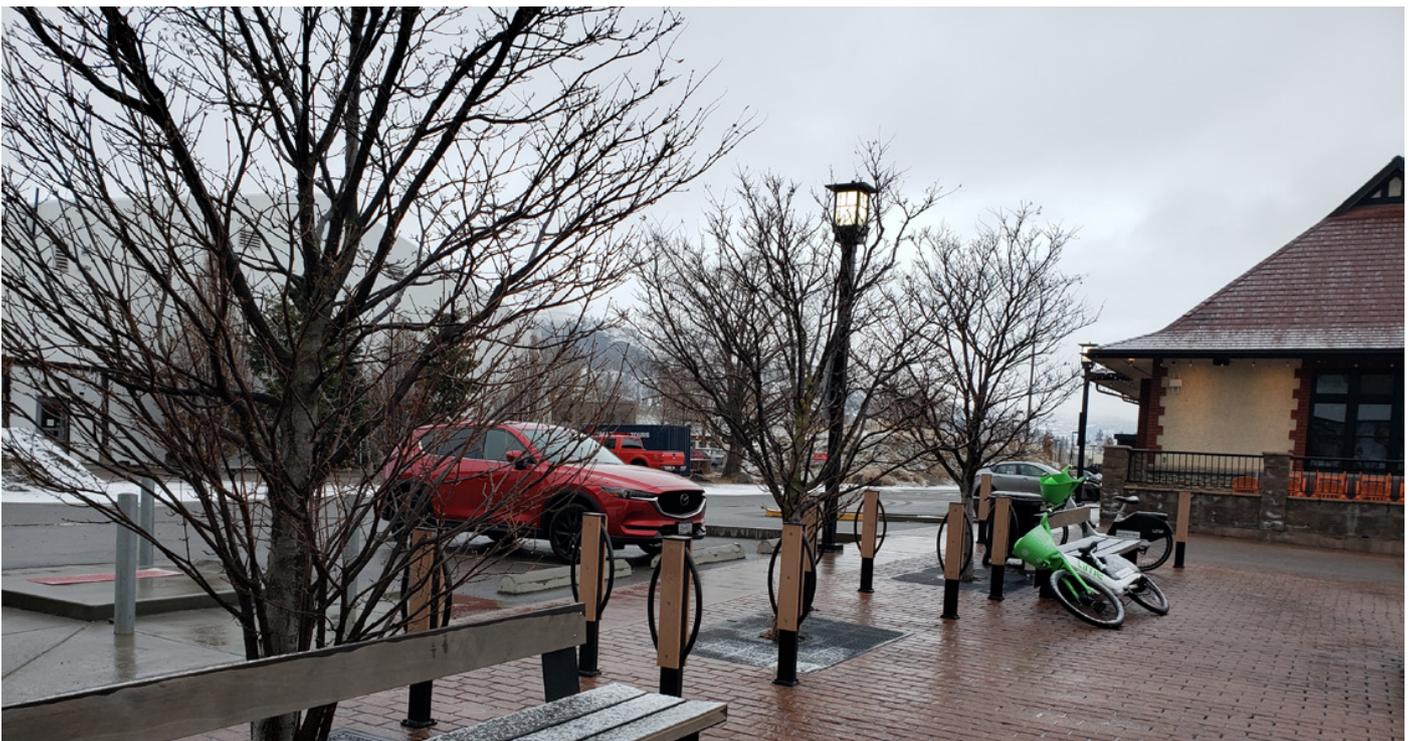
Generally, the plaza appears to be in good condition. At the time of the site visit (mid-February, 2023), no foliage was visible on the tree plantings. Some moss was visible on the tree trunk, but the trees appeared healthy with no visible broken or cracked branches. The tree grates were in excellent condition.

Figure 29: Plaza tree plantings which appear to be in good condition
