**Re: Surtees House and Barn
4629 Lakeshore Road**

SURTEES HOUSE & BARN

4629 LAKESHORE ROAD, KELOWNA, BC

SURTEES HOUSE
CONSERVATION PLAN

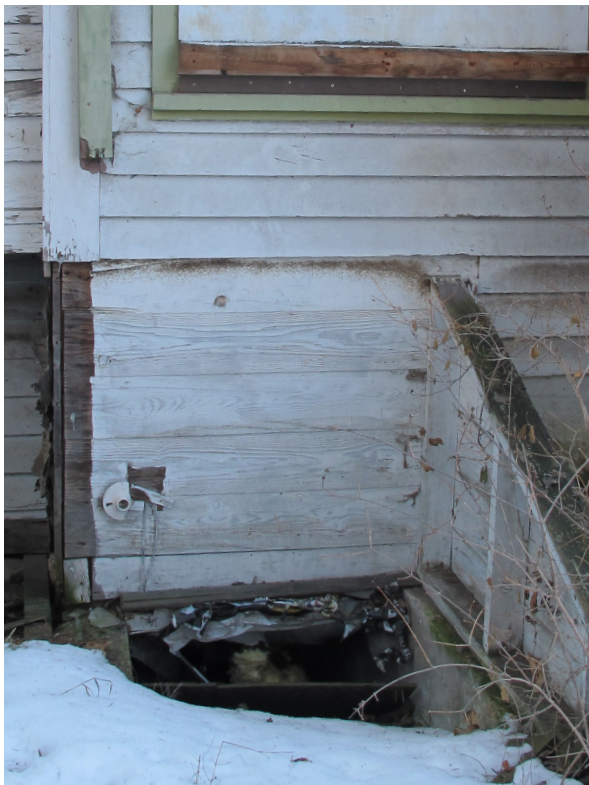
Portion of rear elevation showing opening to unoccupied partial basement, with exposed cast-in-place concrete foundation walls.

The foundation of the Surtees House was inaccessible during the initial review, and would require the removal of exterior cladding in localized area to expose the foundation beneath. However, a partial basement was noted from an opening at the rear of the building, suggesting that the timber-frame structure is sitting on a cast-in-place concrete footing and foundation wall.

The existing foundation should be rehabilitated to include seismic reinforcements, as required. Careful attention should be executed to ensure the exterior walls above grade, particularly the primary elevations (front façade and north elevation), are not damaged during demolition of foundation, and relocation of the house. The heritage resource should be protected from damage or destruction at all times. Reference sections **4.3: General Conservation Strategy** and **4.6: Site Protection** for further information.

- If new foundations are proposed, concrete is a suitable material. New material should match original in appearance, as viewed from the exterior, as possible.
- Foundations should be reviewed by a Structural Engineer. Once condition is assessed, conservation recommendations can be finalized.
- To ensure the prolonged preservation of the new foundations, all landscaping should be separated from the foundations at grade by a course of gravel or decorative stones, which help prevent splash back and assist drainage. New vegetation may assist in concealing the newly exposed foundations, if desired.

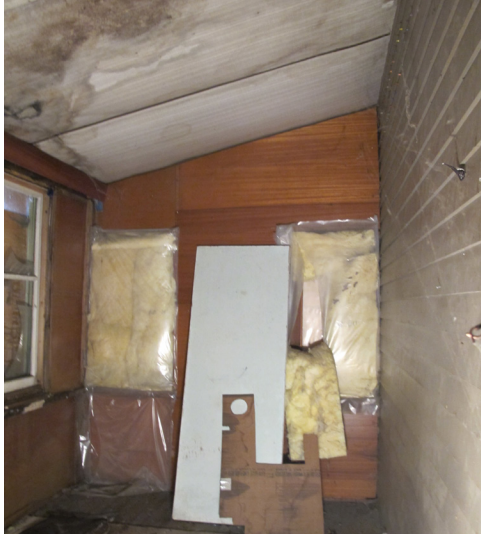
Interior space of the enclosed vestibule (west early addition) showing original exterior horizontal wood lapped siding to the right.

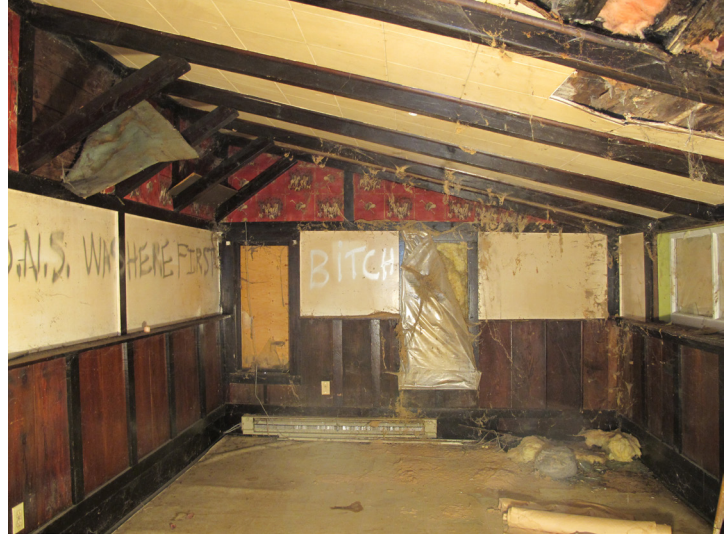
Interior space of the dining room (east early addition) showing exposed shed roof rafters with angle web wood members.

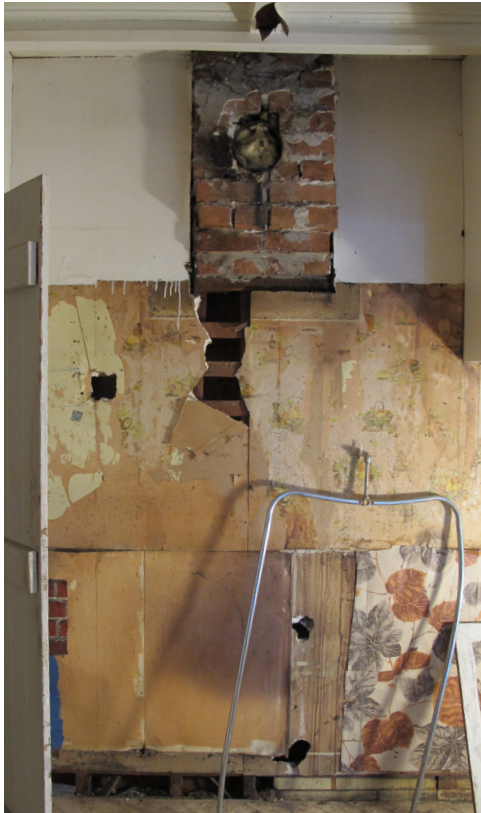
Interior brick masonry chimney flue terminating at midsection of the interior wall, partially showing wood structural support.

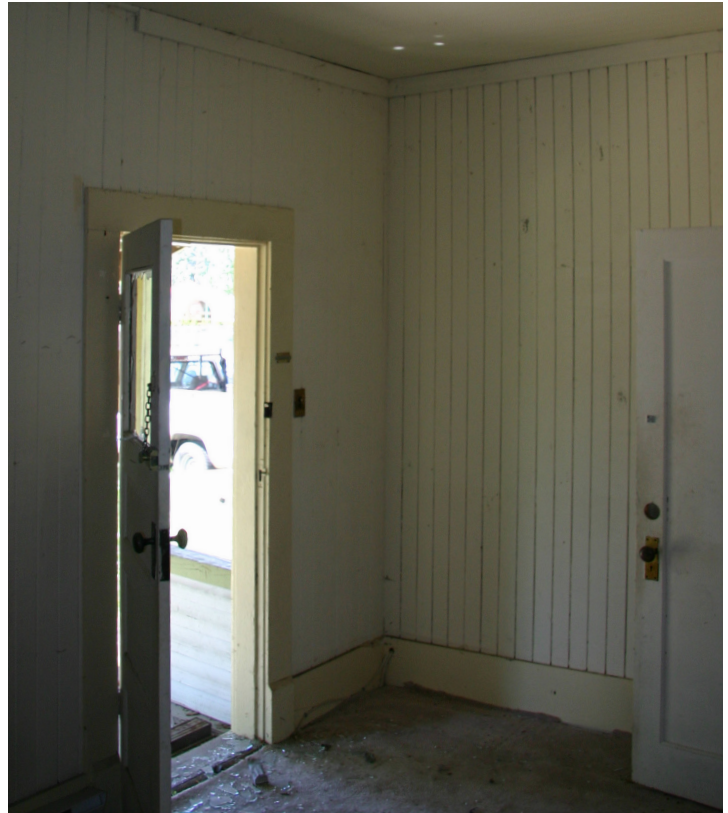
Surviving original v-joint panelling on walls and ceiling of front hall, showing original main entrance door to the left.

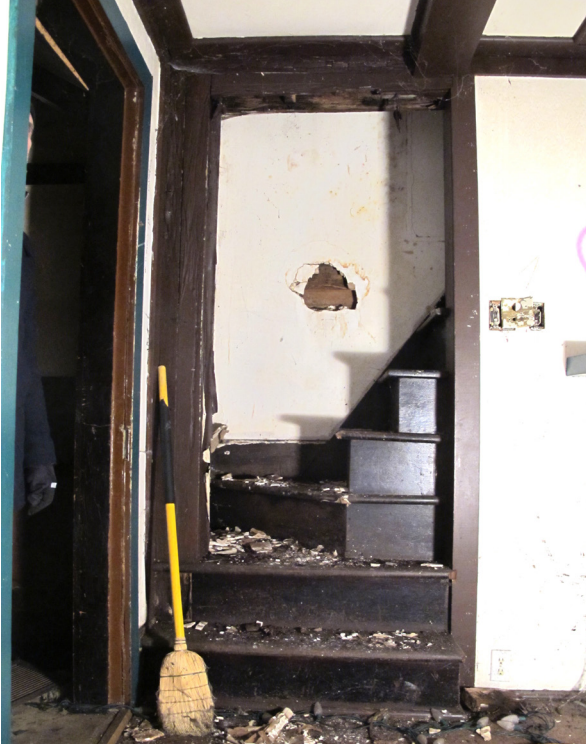
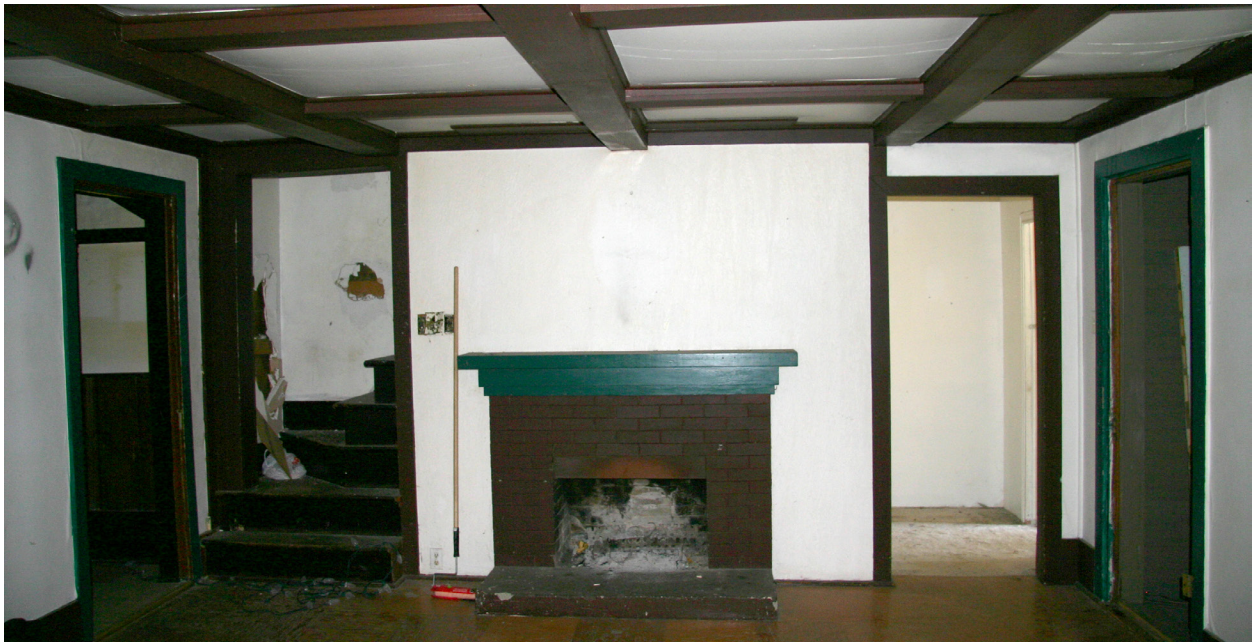
The Surtees House features an original, narrow winder staircase that is accessible from the large bedroom to the north, leading up to the attic spaces behind the fireplace. The low-height attic apaces may have been used for storage or boarding rooms for servants. The staircase is intact and appears to be in good condition, and may be rehabilitated, as necessary.

The Surtees House features a modest brick masonry fireplace with raised concrete hearth and wood mantel. The paint finish is not historically accurate, and should be removed. The fireplace is intact and appears to be in good condition, and may be rehabilitated, as necessary.

Photos showing surviving interior character-defining elements of Surtees House, including narrow winder staircase; brick masonry fireplace with raised concrete hearth and wood mantel; low ceiling with expressed horizontal beams and coffered-effect.

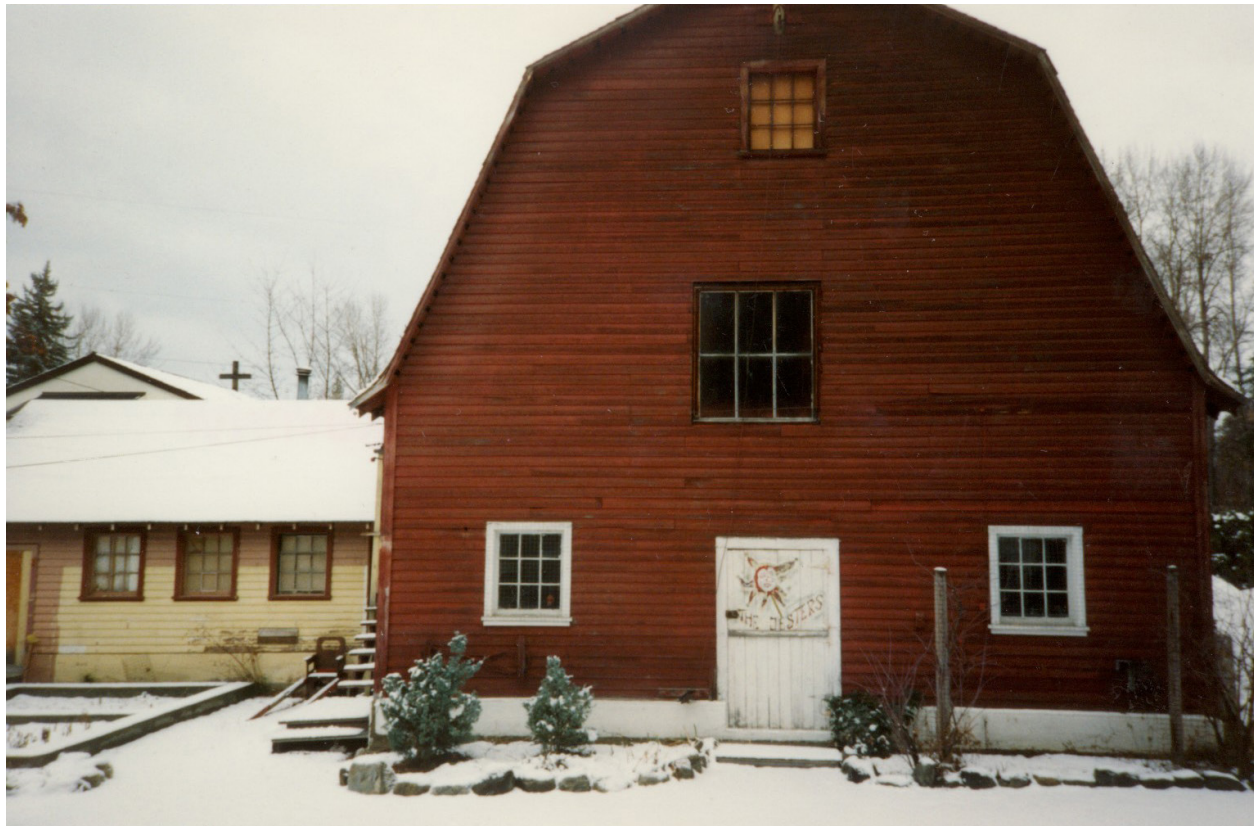
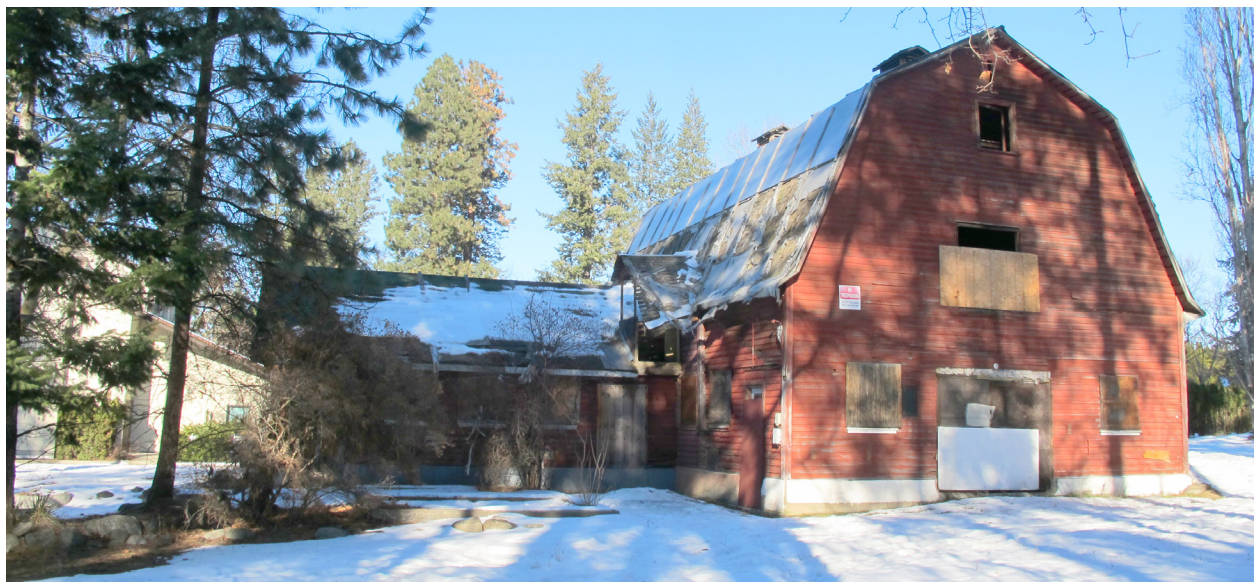
Archival photo showing south elevation of Surtees Barn with cross of church in the background (top; date unknown); photo showing existing condition of Surtees Barn, as viewed from southwest, with St. Andrew's Church in the background.

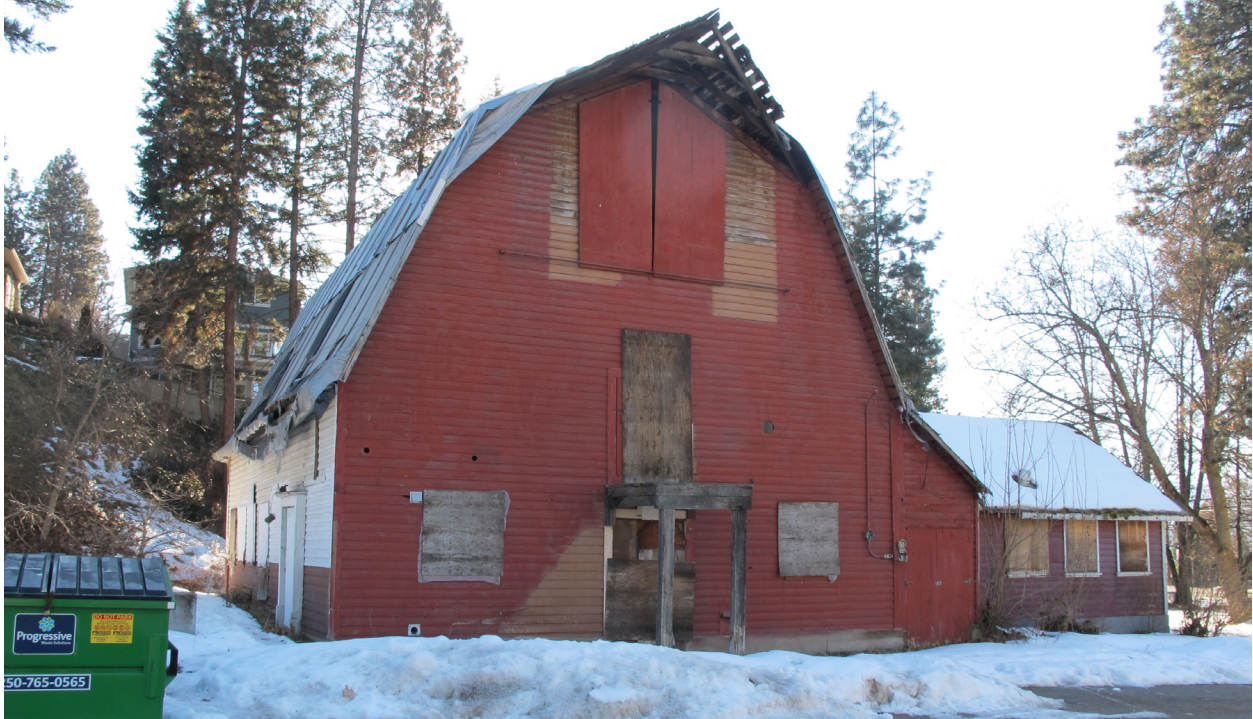
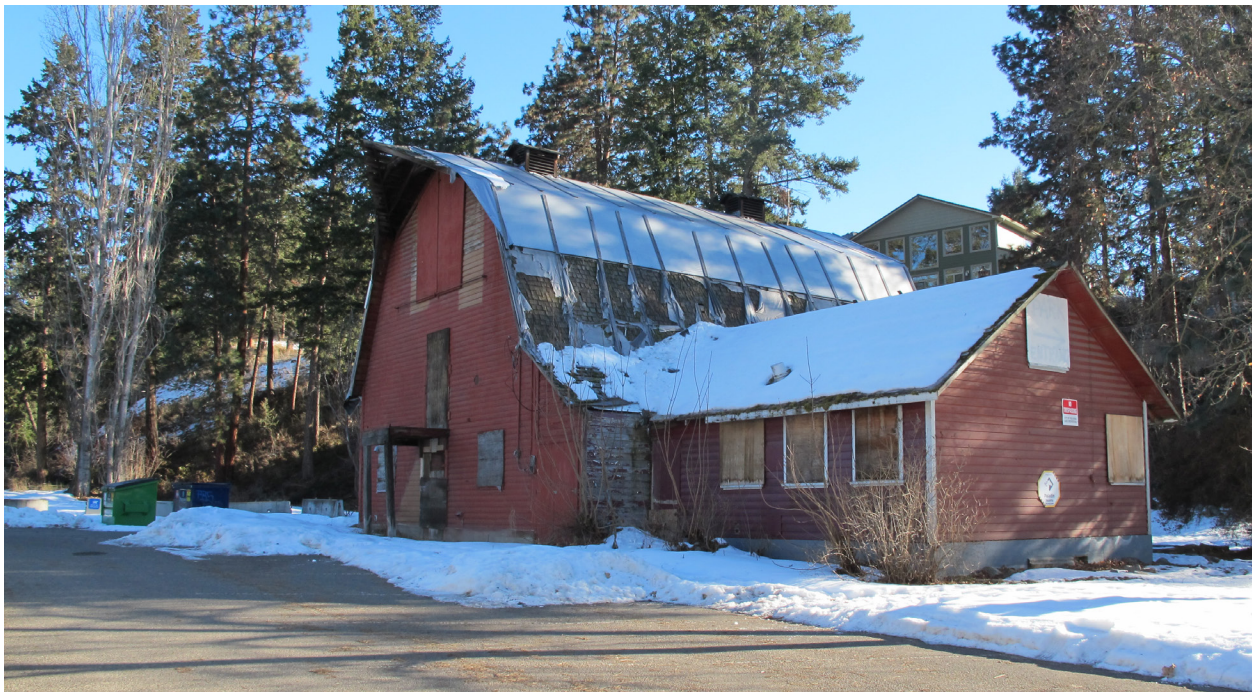
Photos showing north elevation of Surtees Barn, as viewed from northeast (top) and northwest (bottom). Note hill with mature landscape in the background.

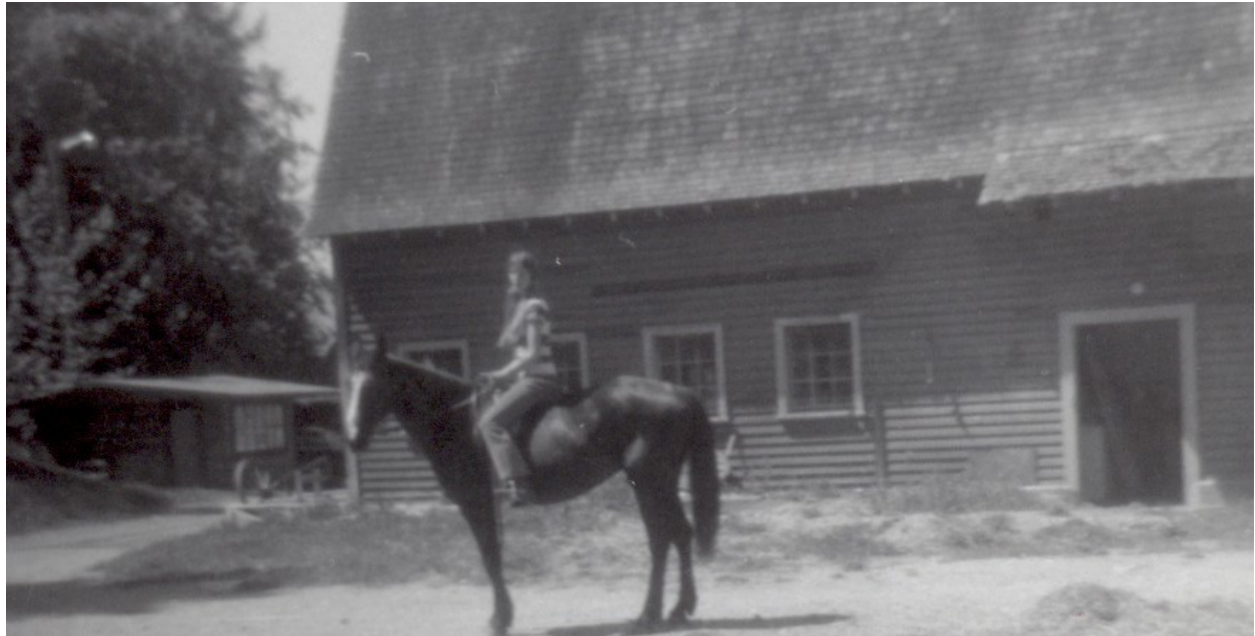
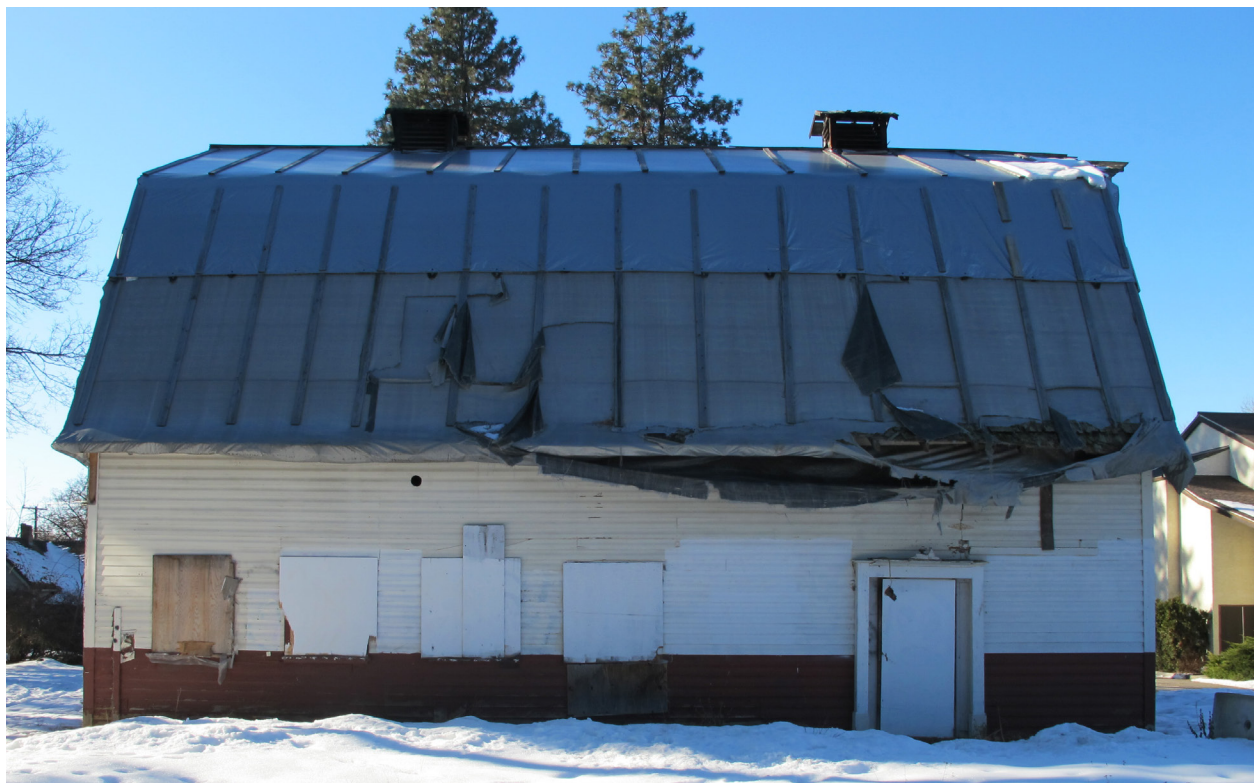
Archival photo showing east elevation of the Surtees Barn (top), with small log house in the background (demolished). Photo showing existing condition of east elevation of the Surtees Barn (bottom); note in the background showing a portion of the Surtees House to the left, and the St. Andrew's Church to the right.

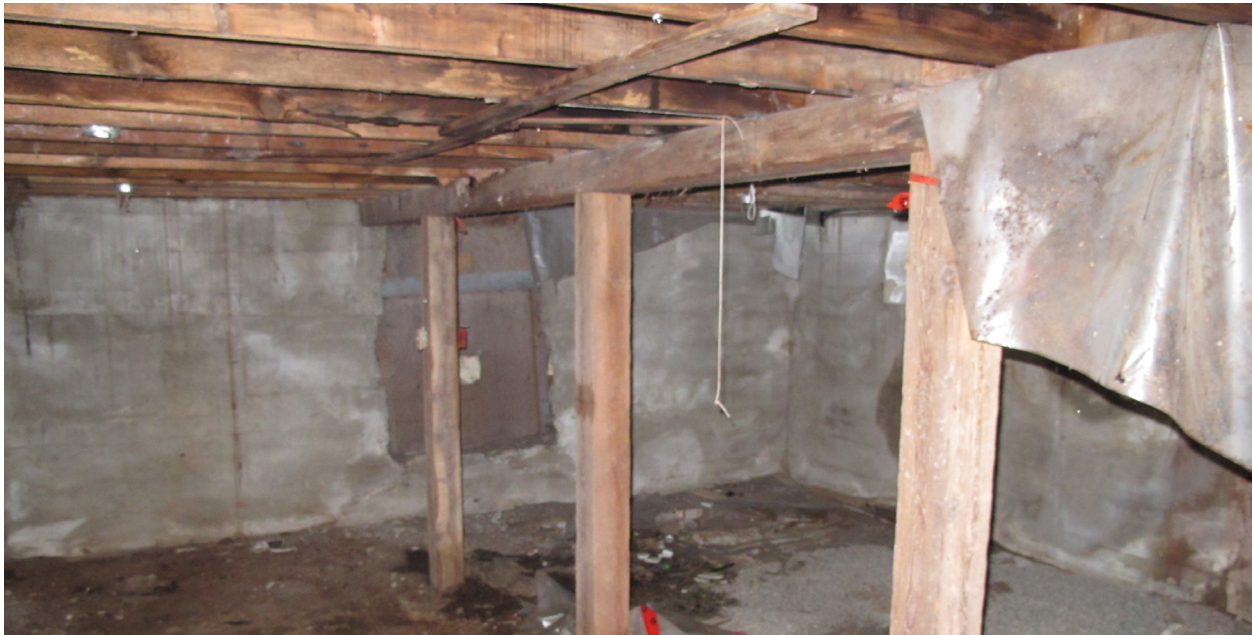
The Surtees Barn features exposed, poured-in-place concrete foundation walls supporting its original wood-frame structure, and raised concrete floor slab. A new concrete foundation will be constructed prior to relocation of the historic building. Careful attention should be executed to ensure the exterior walls above grade are not damaged during demolition of existing foundation and relocation of the barn. The heritage resource should be protected from damage or destruction at all times. Reference sections **4.3: General Conservation Strategy** and **4.6: Site Protection** for further information.

Basement of the west extension to the Surtees Barn.

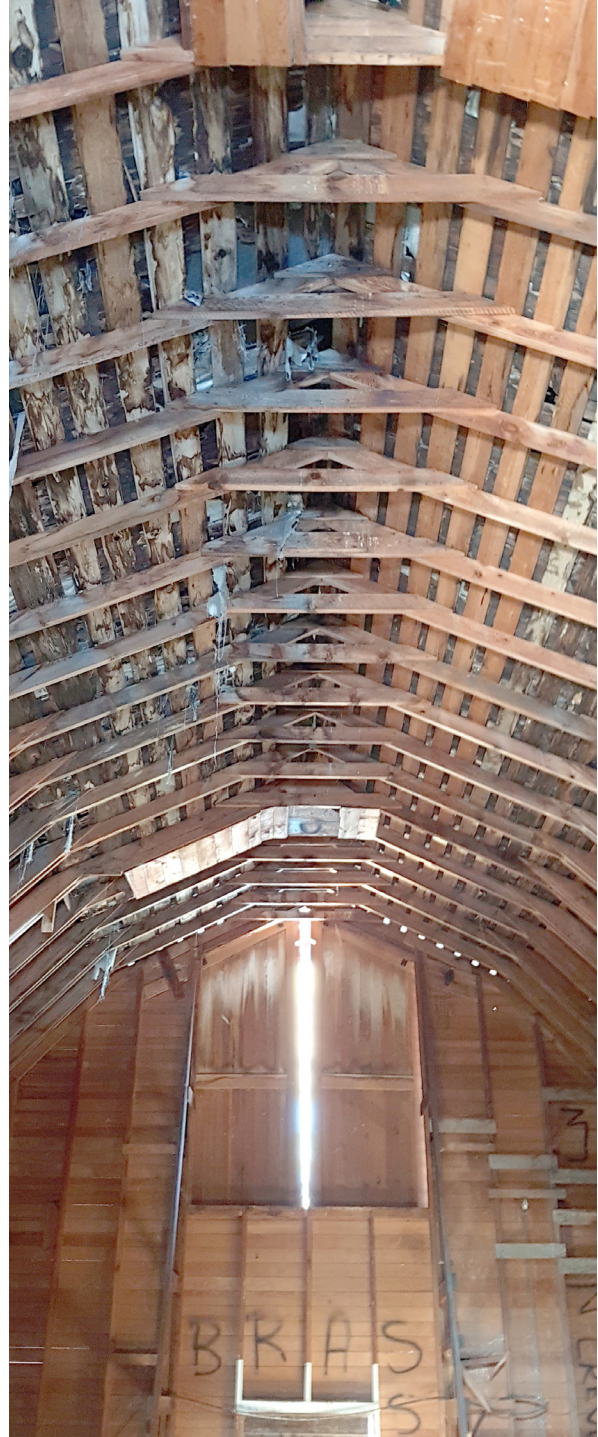
Photo showing interior side of the exterior wood-frame walls, looking north, and underside of the gambrel roof structure of the Surtees Barn.

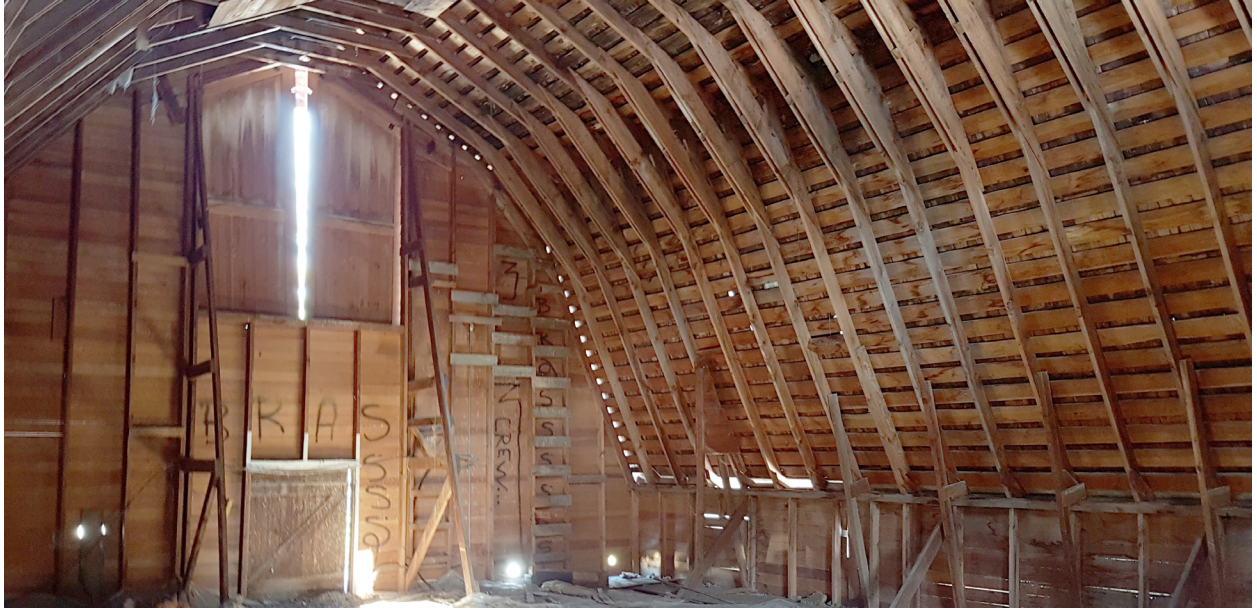
Photos showing exposed gambrel roof structure of the Surtees Barn.

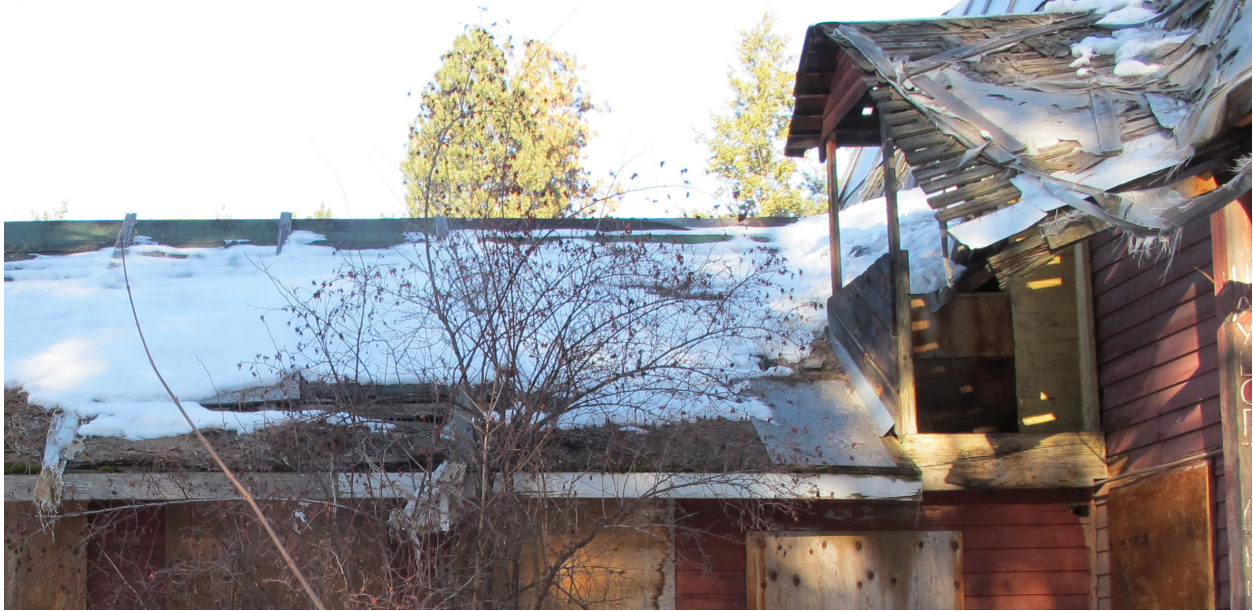
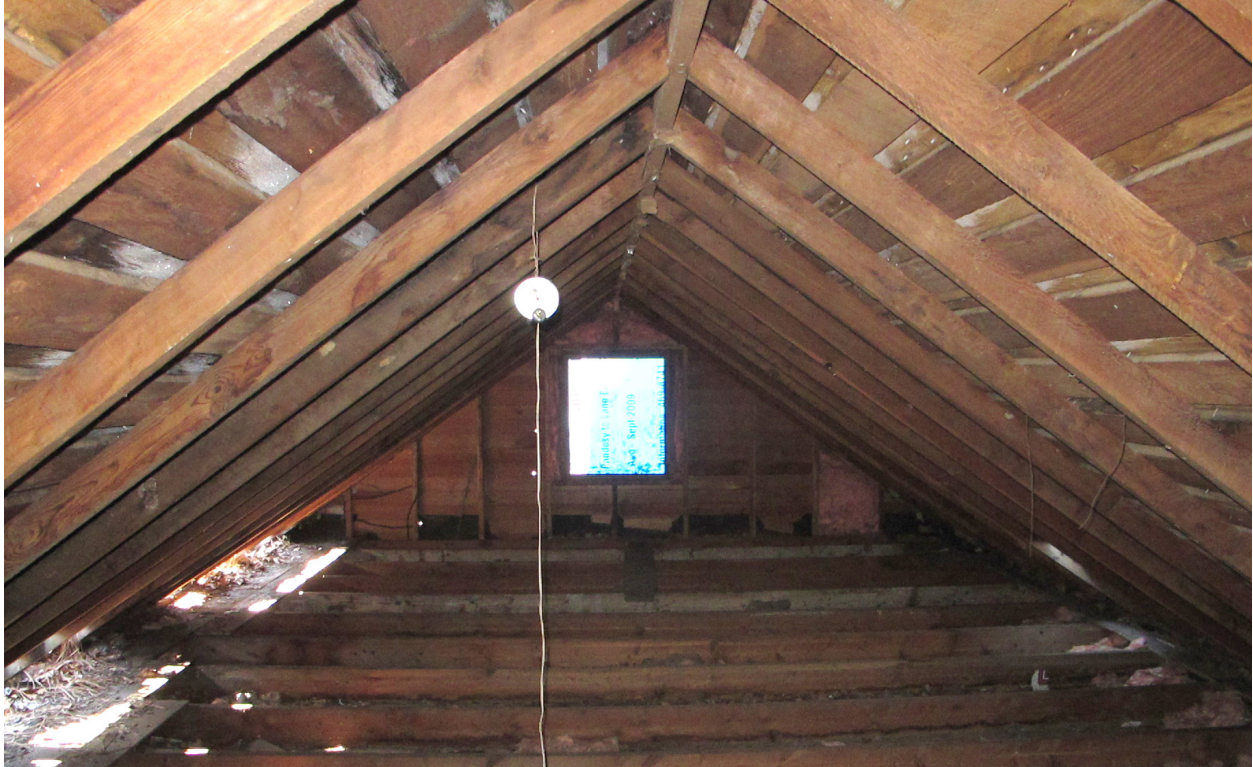
Photos showing side-gabled roof structure of the Surtees Barn extension, from exterior (top) and interior (bottom) side.

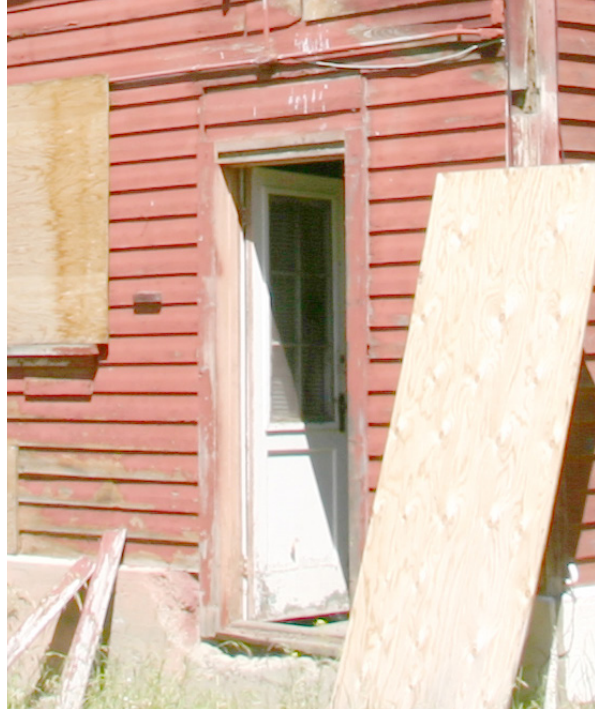
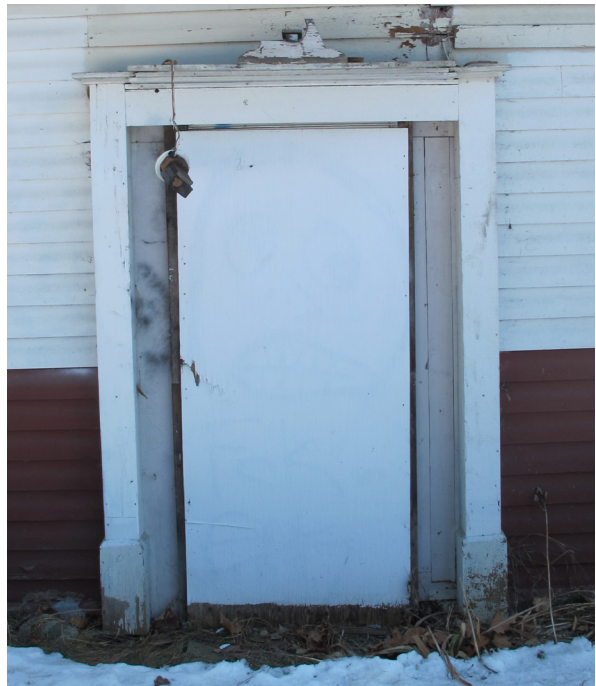
Photos showing original, existing door assembly at west return of south elevation (top), and later door surround trim at east elevation (bottom).
