BYLAW NO. 11408

Heritage Revitalization Agreement Authorization Bylaw HRA17-0001 –

4629 Lakeshore Road

SURTEES HOUSE & BARN

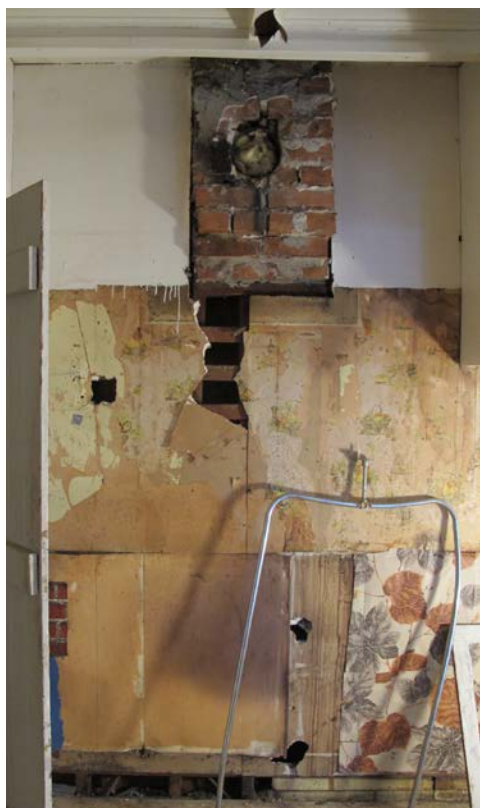
Interior brick masonry chimney flue terminating at midsection of the interior wall, partially showing wood structural support.

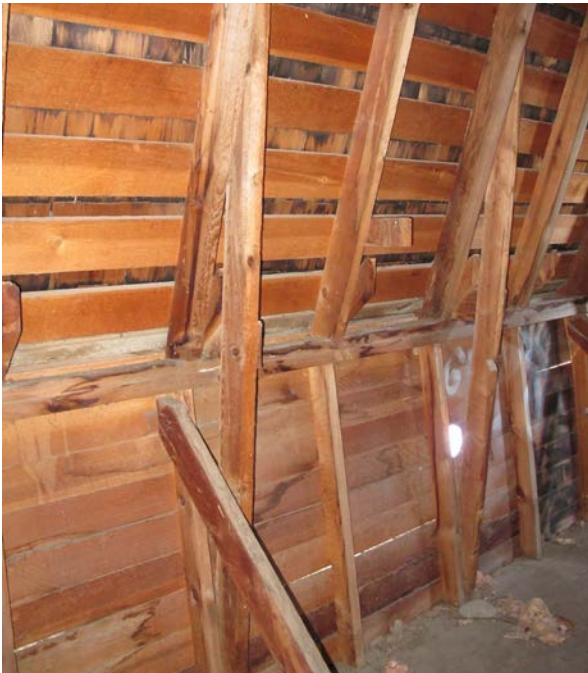
Interior side of the wall-to-roof interface, showing typical existing condition of the original wood materials.

- Cleaning procedures should be undertaken with non-destructive methods. Areas with biological growth should be cleaned using a soft, natural bristle brush, without water, to remove dirt and other material. If a more intense cleaning is required, this can be accomplished with warm water, mild detergent (such as D/2 Biological Solution®) and a soft bristle brush. High-pressure power washing, abrasive cleaning or sandblasting should not be allowed under any circumstances.
