Subject: 4629 Lakeshore Rd Lot A Plan 71341 SURTESS HERITAGE PARK

SURTEES HOUSE & BARN

4629 LAKESHORE ROAD, KELOWNA, BC

SURTEES HOUSE
CONSERVATION PLAN

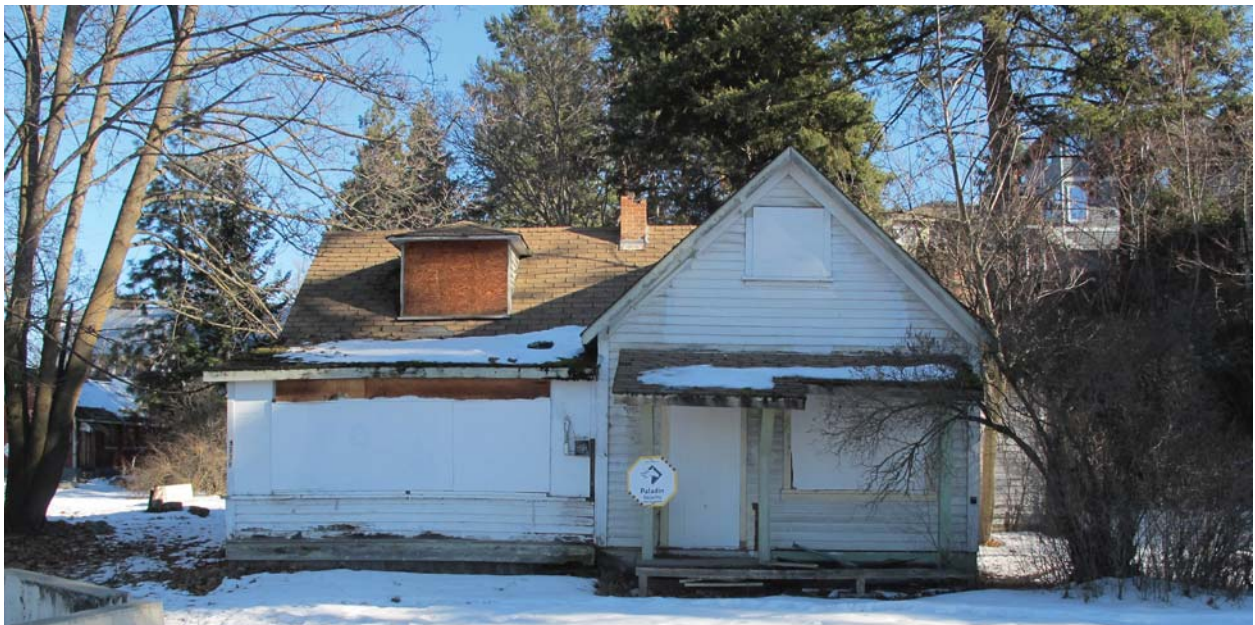
Conservation Strategy: Preservation

- Preserve the overall form, scale and massing of the building.
- Preserve the primary elevations (front façade and north elevation) as it relates to Lakeshore Road.
- All new addition should be reviewed by Heritage Consultant to ensure that the essential form and integrity of the historic asset is preserved.

Historic front facade (west elevation) of Surtees House at 4629 Lakeshore Road.

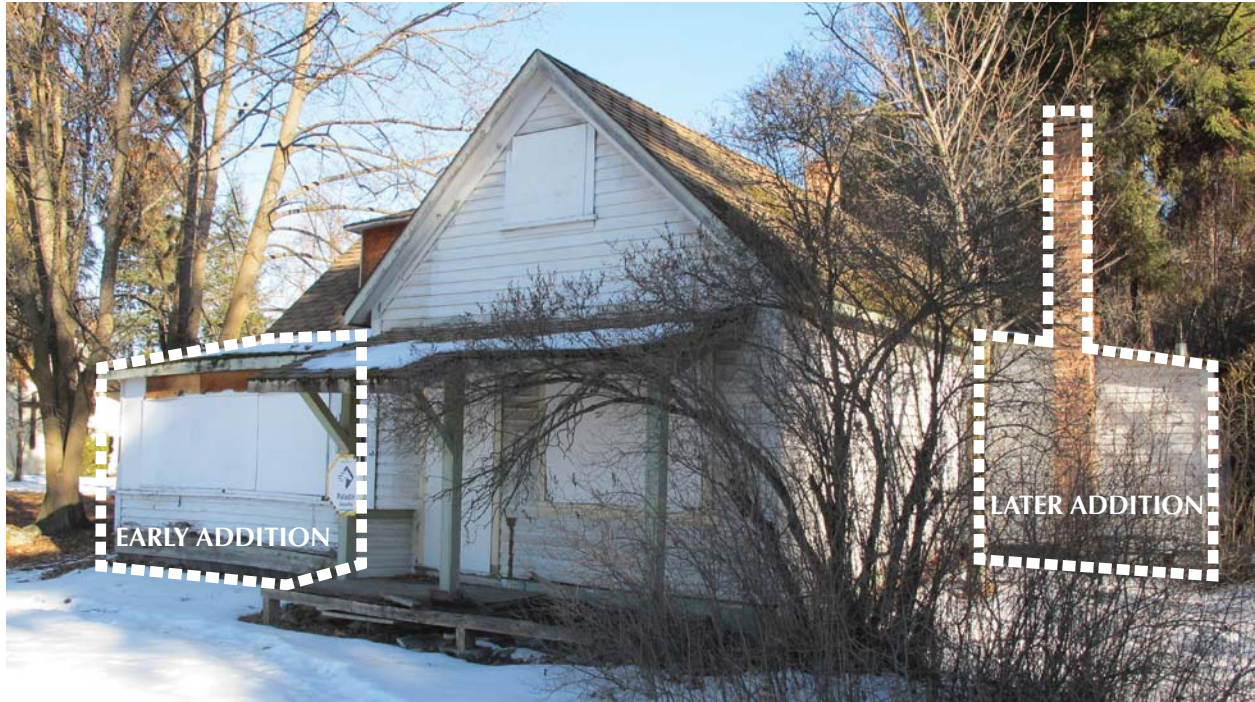
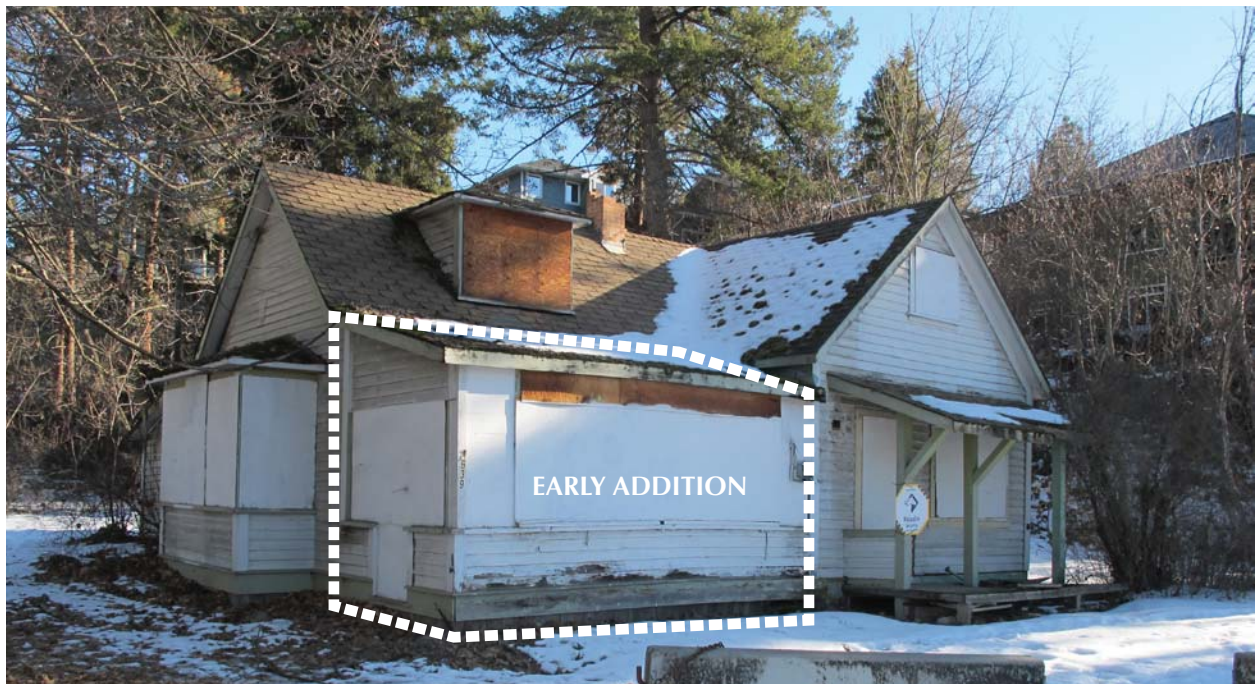
Perspectival views of the Surtees House along Lakeshore Road showing partial west and south elevations (top), and partial west and north elevations (bottom). Note that the .

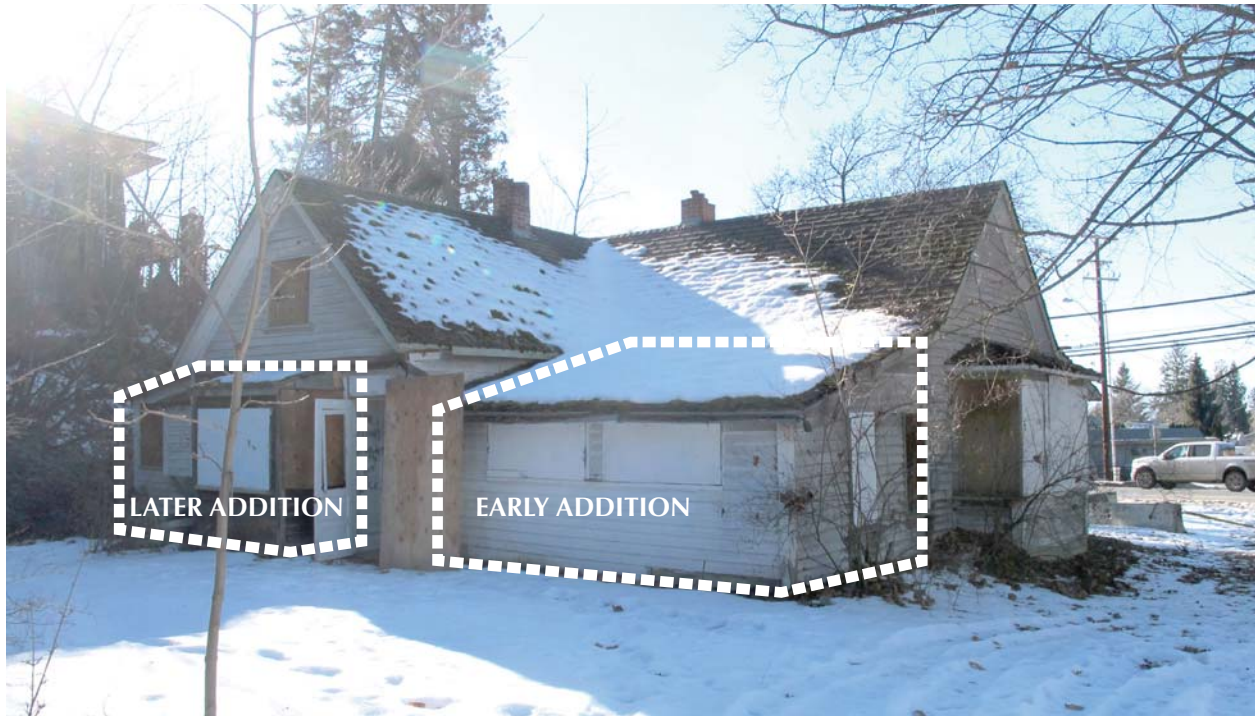
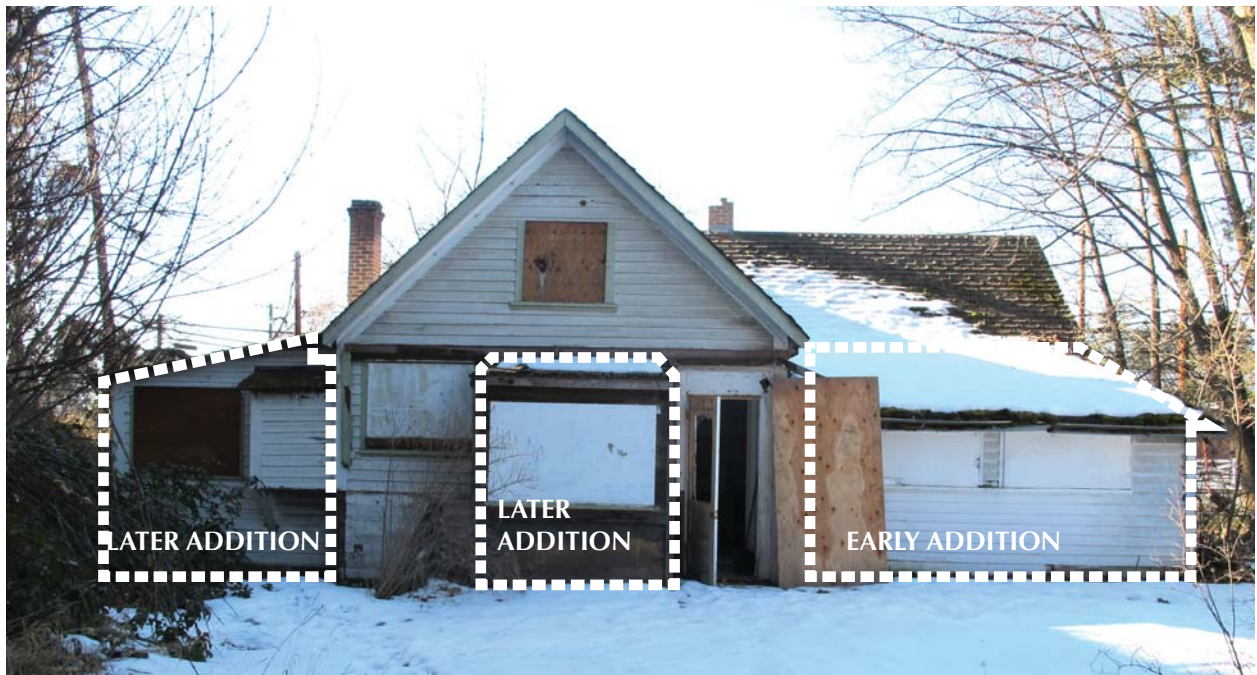
Perspectival view of the Surtees House showing partial east (rear) and north elevations (top); Rear elevation of surtees House to the east (bottom)

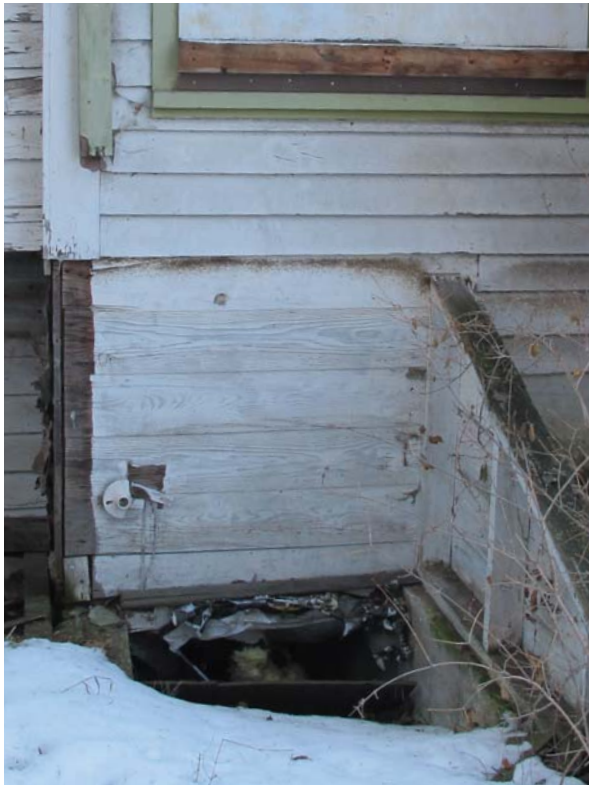
Portion of rear elevation showing opening to unoccupied partial basement, with exposed cast-in-place concrete foundation walls.

The foundation of the Surtees House was inaccessible during the initial review, and would require the removal of exterior cladding in localized area to expose the foundation beneath. However, a partial basement was noted from an opening at the rear of the building, suggesting that the timber-frame structure is sitting on a cast-in-place concrete footing and foundation wall.

The existing foundation should be rehabilitated to include seismic reinforcements, as required. Careful attention should be executed to ensure the exterior walls above grade, particularly the primary elevations (front façade and north elevation), are not damaged during demolition of foundation, and relocation of the house. The heritage resource should be protected from damage or destruction at all times. Reference sections **4.3: General Conservation Strategy** and **4.6: Site Protection** for further information.

- If new foundations are proposed, concrete is a suitable material. New material should match original in appearance, as viewed from the exterior, as possible.
- Foundations should be reviewed by a Structural Engineer. Once condition is assessed, conservation recommendations can be finalized.
- To ensure the prolonged preservation of the new foundations, all landscaping should be separated from the foundations at grade by a course of gravel or decorative stones, which help prevent splash back and assist drainage. New vegetation may assist in concealing the newly exposed foundations, if desired.

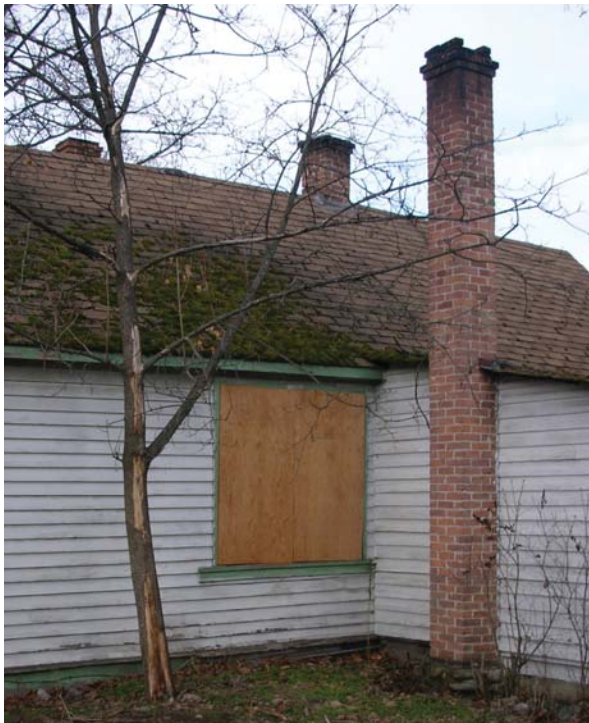
Southwest corner view of the house showing later addition, with exterior brick chimney in the foreground, and two original interior chimney stacks in the background.

The Surtees House features two original interior brick chimney along the roof ridges that provides venting for the kitchen and the fireplace. Above the roofline, the chimneys appear to be in poor condition, with missing brick masonry units, including the original corbelled crown detail. The bricks require cleaning and repointing, but generally appears to be in fair condition. Based on observations in the kitchen area, the chimney flue terminates abruptly within the interior wall, and is only supported by the interior wood-frame of the house. This configuration may have structural implications to the integrity of the chimney, and further investigation is required if the intent is to restore the element from the interior.

- Preserve the original chimneys in its original configuration, if possible.
- Original chimneys may require structural stabilization.
- Investigate condition of brickwork. If required, brickwork may be repointed and cleaned using a natural bristle brush and mild rinse detergent.
- If the existing chimneys need to be removed prior to relocation, the existing chimney should be carefully documented prior to dismantling of the existing chimneys. All sound, brick masonry units should be salvaged. Chimneys should be reinstated above roofline to match original configuration using salvaged masonry as possible, or

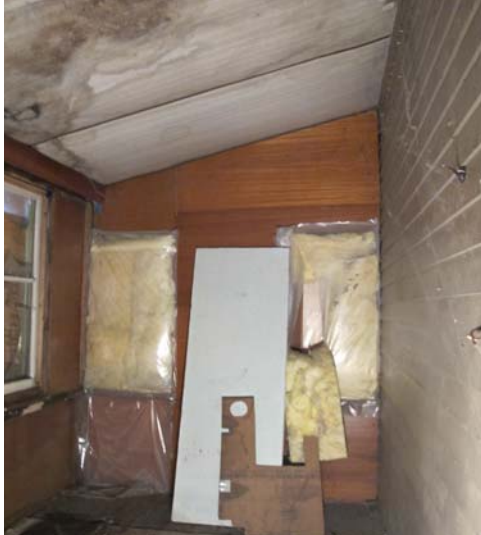
Interior space of the enclosed vestibule (west early addition) showing original exterior horizontal wood lapped siding to the right.

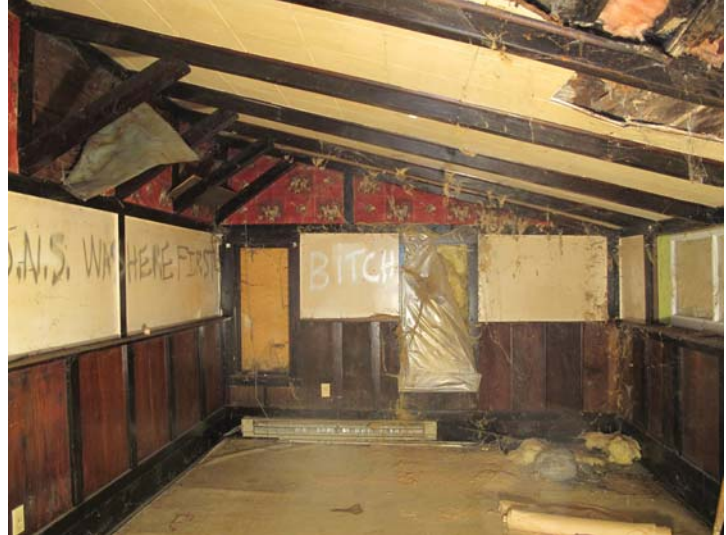
Interior space of the dining room (east early addition) showing exposed shed roof rafters with angle web wood members.

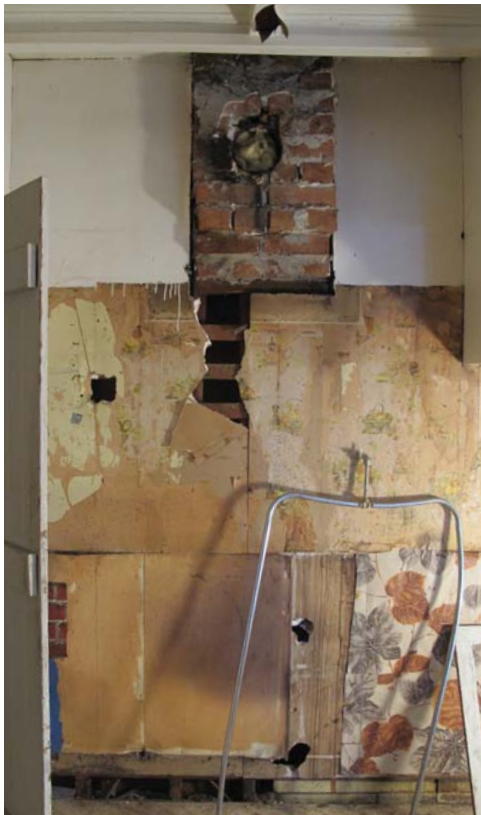
Interior brick masonry chimney flue terminating at midsection of the interior wall, partially showing wood structural support.

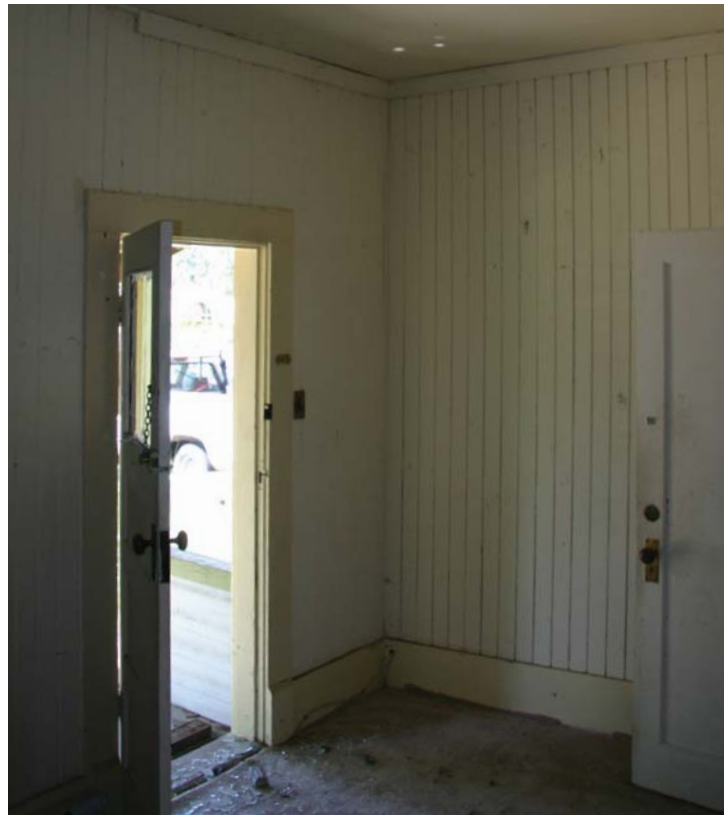
Surviving original v-joint panelling on walls and ceiling of front hall, showing original main entrance door to the left.

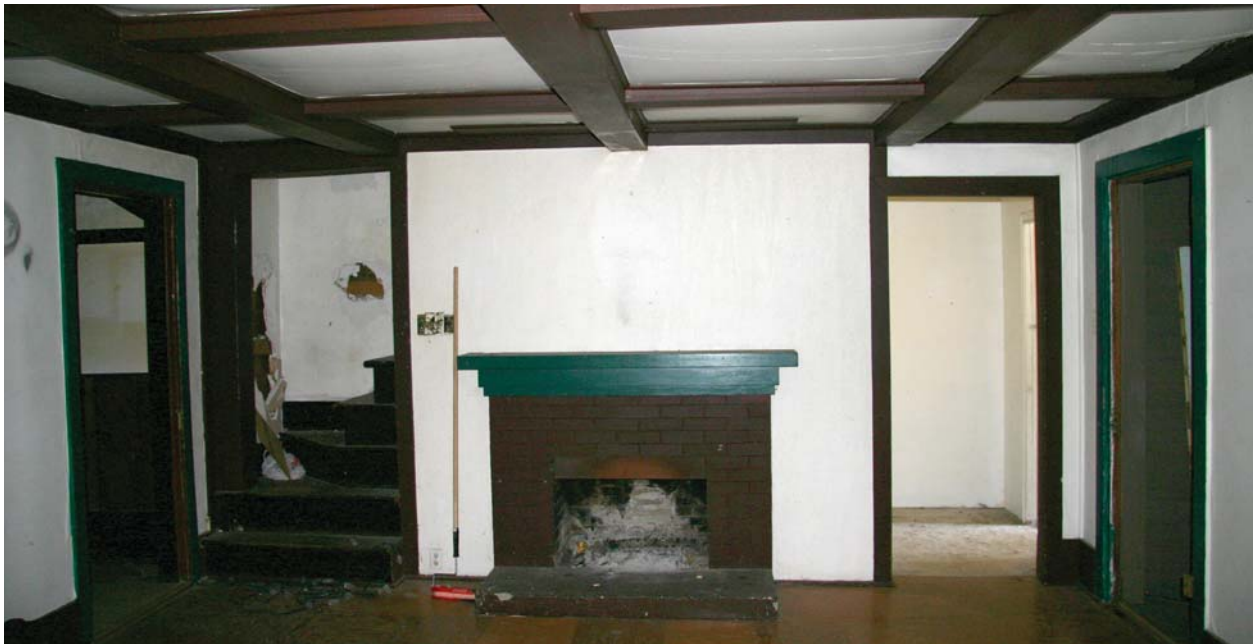
The Surtees House features an original, narrow winder staircase that is accessible from the large bedroom to the north, leading up to the attic spaces behind the fireplace. The low-height attic apices may have been used for storage or boarding rooms for servants. The staircase is intact and appears to be in good condition, and may be rehabilitated, as necessary.

The Surtees House features a modest brick masonry fireplace with raised concrete hearth and wood mantel. The paint finish is not historically accurate, and should be removed. The fireplace is intact and appears to be in good condition, and may be rehabilitated, as necessary.

Photos showing surviving interior character-defining elements of Surtees House, including narrow winder staircase; brick masonry fireplace with raised concrete hearth and wood mantel; low ceiling with expressed horizontal beams and coffered-effect.

Conservation Strategy: Rehabilitation

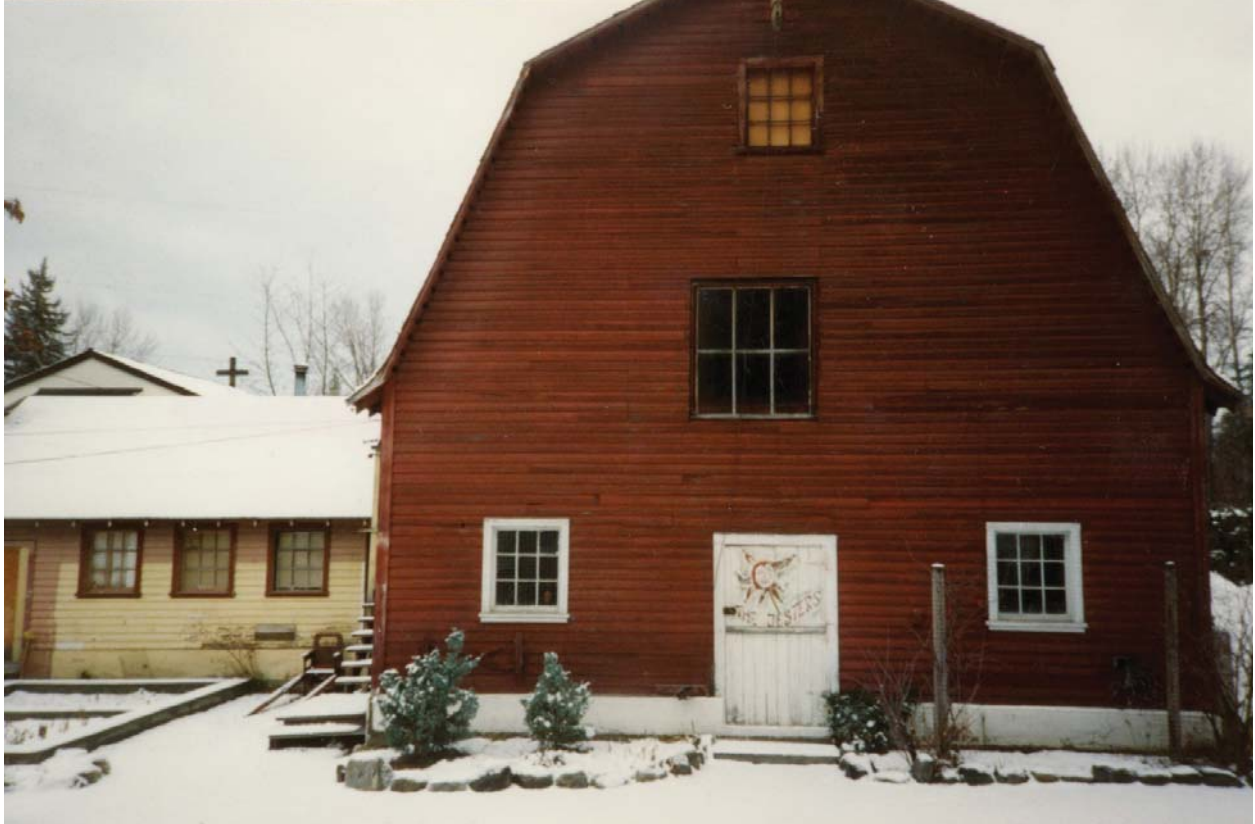
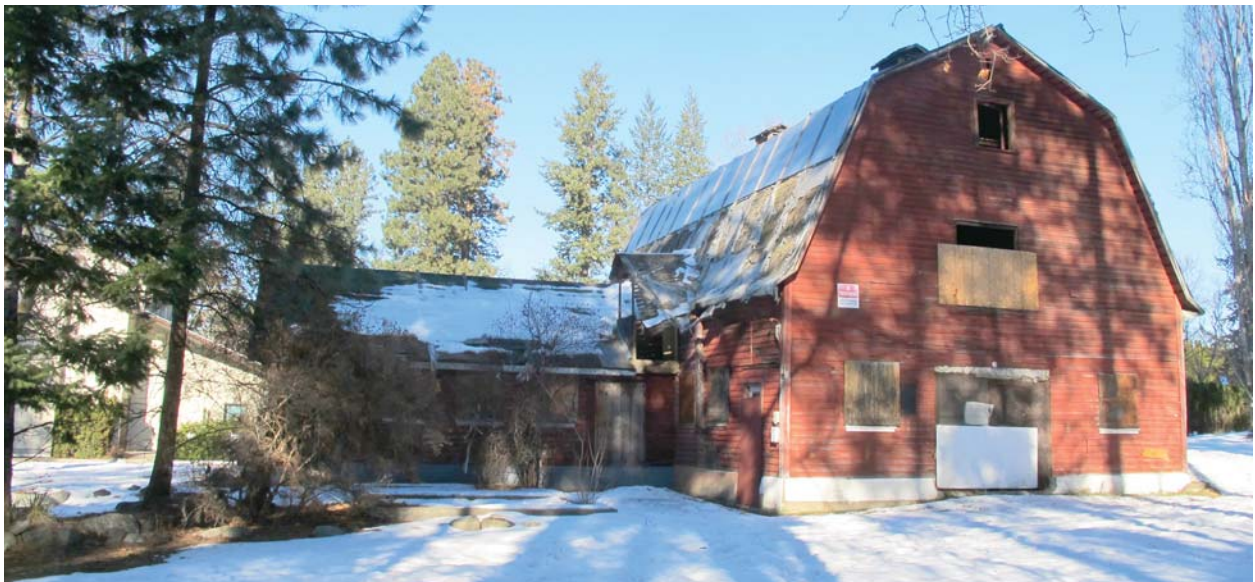
Archival photo showing south elevation of Surtees Barn with cross of church in the background (top; date unknown); photo showing existing condition of Surtees Barn, as viewed from southwest, with St. Andrew's Church in the background.

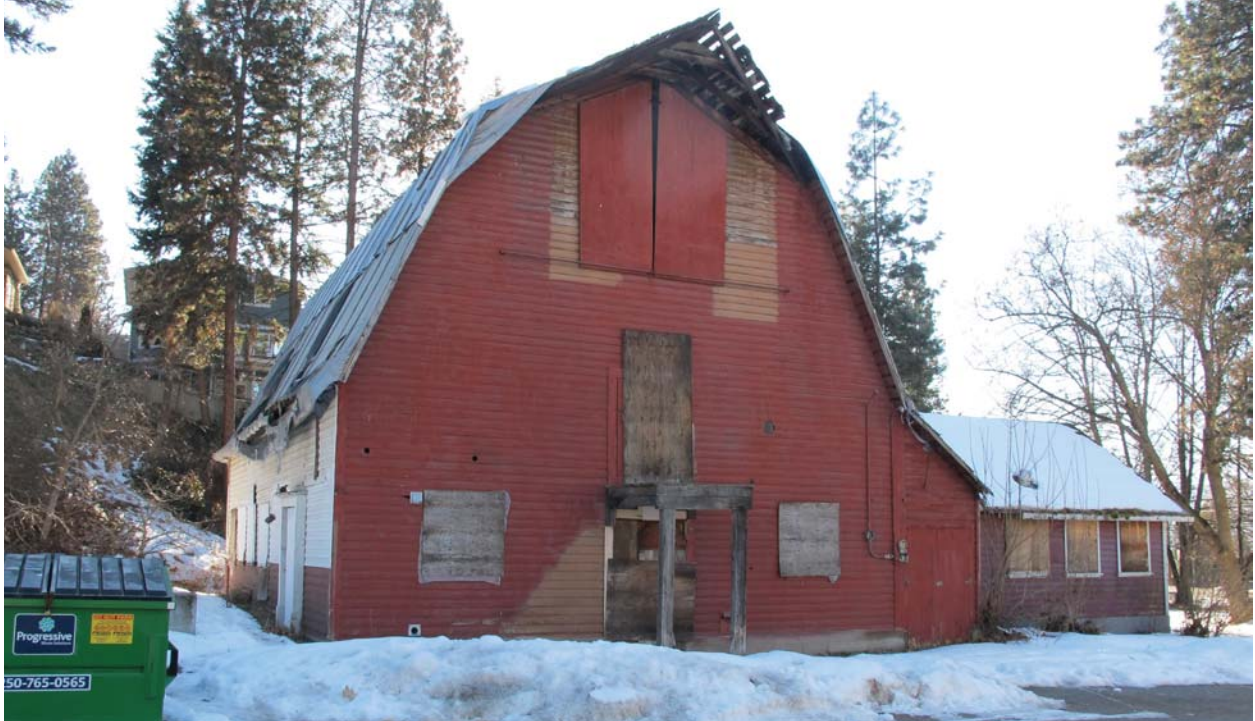
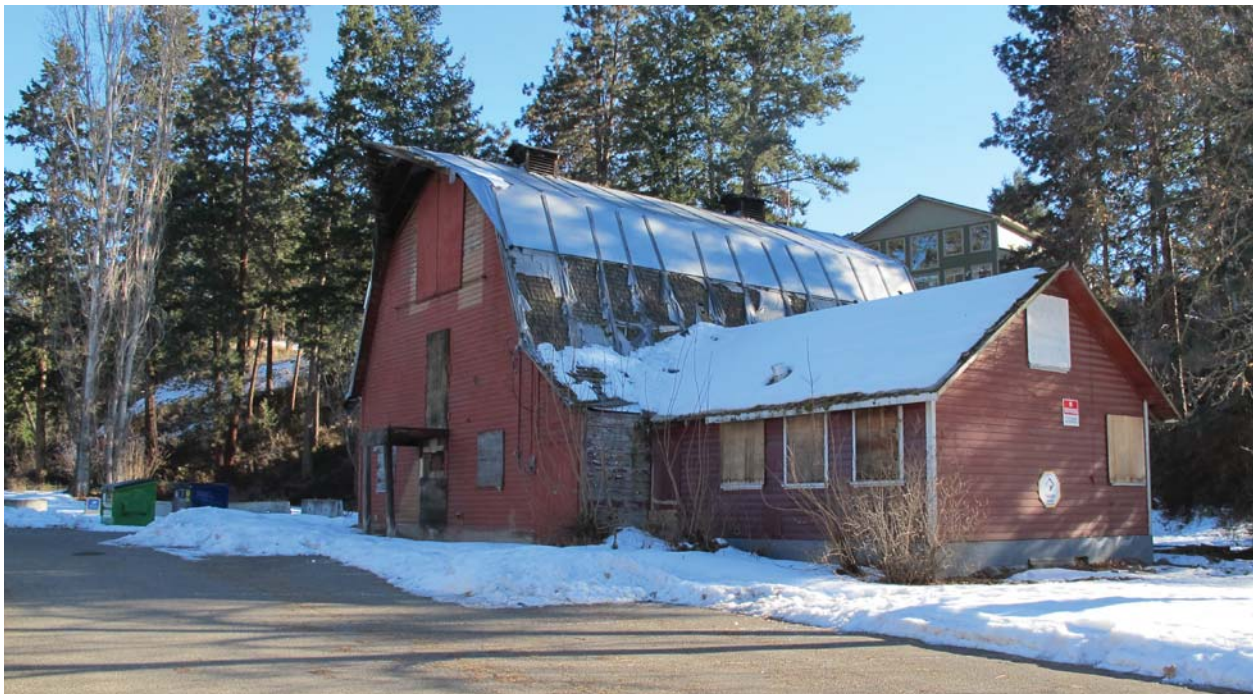
Photos showing north elevation of Surtees Barn, as viewed from northeast (top) and northwest (bottom). Note hill with mature landscape in the background.

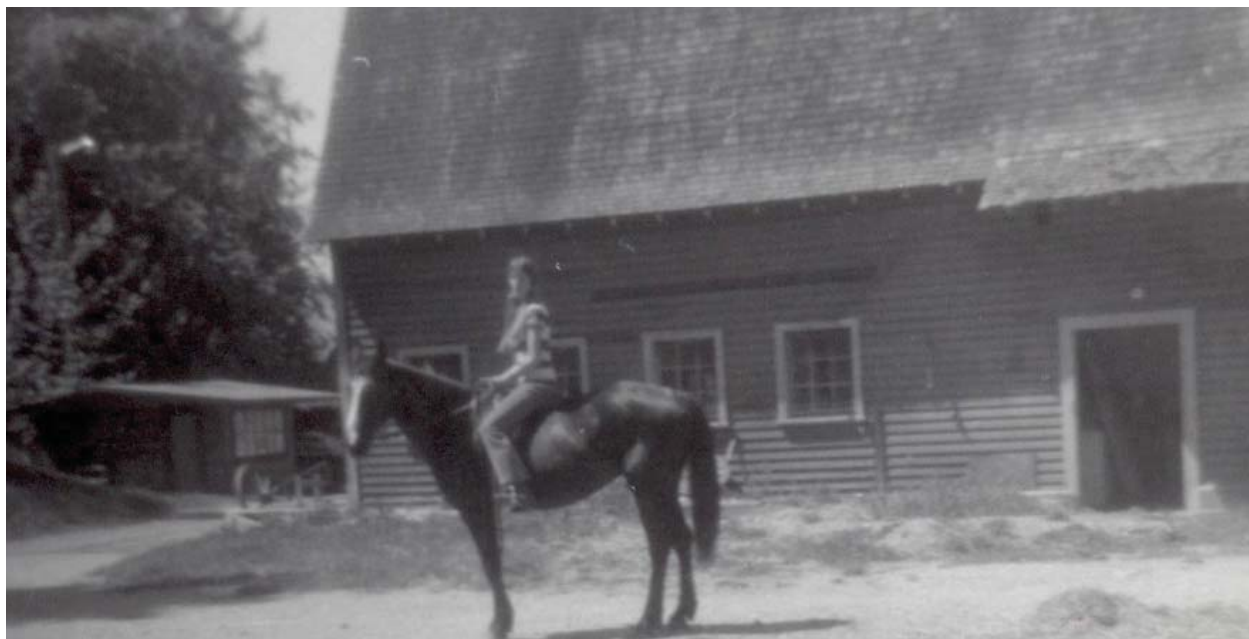
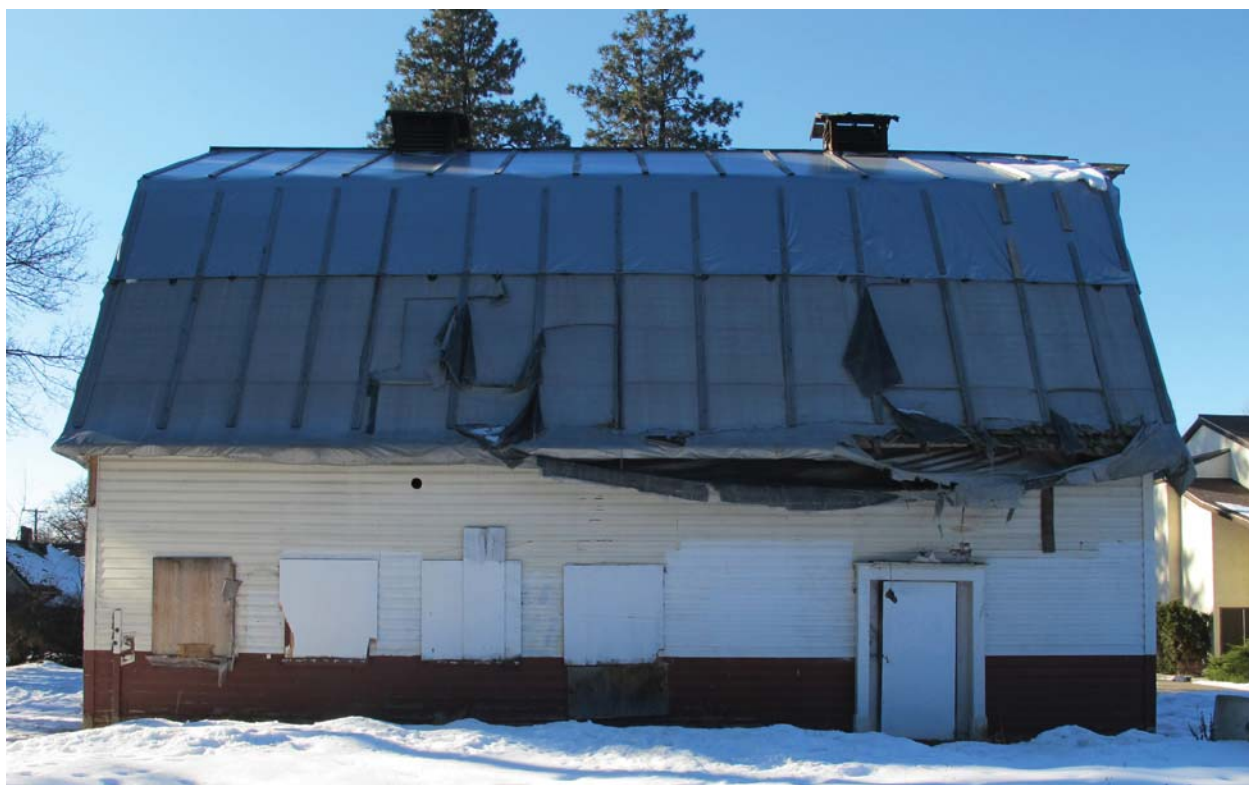
Archival photo showing east elevation of the Surtees Barn (top), with small log house in the background (demolished). Photo showing existing condition of east elevation of the Surtees Barn (bottom); note in the background showing a portion of the Surtees House to the left, and the St. Andrew's Church to the right.

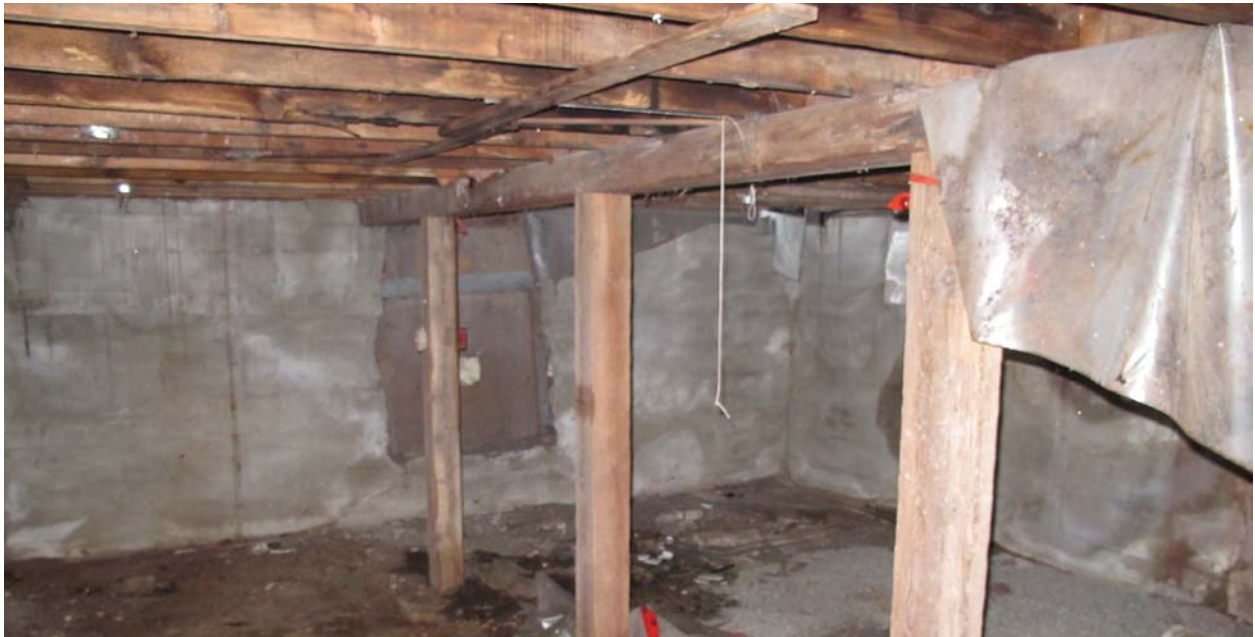
The Surtees Barn features exposed, poured-in-place concrete foundation walls supporting its original wood-frame structure, and raised concrete floor slab. A new concrete foundation will be constructed prior to relocation of the historic building. Careful attention should be executed to ensure the exterior walls above grade are not damaged during demolition of existing foundation and relocation of the barn. The heritage resource should be protected from damage or destruction at all times. Reference sections **4.3: General Conservation Strategy** and **4.6: Site Protection** for further information.

Basement of the west extension to the Surtees Barn.

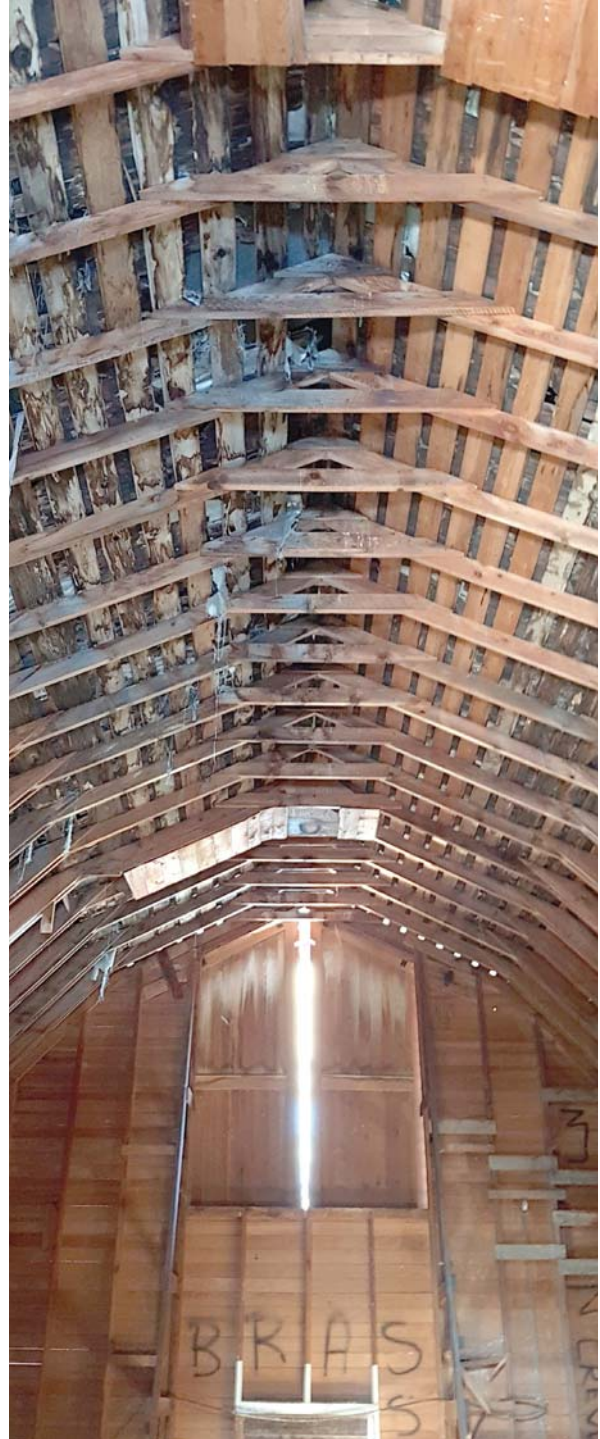
Photo showing interior side of the exterior wood-frame walls, looking north, and underside of the gambrel roof structure of the Surtees Barn.

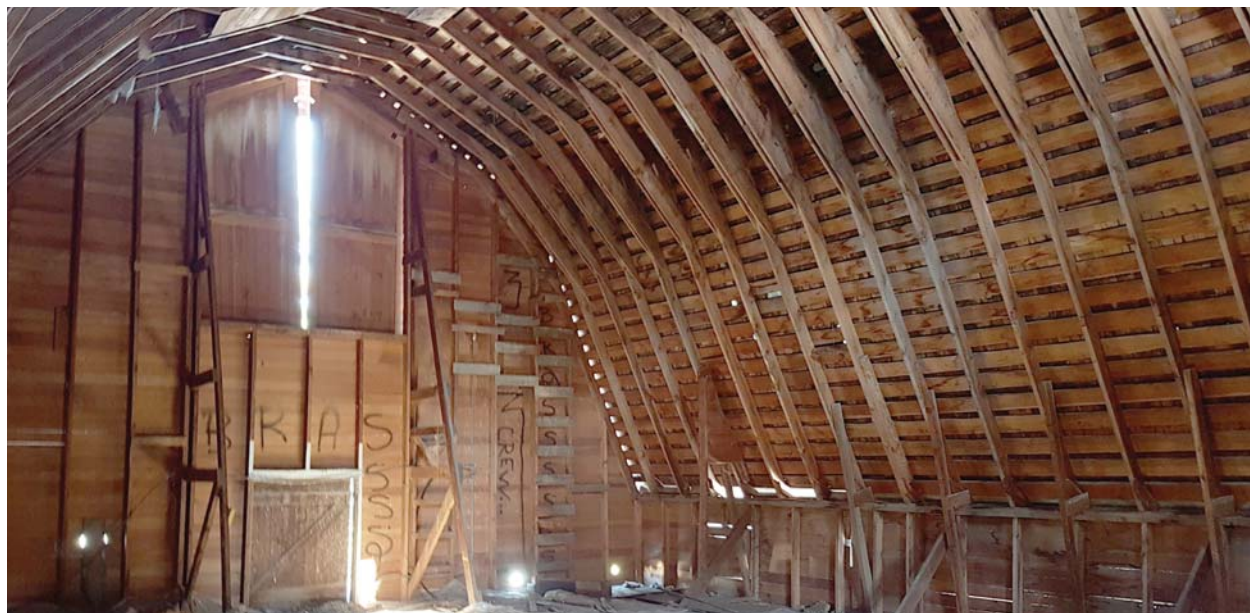
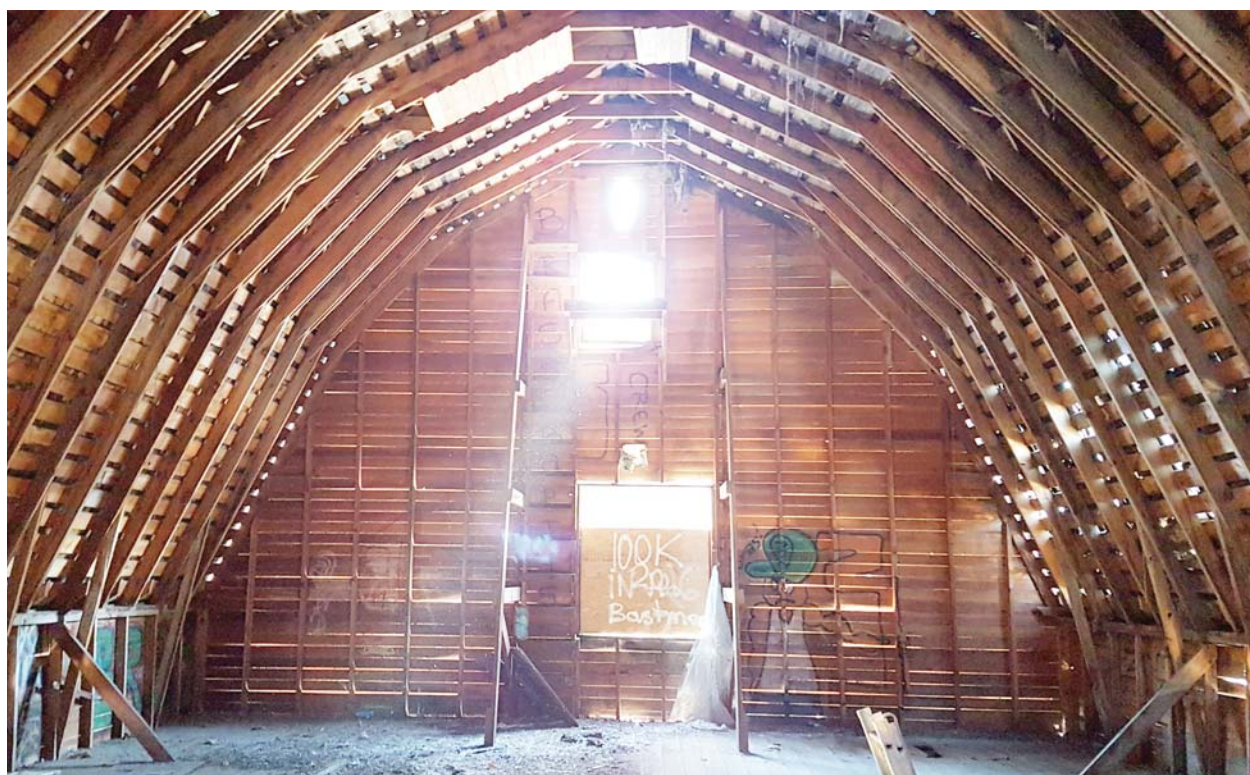
Photos showing exposed gambrel roof structure of the Surtees Barn.

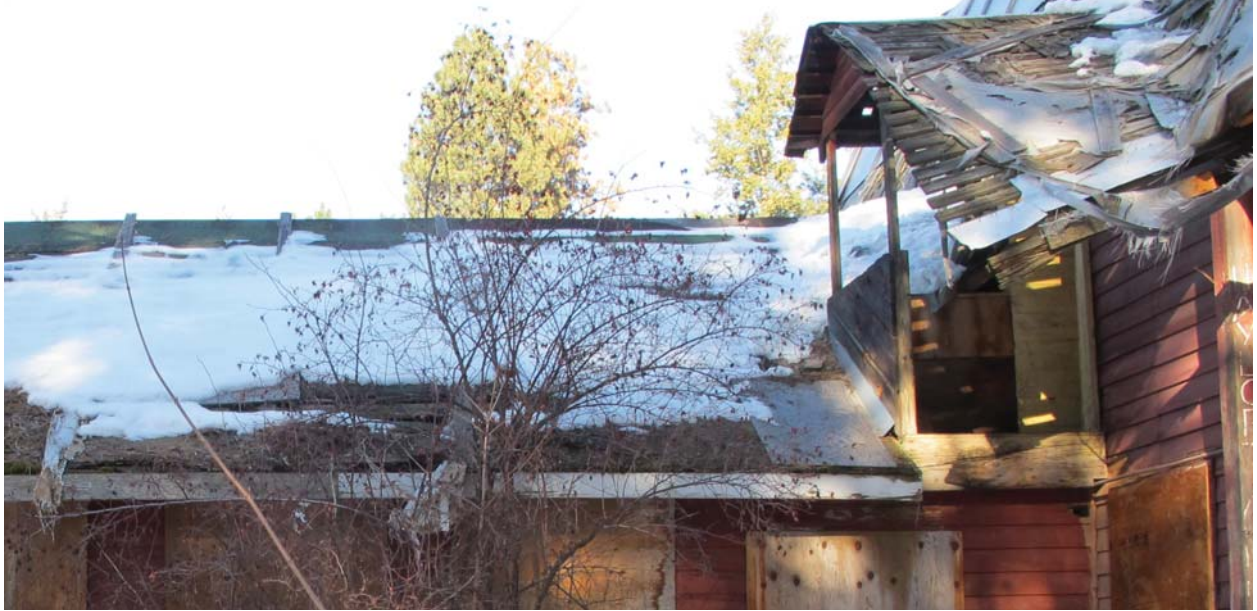
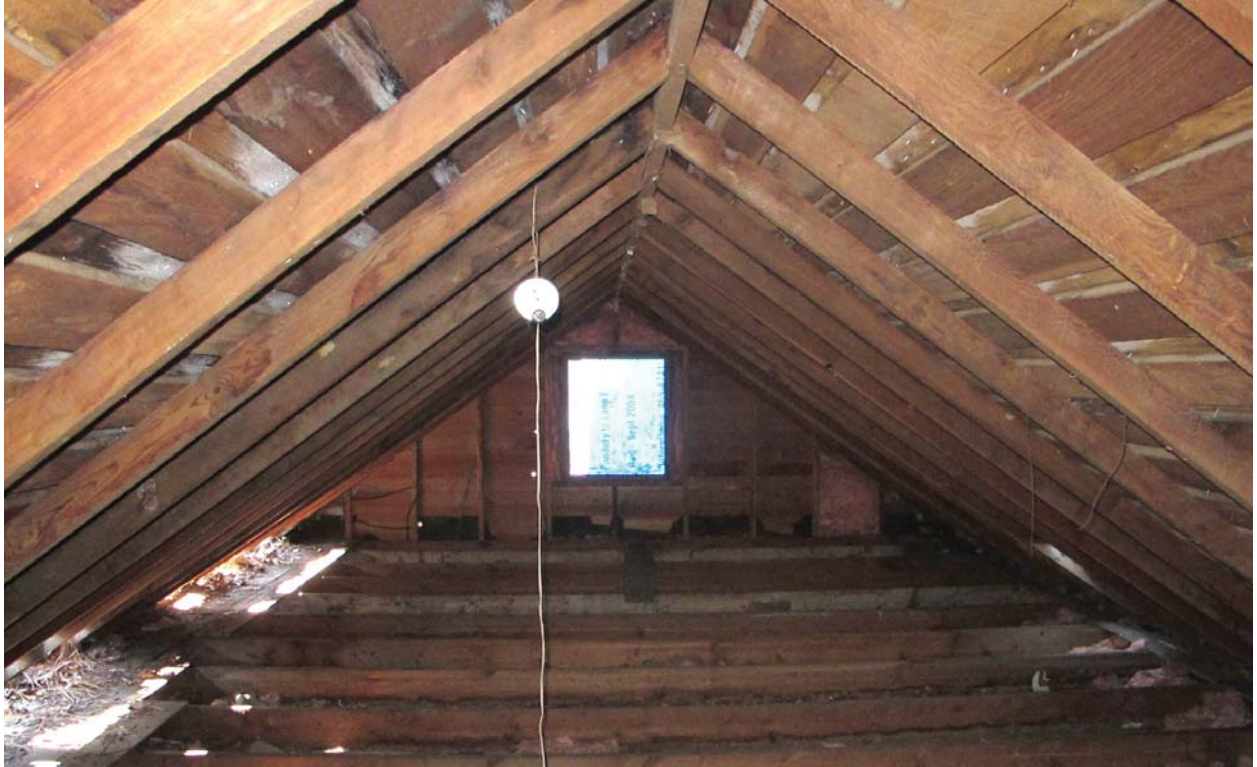
Photos showing side-gabled roof structure of the Surtees Barn extension, from exterior (top) and interior (bottom) side.
