BYLAW NO. 11408

Heritage Revitalization Agreement Authorization Bylaw HRA17-0001 –

4629 Lakeshore Road

SURTEES HOUSE & BARN

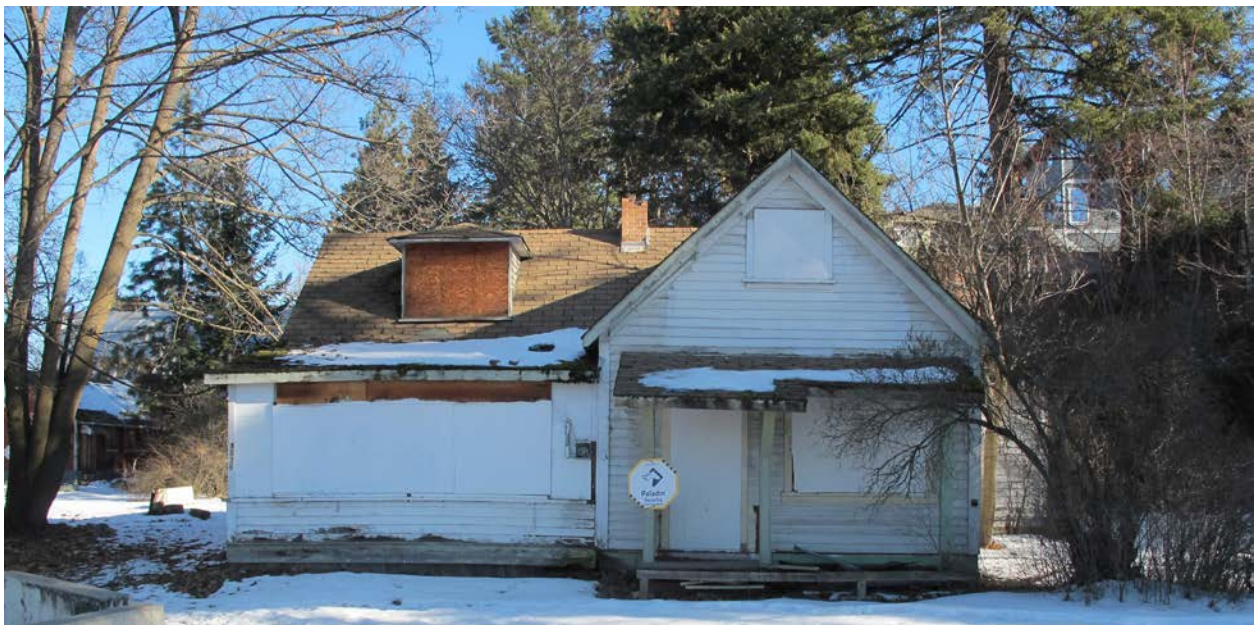
Historic front facade (west elevation) of Surtees House at 4629 Lakeshore Road.

- Preserve the overall form, scale and massing of the building.
- Preserve the primary elevations (front façade and north elevation) as it relates to Lakeshore Road.
- All new addition should be reviewed by Heritage Consultant to ensure that the essential form and integrity of the historic asset is preserved.

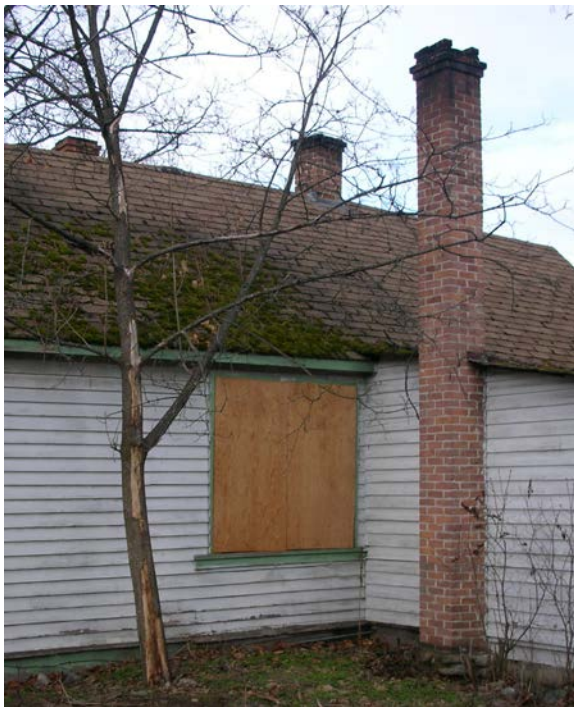
Southwest corner view of the house showing later addition, with exterior brick chimney in the foreground, and two original interior chimney stacks in the background.

- Preserve the roof structure in its current configuration, as expressed by its primary cross-gabled roofstructure.
- If required, roofing membrane and cladding system may be rehabilitated. Cedar shingles are the preferred material, but uroid shingles or Aged Cedar Enviroshingles™ are also acceptable.
- Retain the original bargeboards and fascia boards, as well as the soffit any exposed roof elements.
- Design and install adequate rainwater disposal system and ensure proper drainage from the site is maintained. Wood gutters with galvanized steel downspouts are recommended. Aluminum in appropriate colours is also acceptable. Paint or provide specification of drainage system elements according to colour schedule devised by Heritage Consultant.

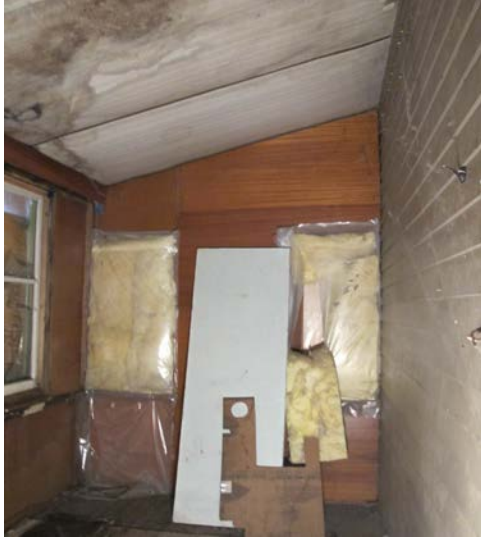
Interior space of the enclosed vestibule (west early addition) showing original exterior horizontal wood lapped siding to the right.

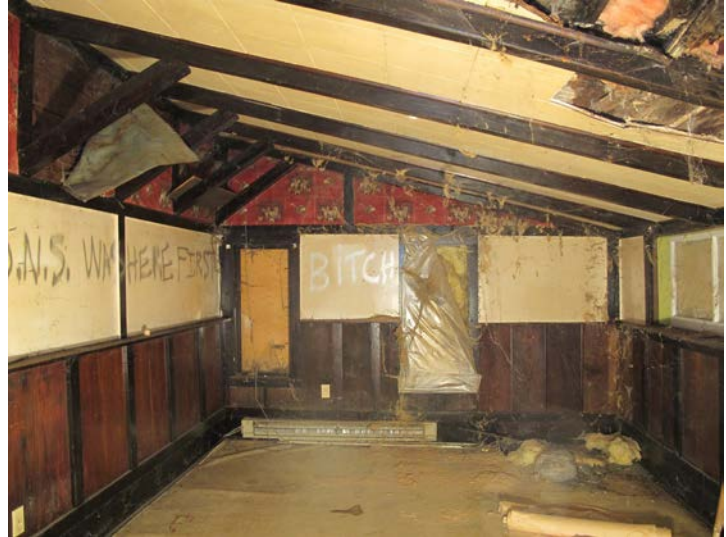
Interior space of the dining room (east early addition) showing exposed shed roof rafters with angle web wood members.

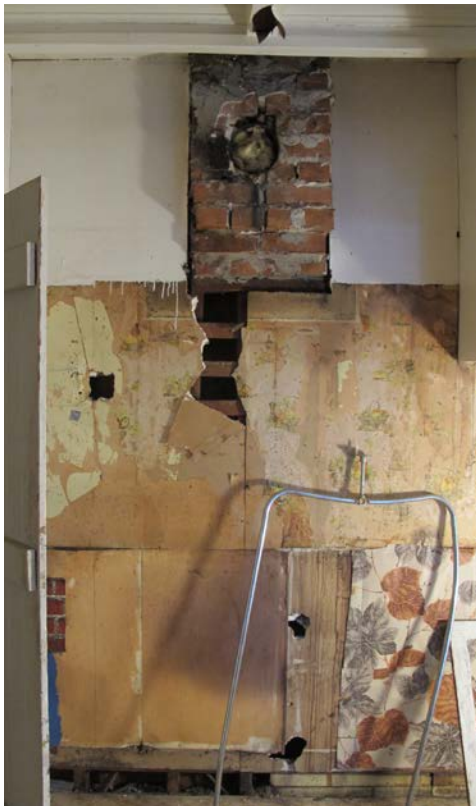
Interior brick masonry chimney flue terminating at midsection of the interior wall, partially showing wood structural support.

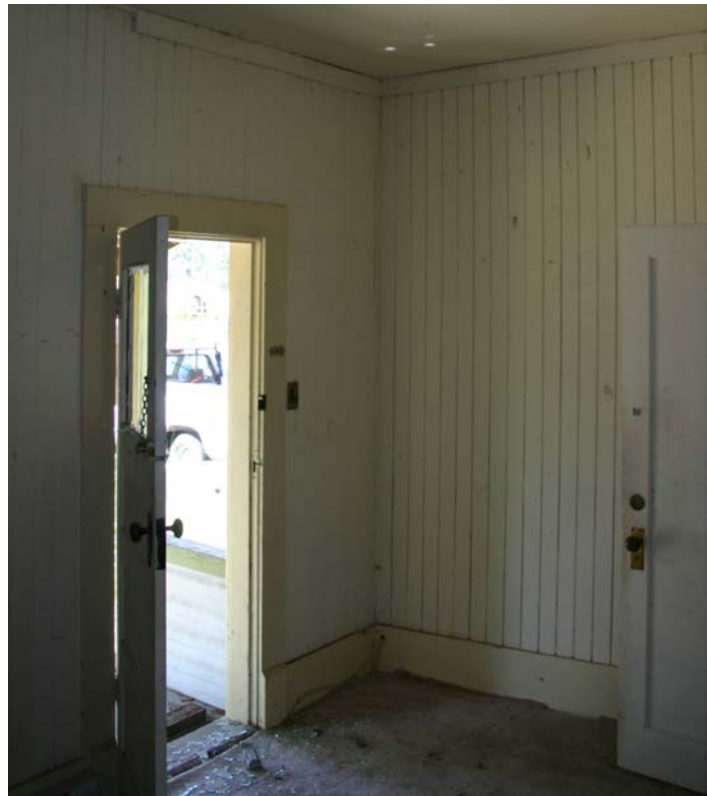
Surviving original v-joint panelling on walls and ceiling of front hall, showing original main entrance door to the left.

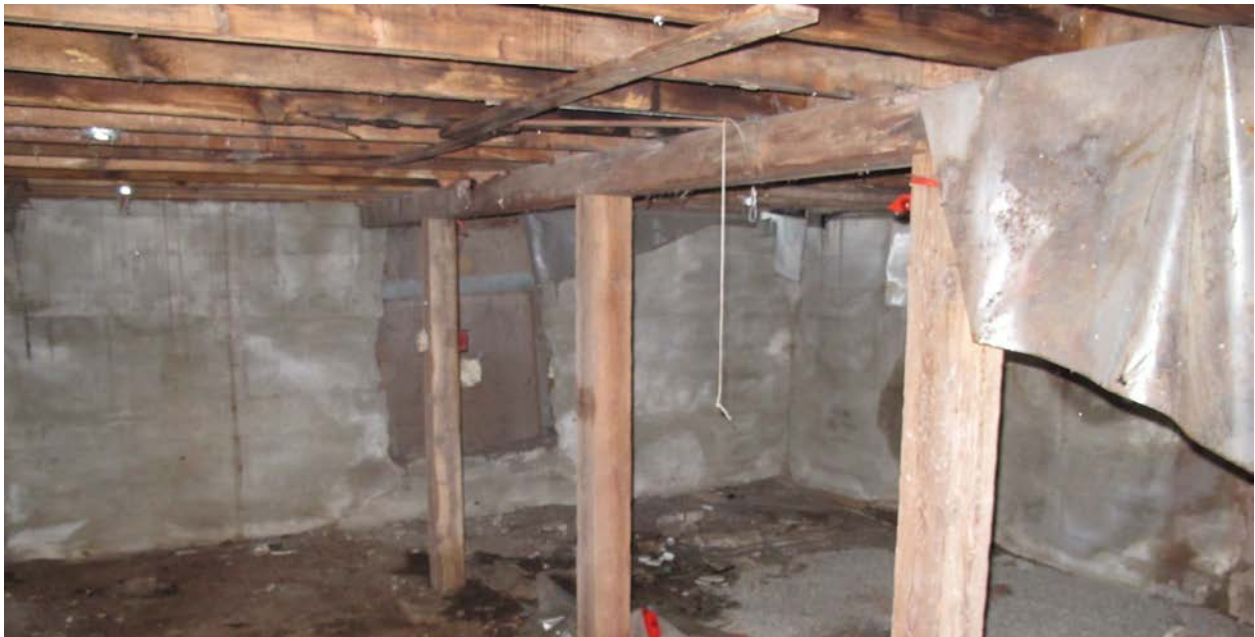
The Surtees Barn features exposed, poured-in-place concrete foundation walls supporting its original wood-frame structure, and raised concrete floor slab. A new concrete foundation will be constructed prior to relocation of the historic building. Careful attention should be executed to ensure the exterior walls above grade are not damaged during demolition of existing foundation and relocation of the barn. The heritage resource should be protected from damage or destruction at all times. Reference sections 4.3: *General Conservation Strategy* and 4.6: *Site Protection* for further information.

Basement of the west extension to the Surtees Barn.

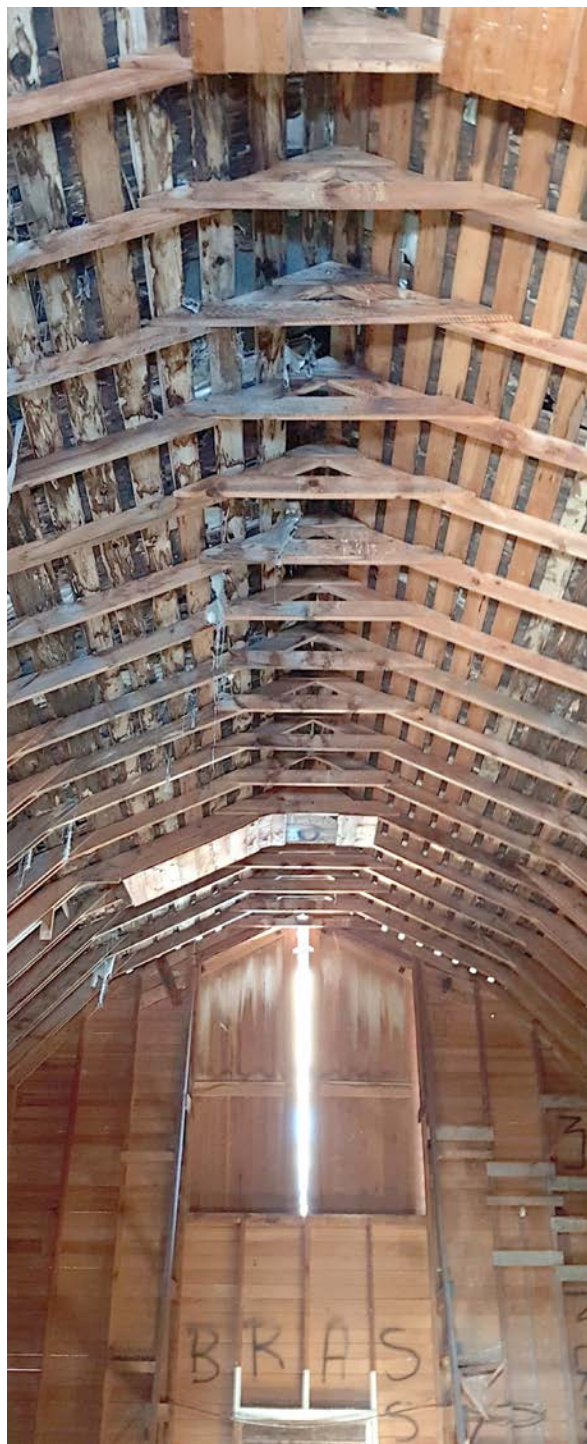
Photo showing interior side of the exterior wood-frame walls, looking north, and underside of the gambrel roof structure of the Surtees Barn.

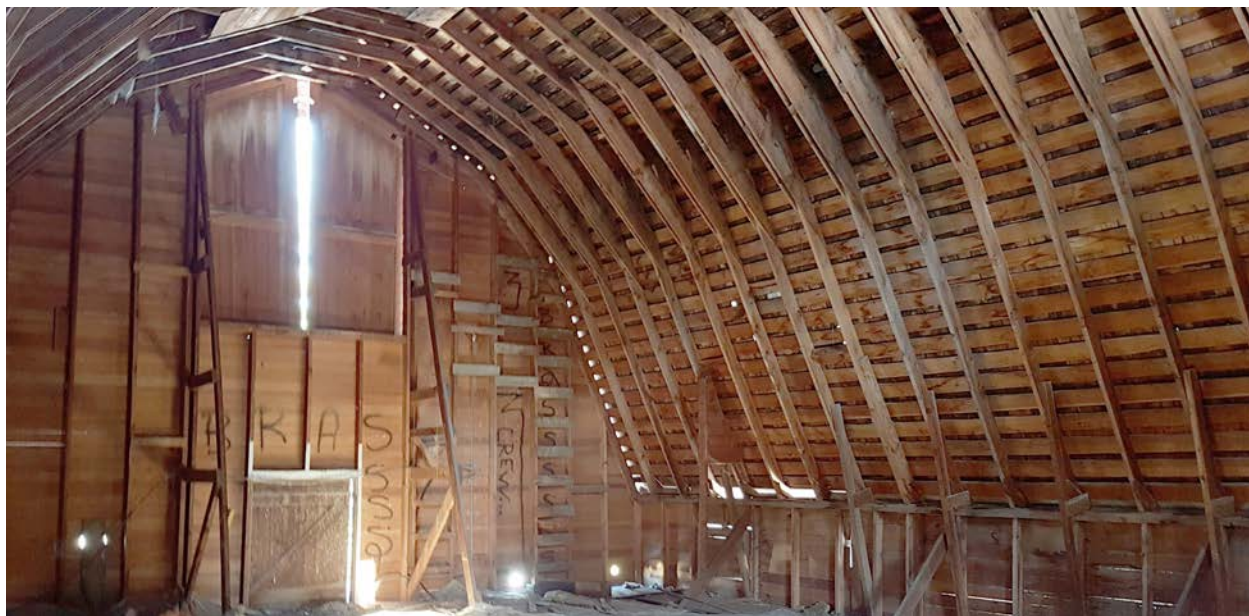
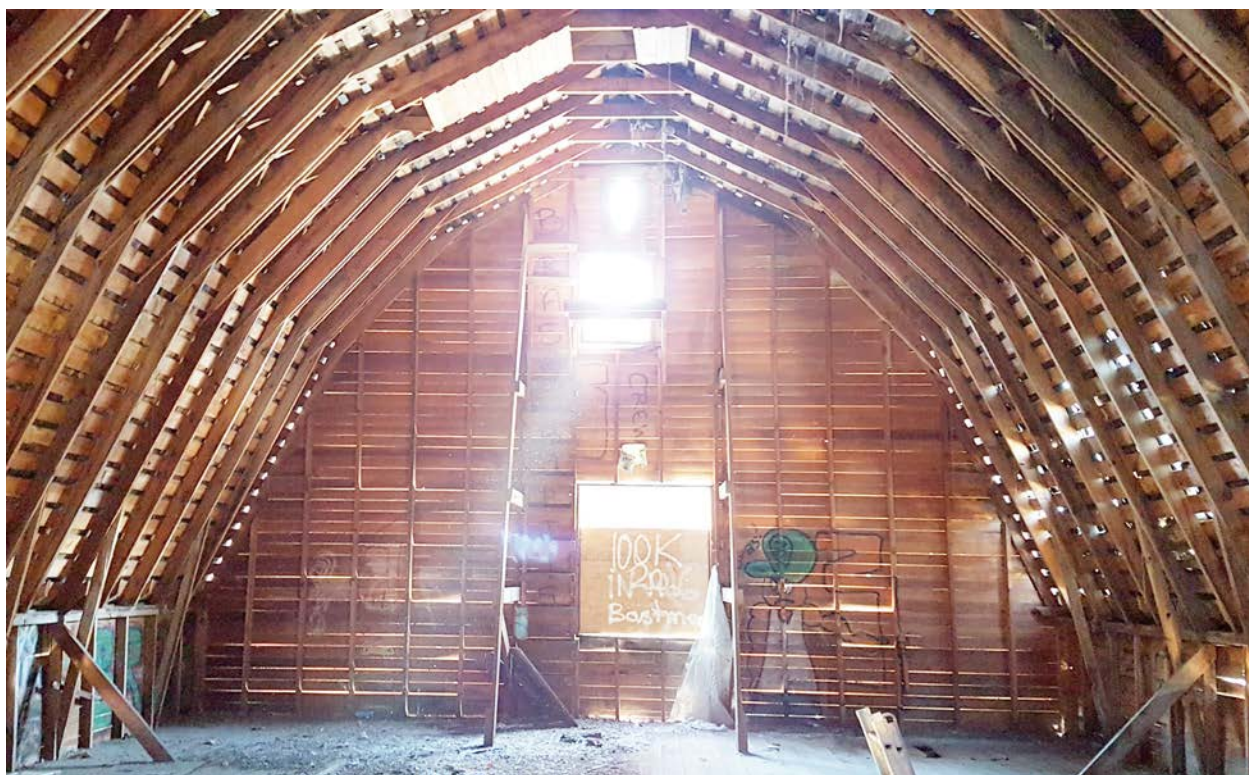
Photos showing exposed gambrel roof structure of the Surtees Barn.

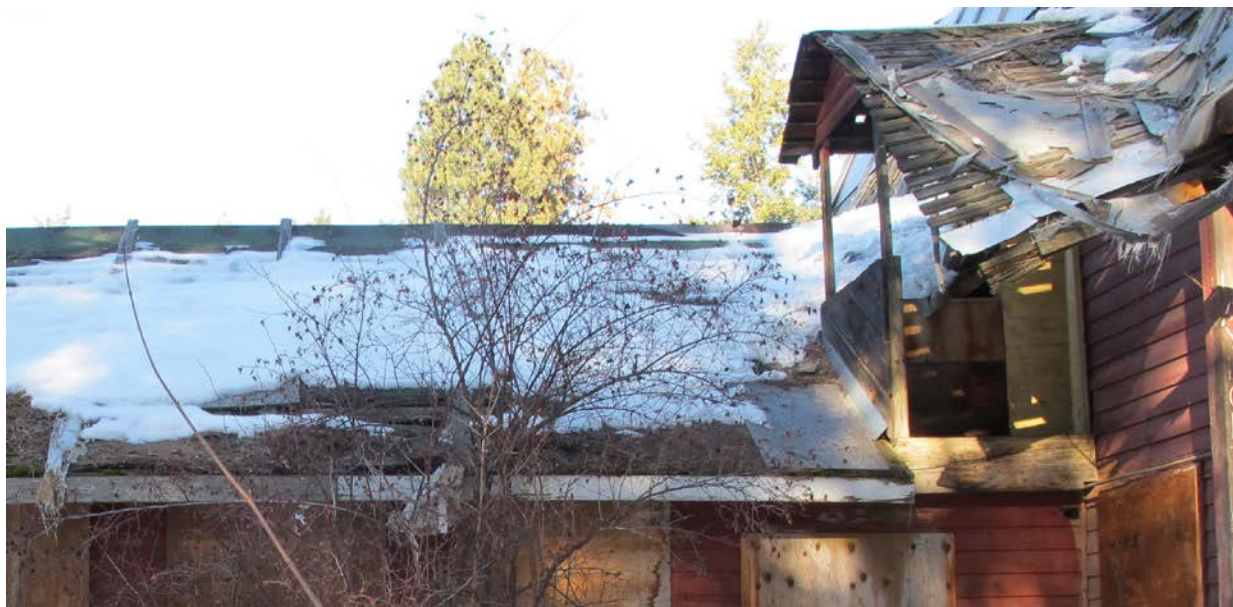
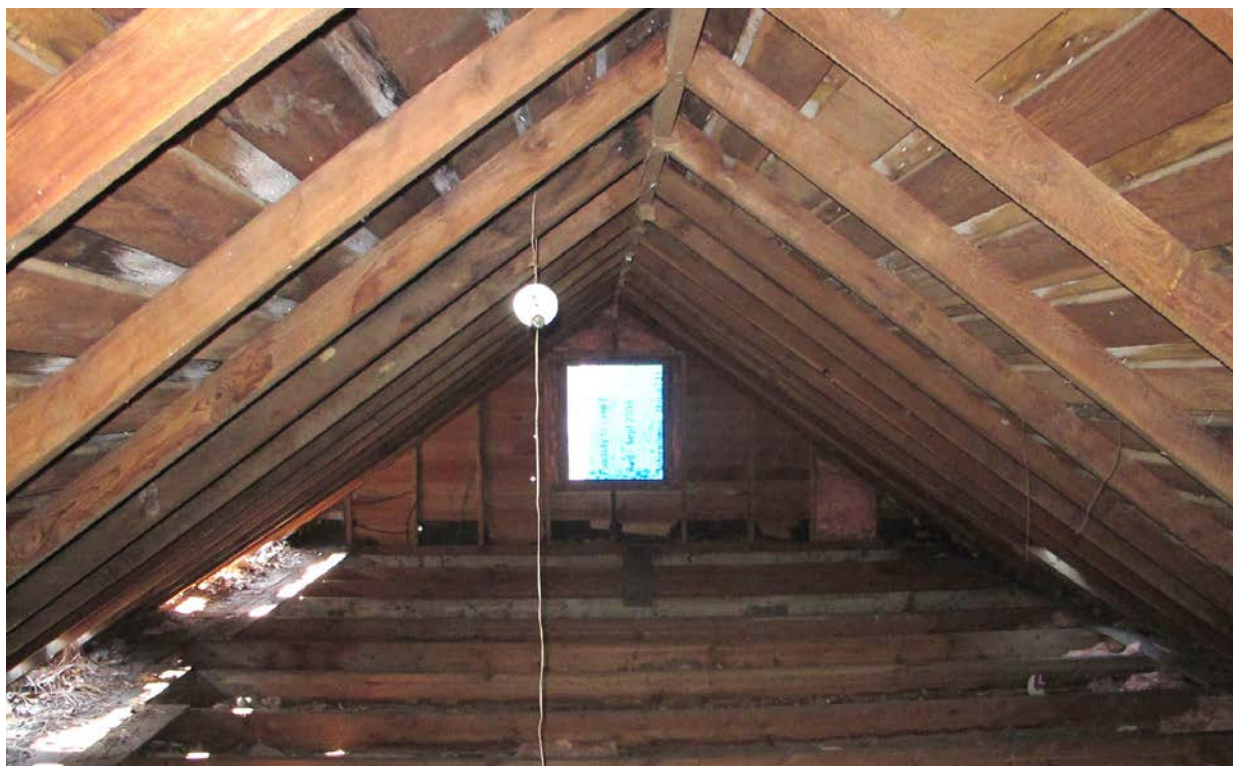
Photos showing side-gabled roof structure of the Surtees Barn extension, from exterior (top) and interior (bottom) side.
