## BYLAW NO. 11408

Heritage Revitalization Agreement Authorization Bylaw HRA17-0001 –

# SURTEES HOUSE & BARN

4629 LAKESHORE ROAD, KELOWNA, BC

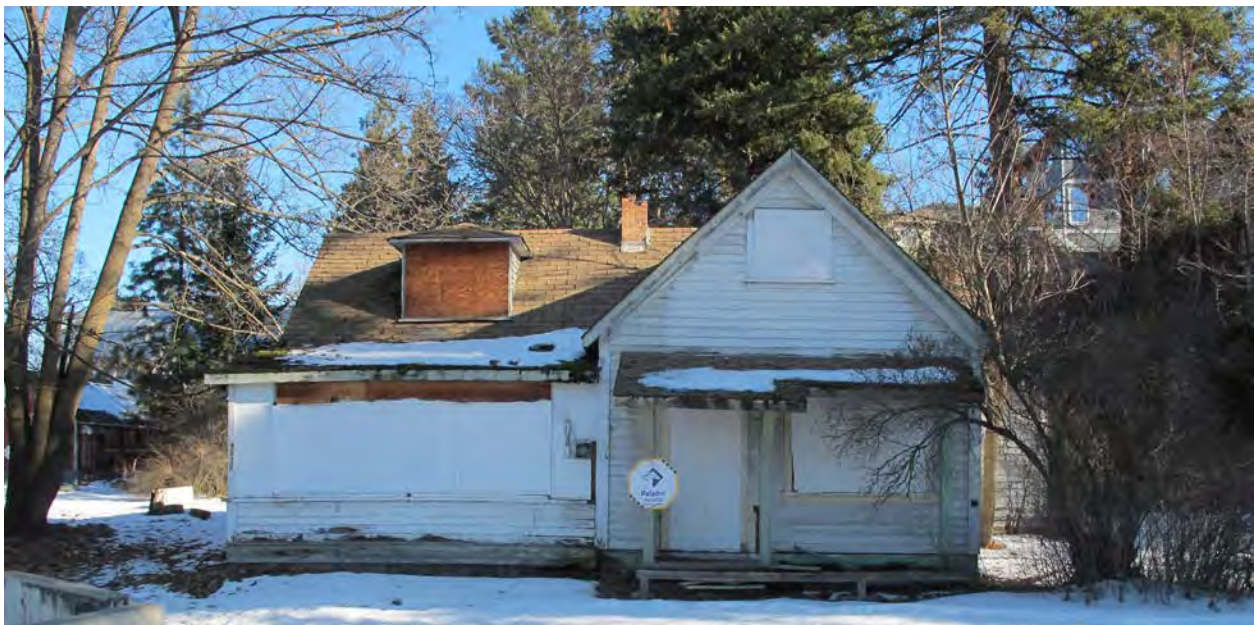
*Historic front facade (west elevation) of Surtees House at 4629 Lakeshore Road.*

- Preserve the overall form, scale and massing of the building.
- Preserve the primary elevations (front façade and north elevation) as it relates to Lakeshore Road.
- All new addition should be reviewed by Heritage Consultant to ensure that the essential form and integrity of the historic asset is preserved.

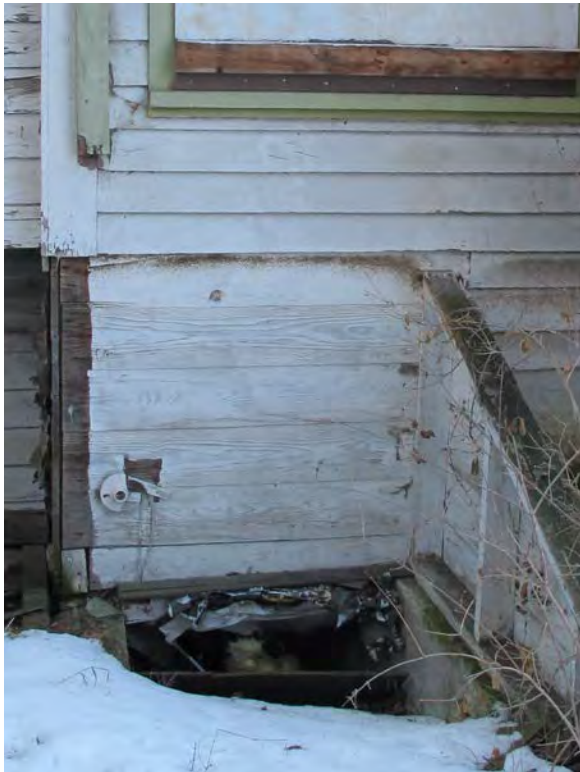
*Portion of rear elevation showing opening to unoccupied partial basement, with exposed cast-in-place concrete foundation walls.*

The foundation of the Surtees House was inaccessible during the initial review, and would require the removal of exterior cladding in localized area to expose the foundation beneath. However, a partial basement was noted from an opening at the rear of the building, suggesting that the timber-frame structure is sitting on a cast-in-place concrete footing and foundation wall.

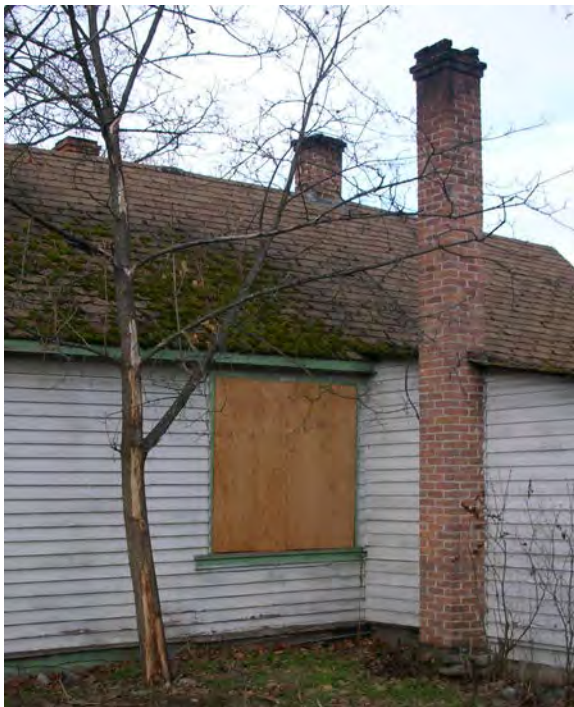
*Southwest corner view of the house showing later addition, with exterior brick chimney in the foreground, and two original interior chimney stacks in the background.*

**Conservation Recommendation: Preservation**

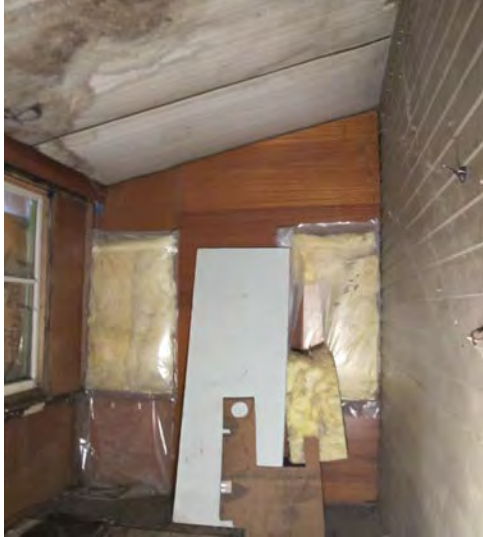
*Interior space of the enclosed vestibule (west early addition) showing original exterior horizontal wood lapped siding to the right.*

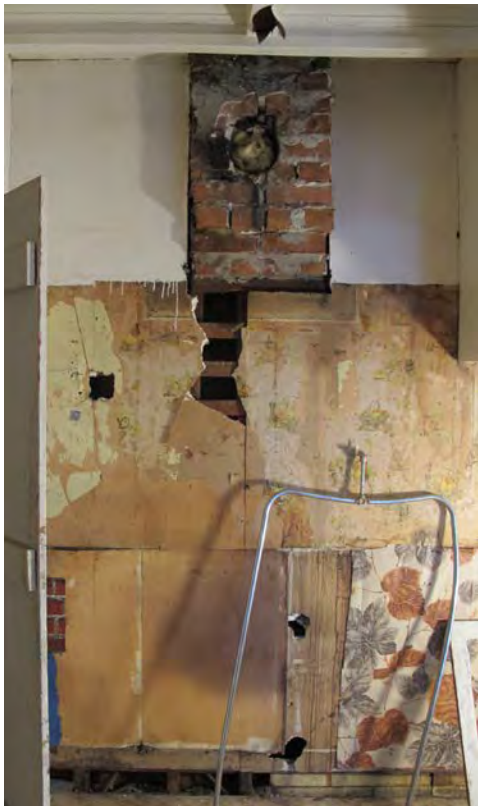
*Interior brick masonry chimney flue terminating at midsection of the interior wall, partially showing wood structural support.*

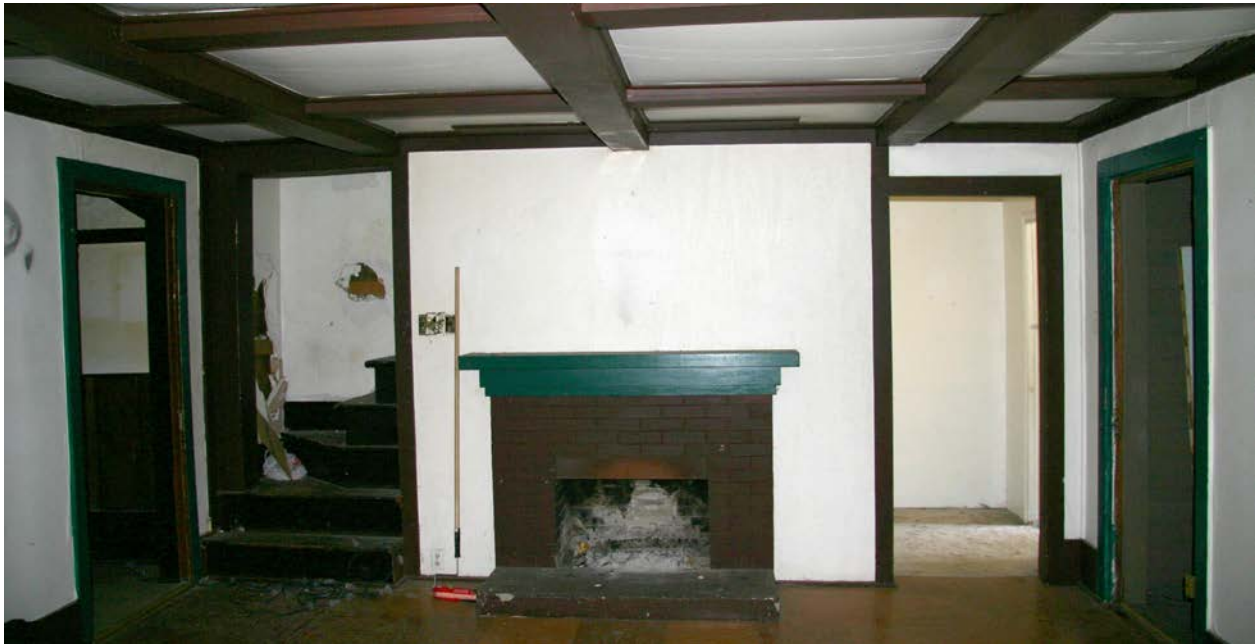
The Surtees House features an original, narrow winder staircase that is accessible from the large bedroom to the north, leading up to the attic spaces behind the fireplace. The low-height attic apices may have been used for storage or boarding rooms for servants. The staircase is intact and appears to be in good condition, and may be rehabilitated, as necessary.

The Surtees House features a modest brick masonry fireplace with raised concrete hearth and wood mantel. The paint finish is not historically accurate, and should be removed. The fireplace is intact and appears to be in good condition, and may be rehabilitated, as necessary.

*Photos showing surviving interior character-defining elements of Surtees House, including narrow winder staircase; brick masonry fireplace with raised concrete hearth and wood mantel; low ceiling with expressed horizontal beams and coffered-effect.*

**Conservation Strategy: Rehabilitation**

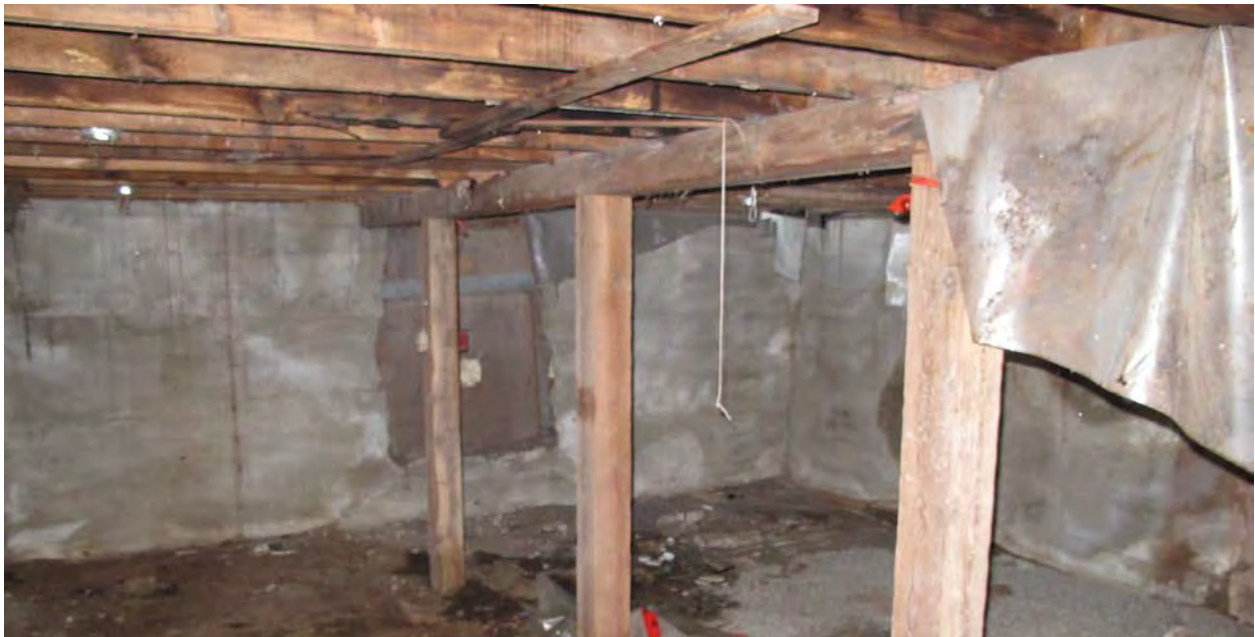
*Basement of the west extension to the Surtees Barn.*

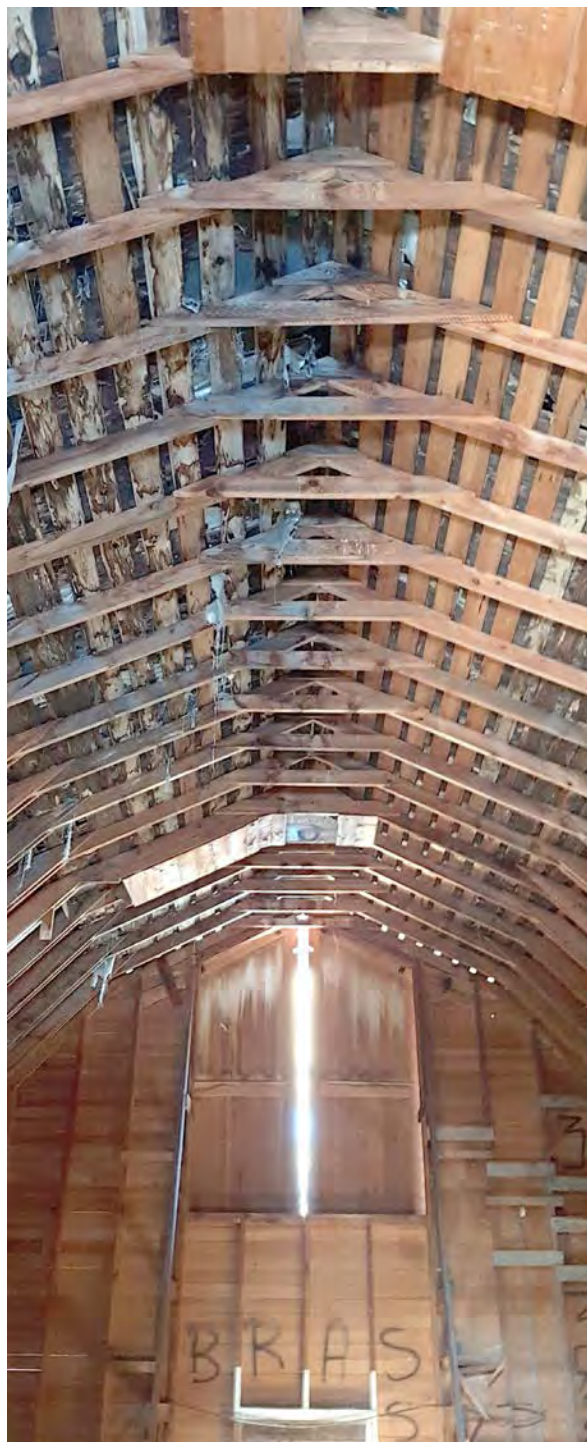
*Photo showing interior side of the exterior wood-frame walls, looking north, and underside of the gambrel roof structure of the Surtees Barn.*

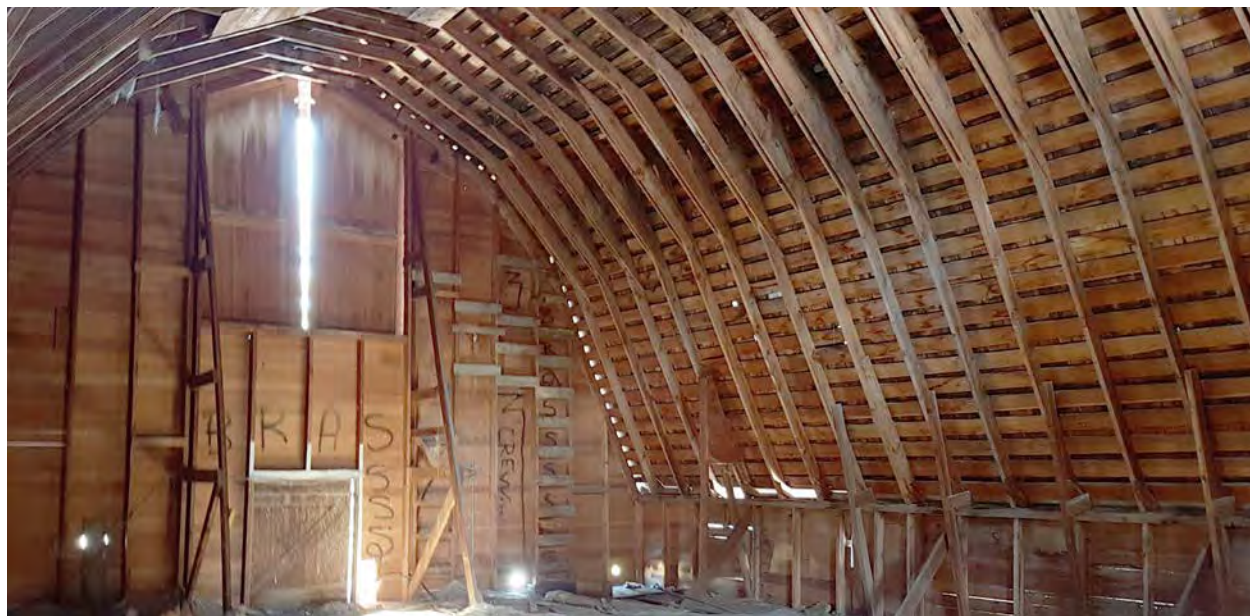
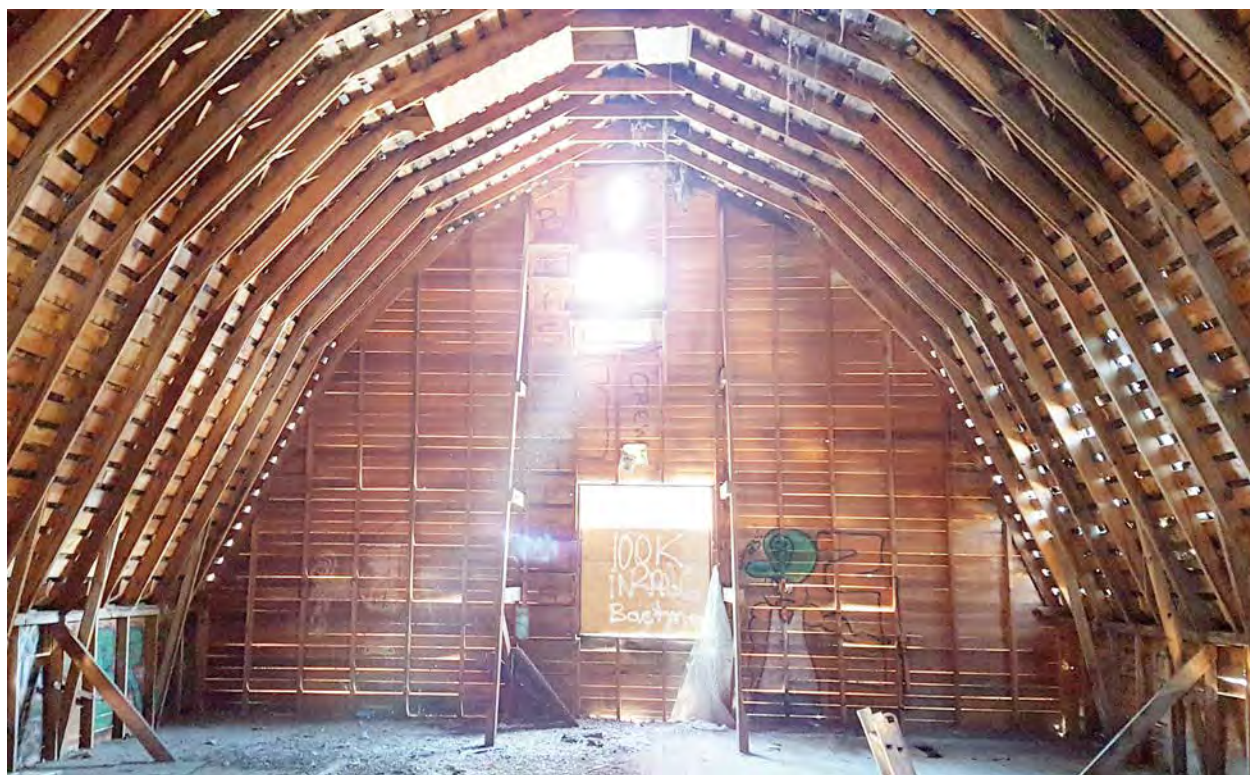
*Photos showing exposed gambrel roof structure of the Surtees Barn.*

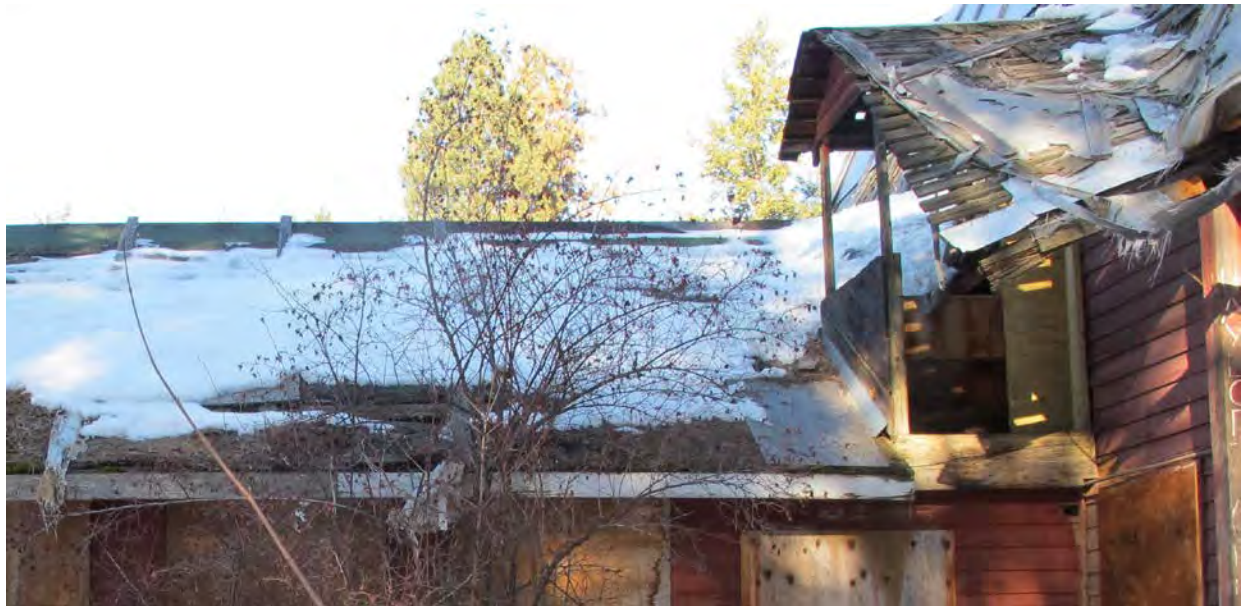
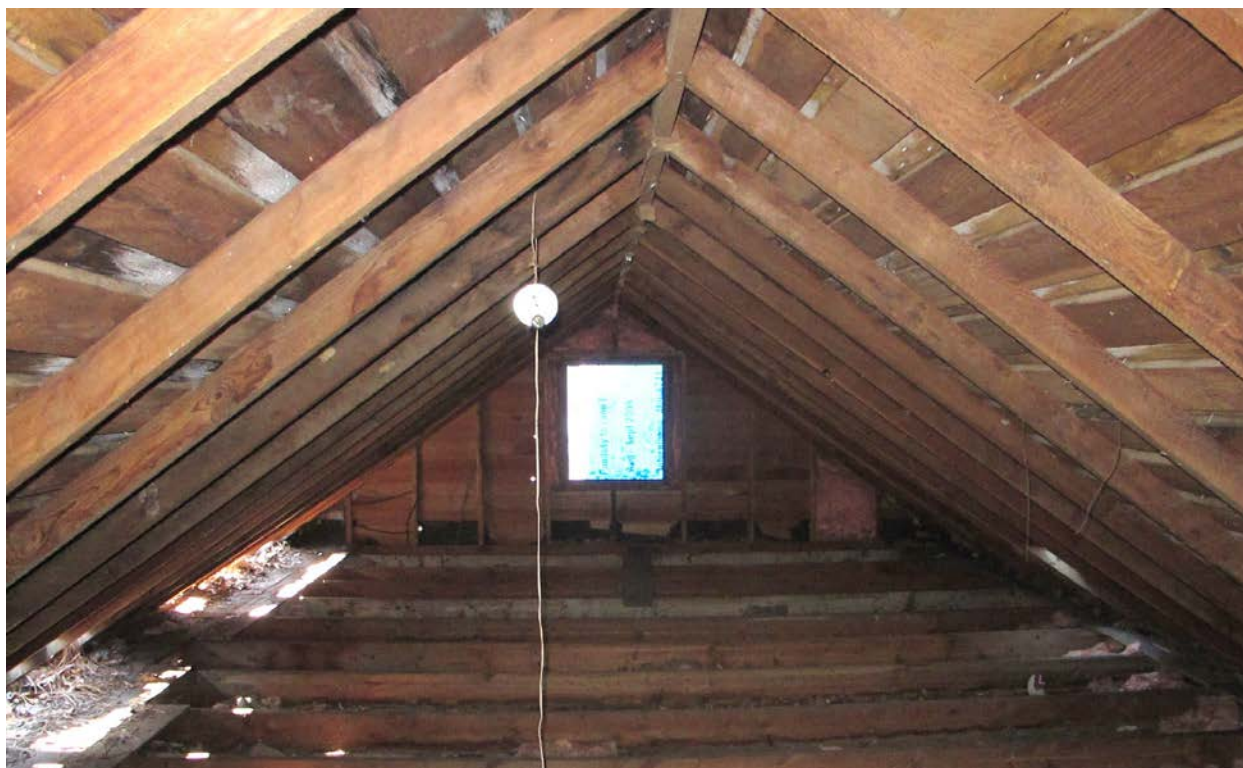
*Photos showing side-gabled roof structure of the Surtees Barn extension, from exterior (top) and interior (bottom) side.*
