# CITY OF KELOWNA

## BYLAW NO. 11408

Heritage Revitalization Agreement Authorization Bylaw HRA17-0001 –

# SURTEES HOUSE & BARN

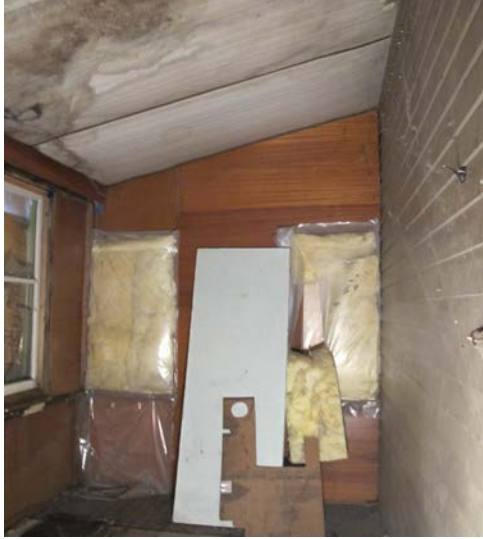
*Interior space of the enclosed vestibule (west early addition) showing original exterior horizontal wood lapped siding to the right.*

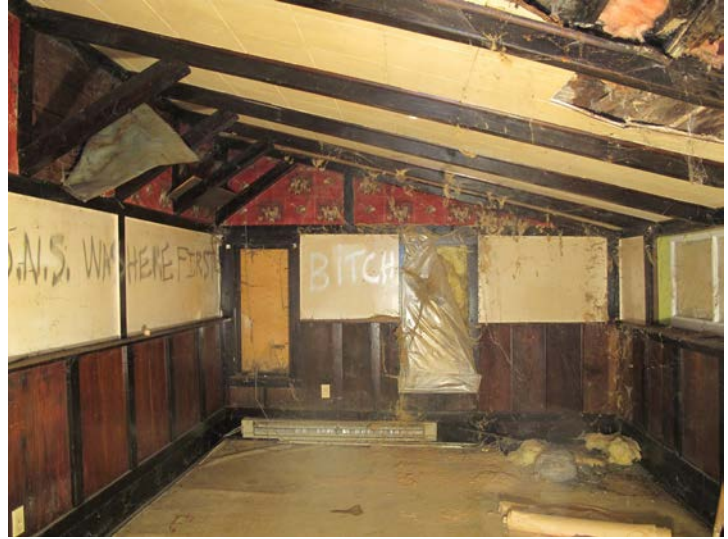
*Interior space of the dining room (east early addition) showing exposed shed roof rafters with angle web wood members.*
