**Rationale for Request to Designate the Benvoulin Heritage Park (2279 Benvoulin Road) with a Municipal Heritage Designation Bylaw: (attached to form)**

# HERITAGE CONSERVATION (MANAGEMENT) PLAN for the McIver House

2269 - 2279 Benvoulin Road, Kelowna, BC

Prepared for: **The Central Okanagan Heritage Society,**  
**August 2018**

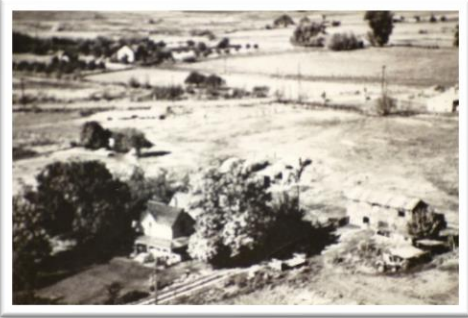
<p>This aerial photo shows the Mclver House (left lower corner) in its farm setting, including a large barn set back to the right of the house. KLO Road, located in front of the house, is not in the photo, but the driveway from KLO Road to the house is visible to the right of the house. This photo was taken during the time that the Mclver Family lived in the house. Mclver Family Photos &amp; COHS Fonds, n.d.</p>	<p><b>Original design and elements:</b></p> <ul style="list-style-type: none"> <li>- post and beam wood frame structure</li> <li>-1.5-storey house has a front sloping pitched roof and shed rear extension in the saltbox form</li> <li>-front gable roof has a central raised gable over the second-floor door to the balcony</li> <li>-gable roof drops lower in the back of the building to cover a second set of rooms</li> <li>-front façade has a three-bay façade: second floor- door with balcony with plain walls on each side; main floor- three bays are emphasized by the posts dividing the space.</li> <li>-exterior is clad with horizontal drop siding, including details such as corner boards, simple window and door trims.</li> <li>-front upper central balcony</li> <li>-wrap-around verandah in front, right side, and back</li> <li>-sleeping porch (either original or early addition on verandah; important in hot Okanagan summers)</li> <li>-delicate wood detail on posts and beneath the eaves on front and side; back has simple posts only</li> <li>-single hung windows with one over one and two over two sashes with simple wood mouldings</li> </ul>

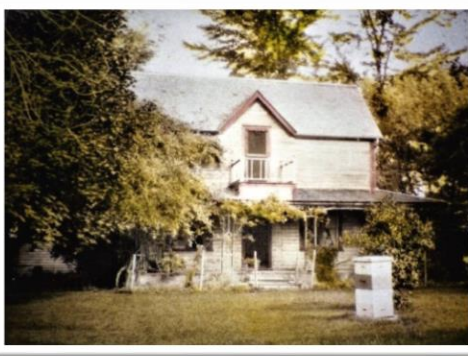
<p>View of the front of the house soon after the Mclver family moved in. Many of the house’s original design and elements are visible. Mclver Family Photos &amp; COHS Fonds, c.1930s</p>	<p><b>Original design and elements:</b></p> <p>The approx. 30-year-old house appears to be in fair to good condition. The burgundy trims are faded. The siding colour has faded and appears to be a lighter tone. The roof appears to be in good condition, with the chimney not visible from this side of the house. The second-floor balcony appears to be in fair condition. Both the second-floor door onto the balcony and the front door have simple two panel screen doors. The front verandah is in fair condition with the wood detailing on the posts and beneath the eaves visible. The vertical verandah skirting, as well as the simple steps up to the verandah can be seen.</p>

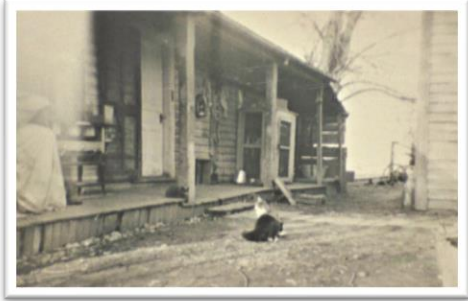
<p>View of the back of the house after the Mclver family moved in. The original design of the verandah is visible. Mclver Family Photos &amp; COHS Fonds, c.1930s</p>	<p><b>Original design and elements:</b></p> <p>The back verandah of the house looks to be in fair to poor condition. The skirting that encloses the deck has missing boards. The verandah posts are visible, as well as the horizontal boards at the end of the verandah, that have likely been added later to enclose this section of the verandah. The simple step up to the verandah's back door and the open four-panel screen door is visible.</p> <p>The verandah was on three sides of the house when the Mclver family moved in. This included the early/ original sleeping porch, which was enclosed with boards in between the posts with screening on the upper half. There would have been a screen door facing the back of the house, next to the side door into the kitchen area of the house.</p>

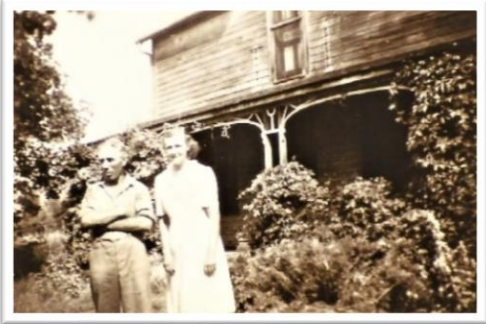
<p>Bernard ('Barney') and Harriet Mclver standing in front of their house without the second-floor balcony. Mclver Family Photos &amp; COHS Fonds, c.1945</p>	<p><b>Original element removed:</b></p> <p>The 40-year-old house appears to be in fair condition, with the first major change to the front façade visible. The second-floor balcony has been removed, likely due to rot. In this c. 1945 photo, the area where the balcony was attached to the house is visible.</p> <p>The house appears to be in desperate need of new paint, as there is a significant amount of bare wood showing on the upper siding. Some of the wood detailing on the verandah posts is missing.</p>
1940s/ 1950s	<p>A 'mudroom' was built at the rear of the house on the right-hand side, replacing the back verandah.</p>

*Note: The house was likely still painted in the above colours when the McIver Family bought the house in 1927. The house was not repainted for many years, as seen in the bare wood in the 1940s photo of the front of the house showing that the balcony was removed.*

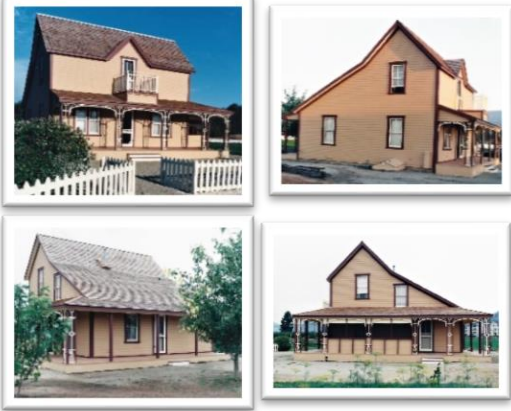
<p>View of SW, NW, NE &amp; SE facades. COHS Fonds, 1996</p>	<p><b>Original elements restored:</b></p> <p>See above for details</p>
Fall 1996

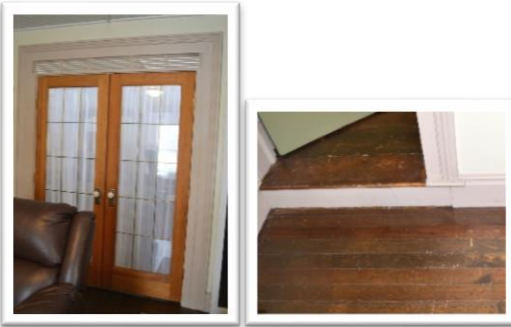
<p>New French doors &amp; Refinished floors (living room) with vintage paint removed. L. Dauncey, 2018</p>	<p><b>Renovation of interior to make more livable for caretaker(s)</b></p> <ul style="list-style-type: none"> <li>-floors were refinished (the perimeter black paint in living room was removed) and work done to keep mice from getting into the house through the crawlspace</li> <li>-interior was repainted</li> <li>-new French doors were installed between the living room and the dining room to create a new main floor bedroom. The space was modified in order to install the new doors.</li> <li>-two bathrooms had renovations and updates, such as new sinks, toilets, etc.</li> </ul>

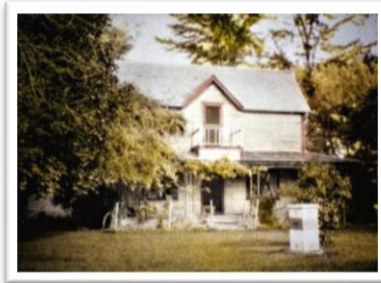
#### Original/early colours:

Siding – creamy caramel/gold

Sashes, soffits & decorative elements- cream

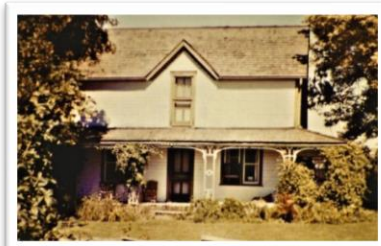
#### Repainted in the 1950s/early 1960s

Siding- warm white

Sashes, soffits & decorative elements- warm white

*Note: In the 1950s/1960s, the house was repainted in a more modern colour scheme.*

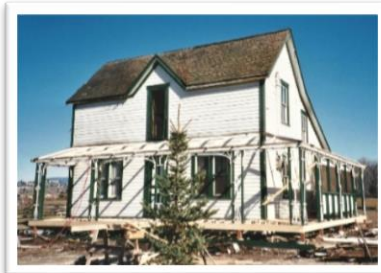
#### Repainted in the 1970s

Siding- bright white

Sashes, soffits & decorative elements- bright white

*\*Note: this is the colour scheme that was on the McIver House when it was donated to COHS and moved onto the Benvoulin Park site.*

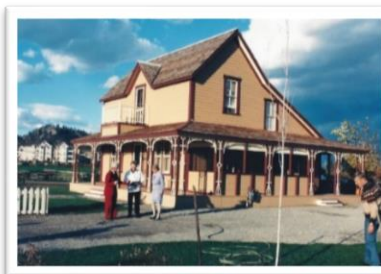
#### Repainted in 1995 to 'match' original/early colour scheme

Siding – creamy caramel/gold (Pantone 1245 U)

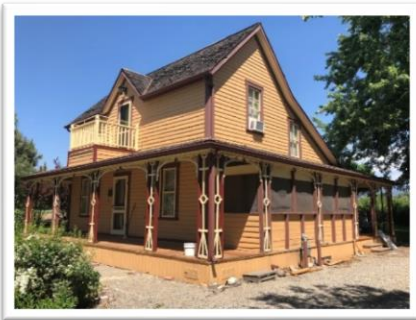
Part of the conservation of the building is to ensure that the exterior of the McIver House is painted in historically appropriate paint colours. The following colour scheme has been determined by finding the closest match of the Benjamin Moore *Historical True Colour Palette for Western Canada* with the building's current colours.

**\*Note:** The conservation work undertaken in 2017-18 included a coat of paint where repairs or replacement was necessary using the True Colours palette. The match is not exact, partially due to fading of the intense colours (repainted 11-12 years ago), especially the dark burgundy colour. This will be corrected once the house is repainted in the near future. It should also be noted that the siding is not a very close match to the True Colour palette. The True Colour, Strathcona Gold VC-9, chosen is the closest colour on the palette. It was decided to use a closer match for the verandah skirting and the balcony boards for this project and use the VC-9, when the house is repainted.
