409 Park Avenue

Application for Removal from the City of Kelowna - Heritage Register

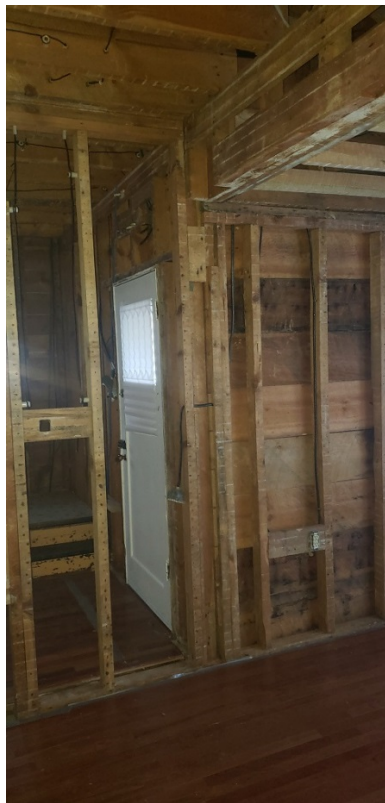
Interior after removal of Lath and Plaster

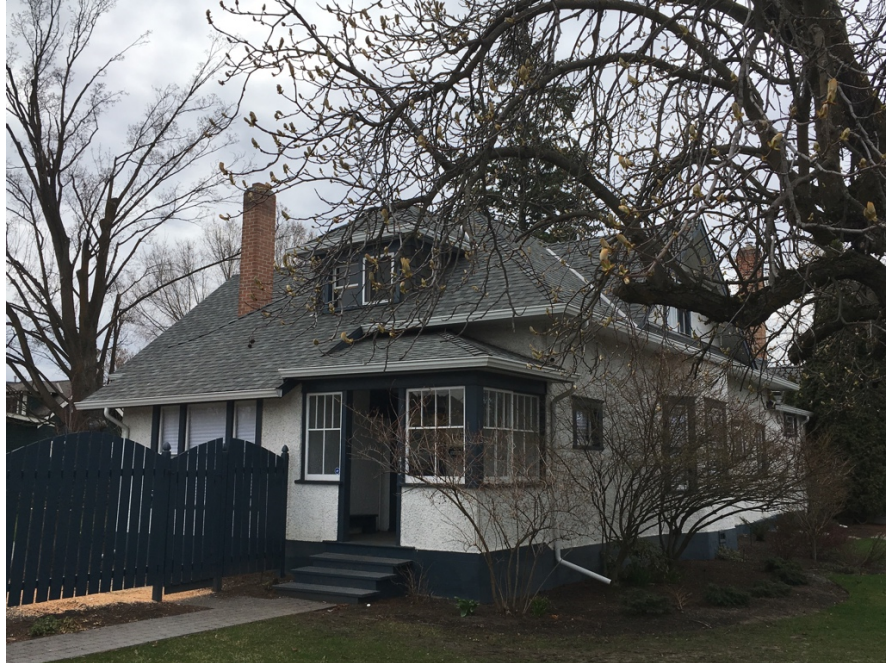
- HAP approval was granted in March 2019 (HAP 19-004). The plans submitted with the approved HAP were based on the following:
 - removal of the front porch addition in 1939 (as shown in the photo below);
 - removal of the fireplace and chimney (due to very poor structural condition). The chimney has separated from the house and would not survive the lifting of the existing house to facilitate construction of the concrete foundation.
 - removal of the east wing addition completed in 1995 (including roof) as shown in the photo below);

East Wing, Fireplace and Front porch to be removed as per approved HAP

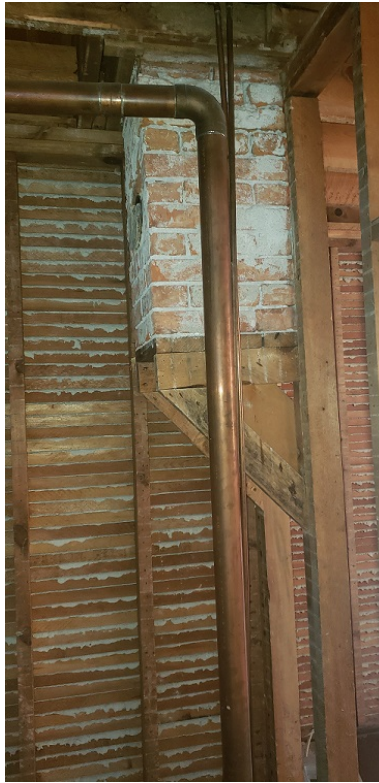
- removal of the south wing addition (completed in 1948);
- removal of the southern portion of the roof (completed in 1939);
- removal of the west dormer and to construct a new dormer to be centered over the bay windows;
- removal of the kitchen chimney due to poor structural condition and inadequate support (would not survive the lifting of the house, as shown in the photo below);

Kitchen Chimney

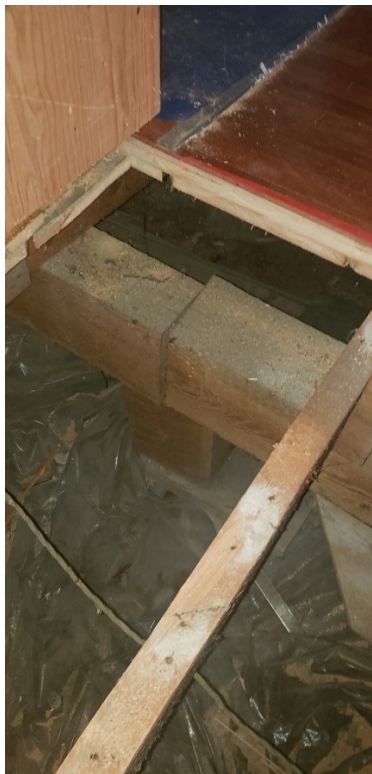
Existing wood foundation

The existing foundation system is structurally inadequate and in contravention of the Building Code. The foundation system could not be upgraded to satisfy the code and will therefore need to be completely replaced.

- raise the central portion of the house in order to construct a concrete foundation, to replace the current wooden foundation (as shown in the photo below);

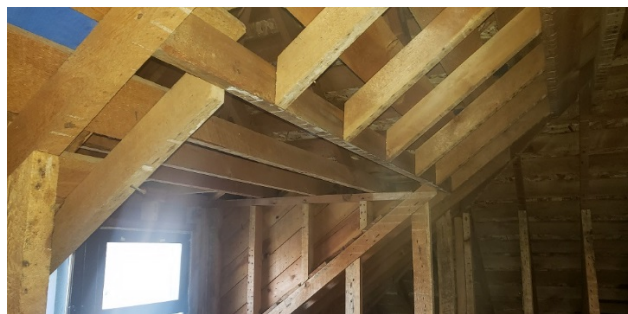
- replace the entire roof due to structural inadequacy (as shown on the photo below);

Existing roof assembly

The roof structure has been heavily compromised during previous modifications to the building to the extent that it would be impractical to consider anything other than complete replacement.
